2019-2020 PSFA Summary of Applicant Campus

Gallup – Crownpoint Middle School (MS) **Rank: 124** **wNMCI: 35.46%** **FCI: 61.63%**

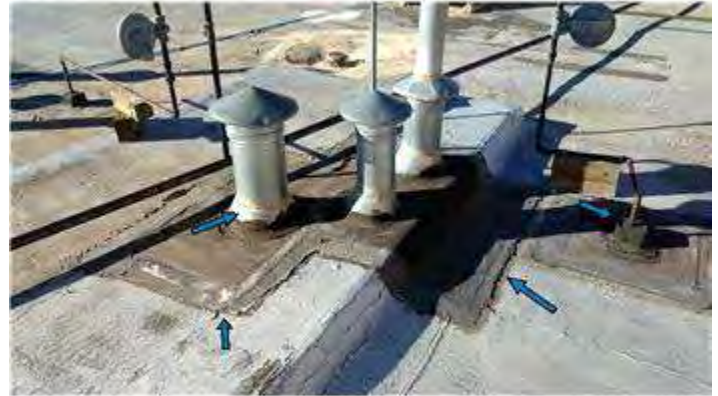
IMG_20181220_094107979

Typical flashings details at various penetrations, Most are open or deteriorated

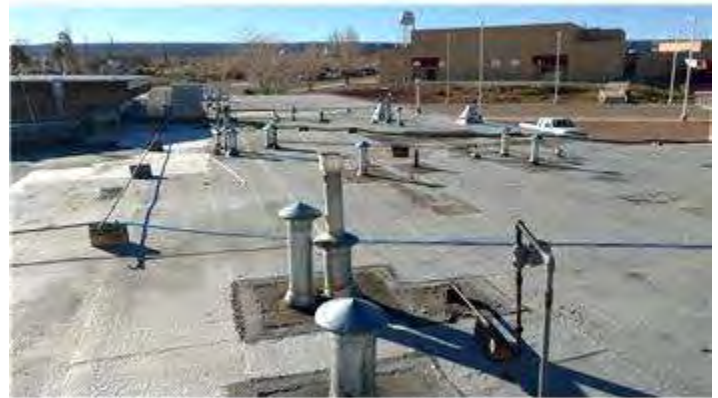
IMG_20181220_094213146

Past repairs using various products.. Cap sheet roofs need to be repaired with asphaltic products and not coatings and silicones

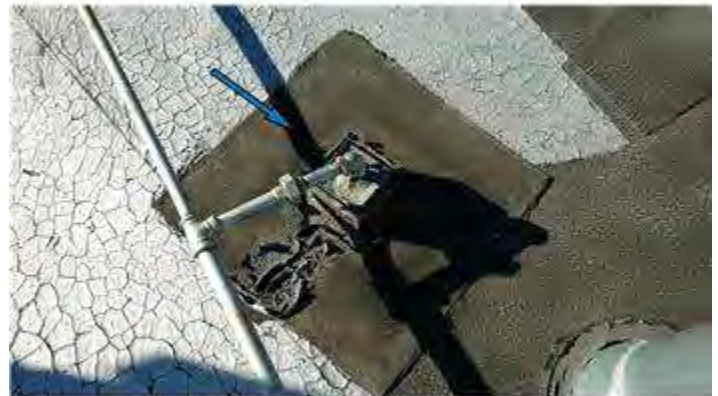
IMG_20181220_094506701

Silicone or similar used to try to stop ongoing leaks
May need to flood test drains for loose fittings

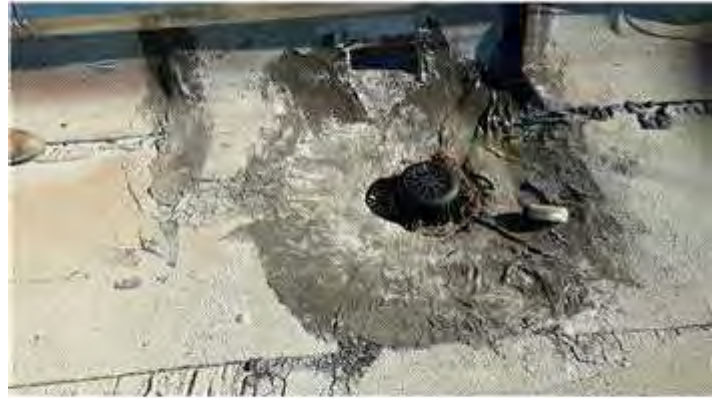
IMG_20181220_111622963

Past repairs at drains.

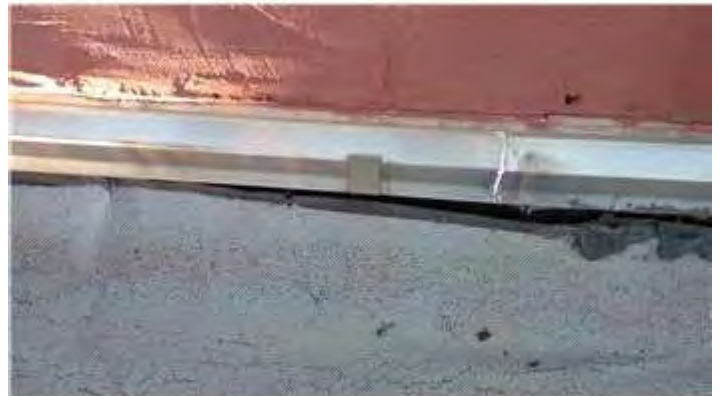
IMG_20181220_111633519

Wall flashings pulling loose and open from cap sheet movement

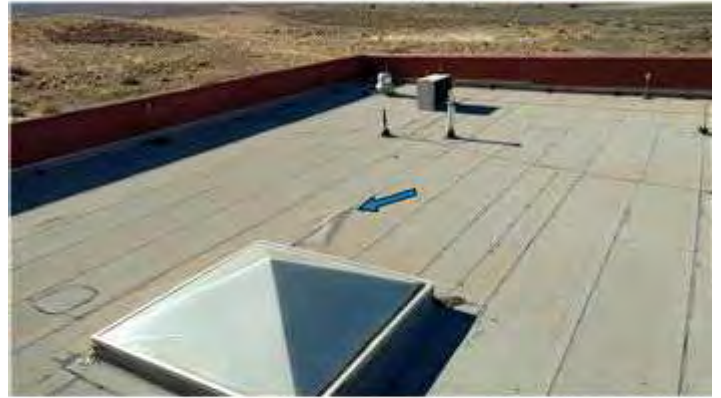
IMG_20181220_111743741

Blistering in field and staining from ridging on roof

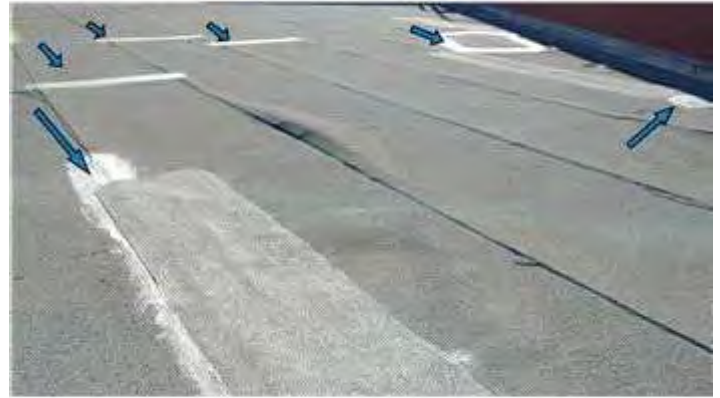
IMG_20181220_113753841
Previous repairs and patches on gym roof

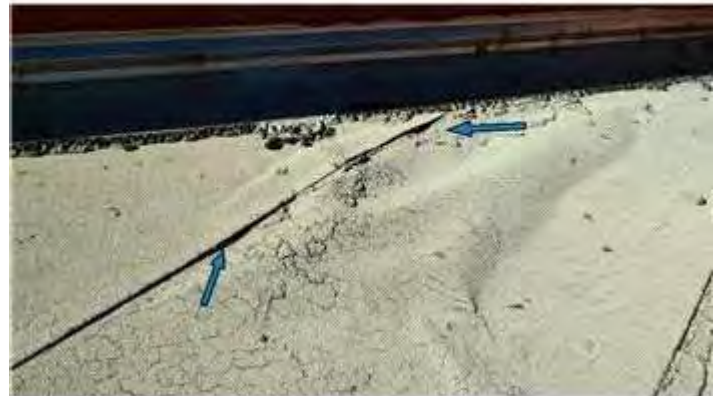
IMG_20181220_113759175
Laps popping open at new blister

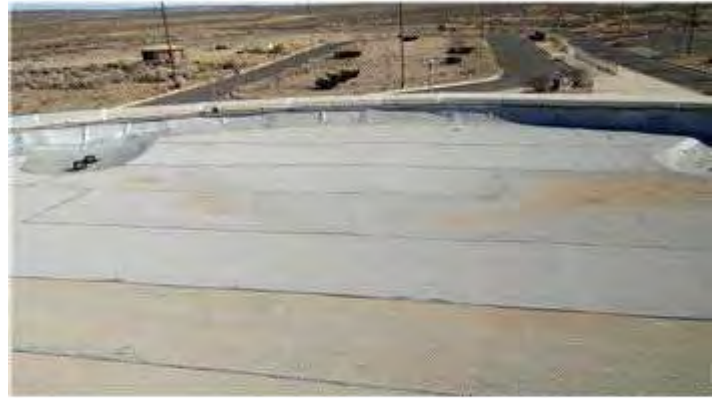
IMG_20181220_113815890

Curved roof section at main entrance to site
Some of the roof had new cap sheet installed recently. Note staining on new roof area from ponding water

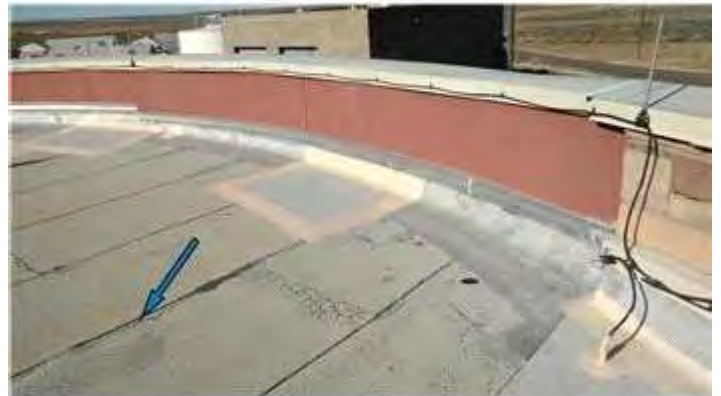
IMG_20181220_113836456

Newer cap sheet area was loose and beginning to blister

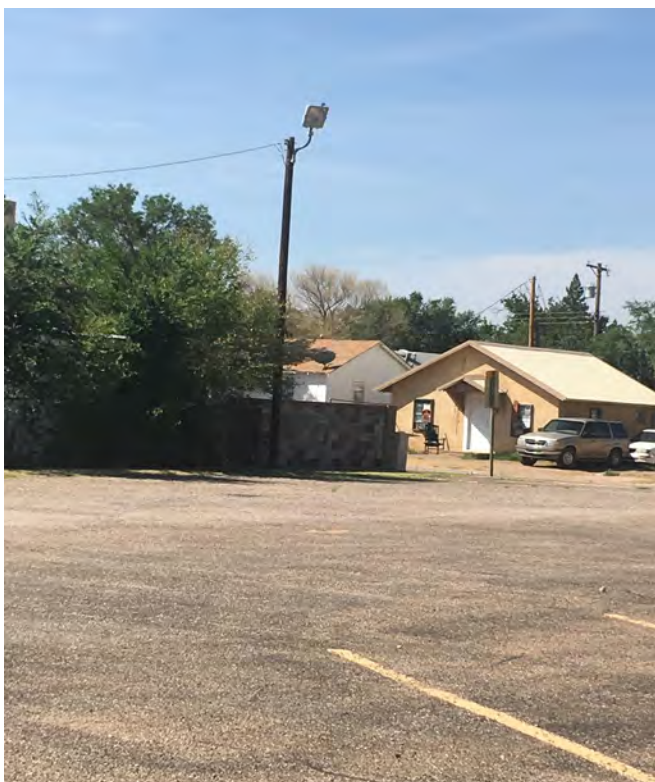
Exposed Subgrade in Existing Parking

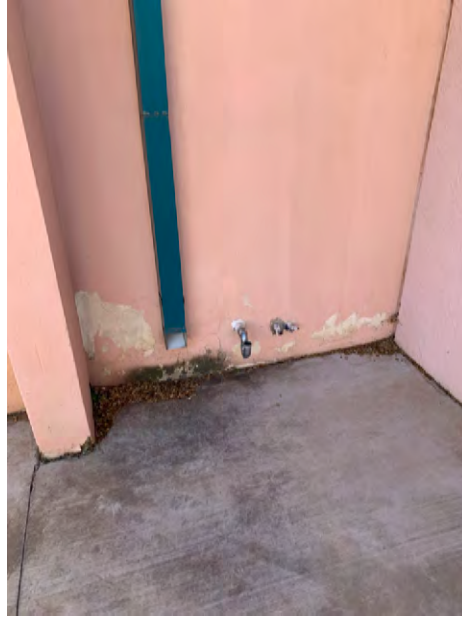
Damaged Plaster

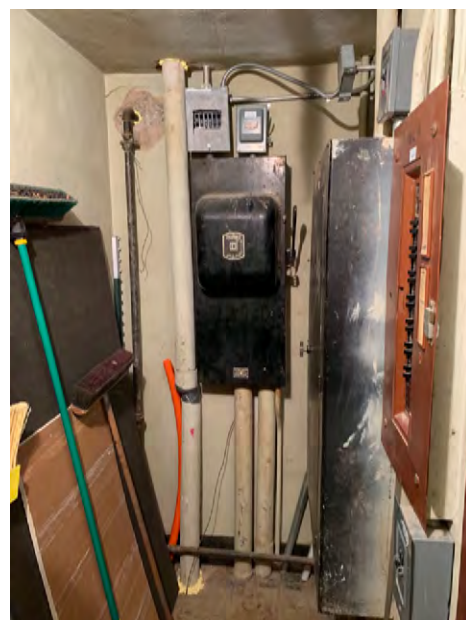
Main electrical room with visible code violation

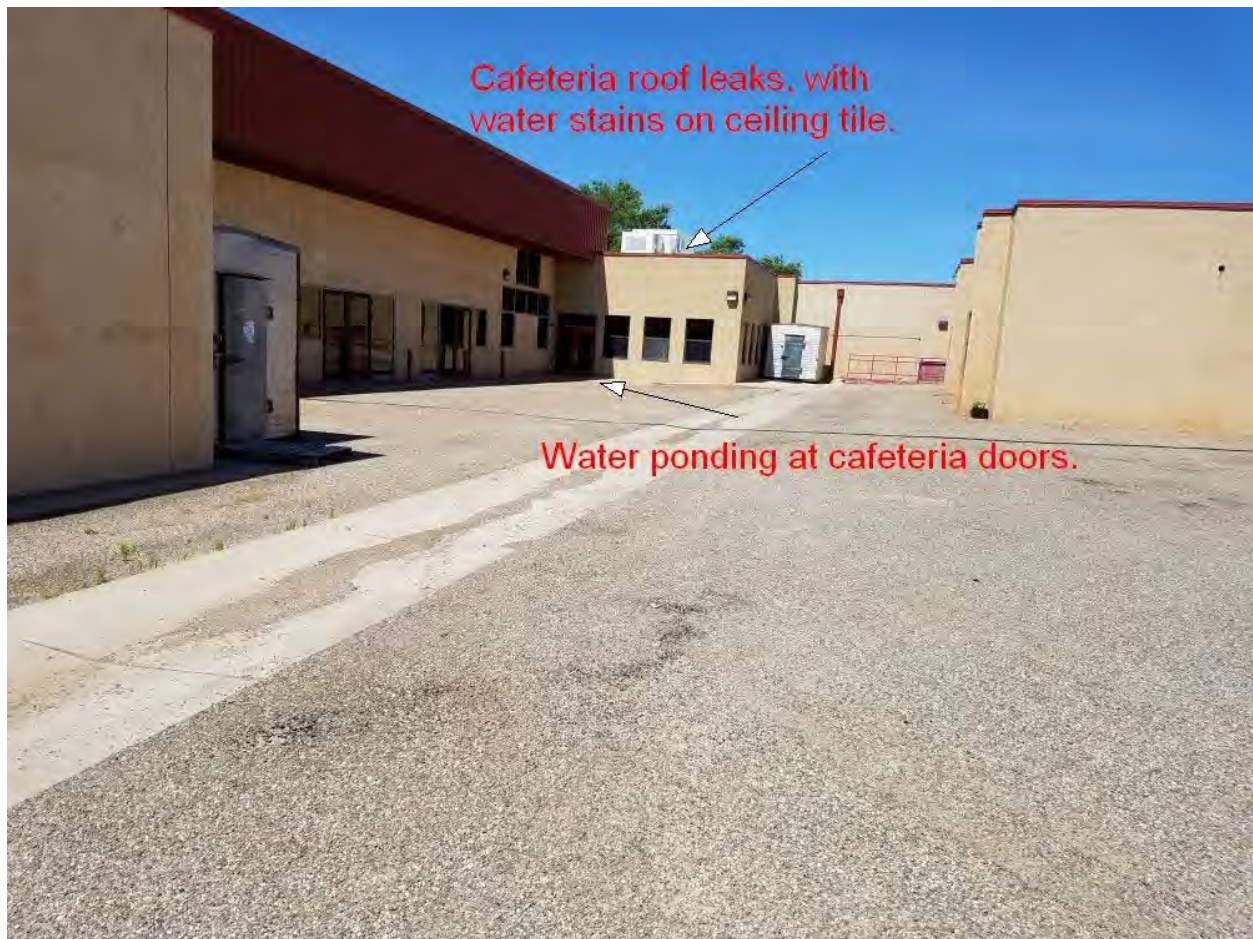
Cafeteria roof leaks, with
water stains on ceiling tile.

Water ponding at cafeteria doors.

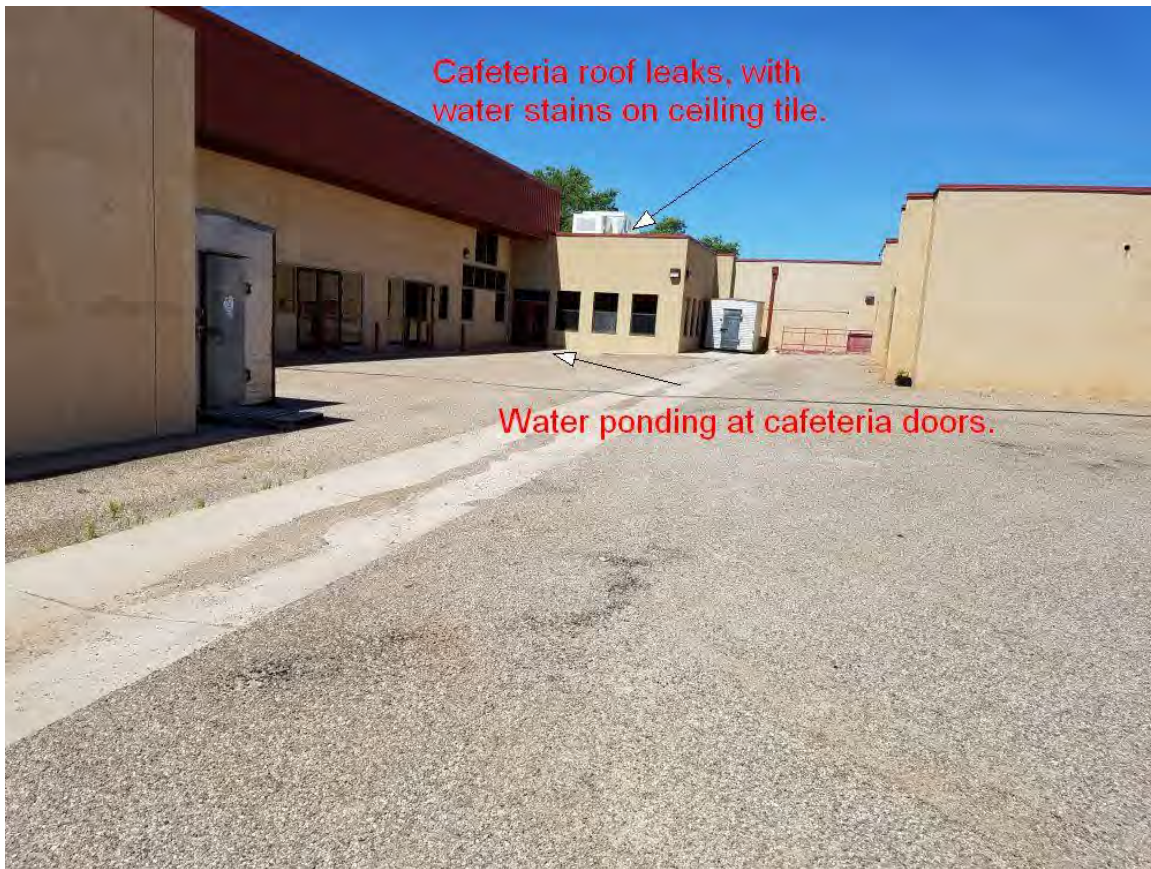
Cafeteria roof leaks, with
water stains on ceiling tile.

Water ponding at cafeteria doors.

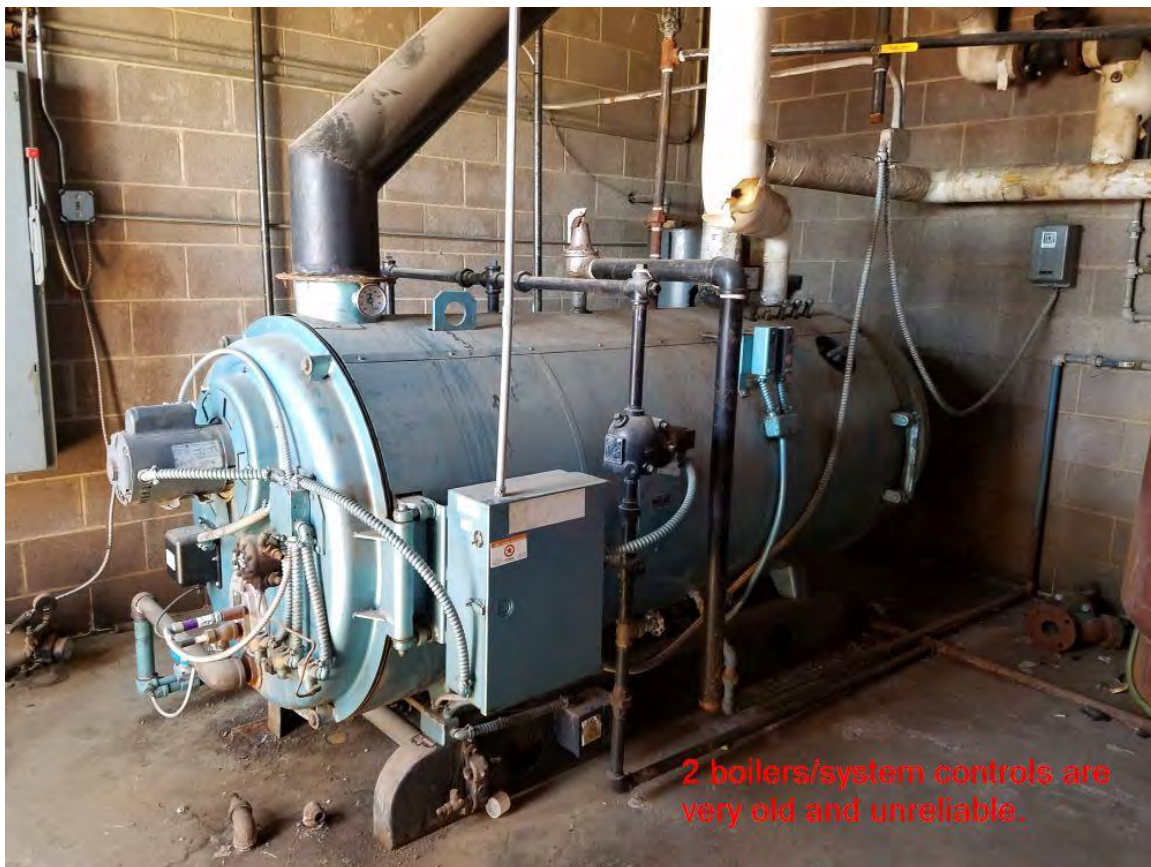
2 boilers/system controls are
very old and unreliable.
