PUBLIC SCHOOL CAPITAL OUTLAY COUNCIL

**PUBLIC SCHOOL CAPITAL OUTLAY COUNCIL (PSCOC)
AGENDA**

2018 / 2019 PSCOC SYSTEMS-BASED
FUNDING REQUEST
PRESENTATION INFORMATION FOR
BERNALILLO MIDDLE SCHOOL

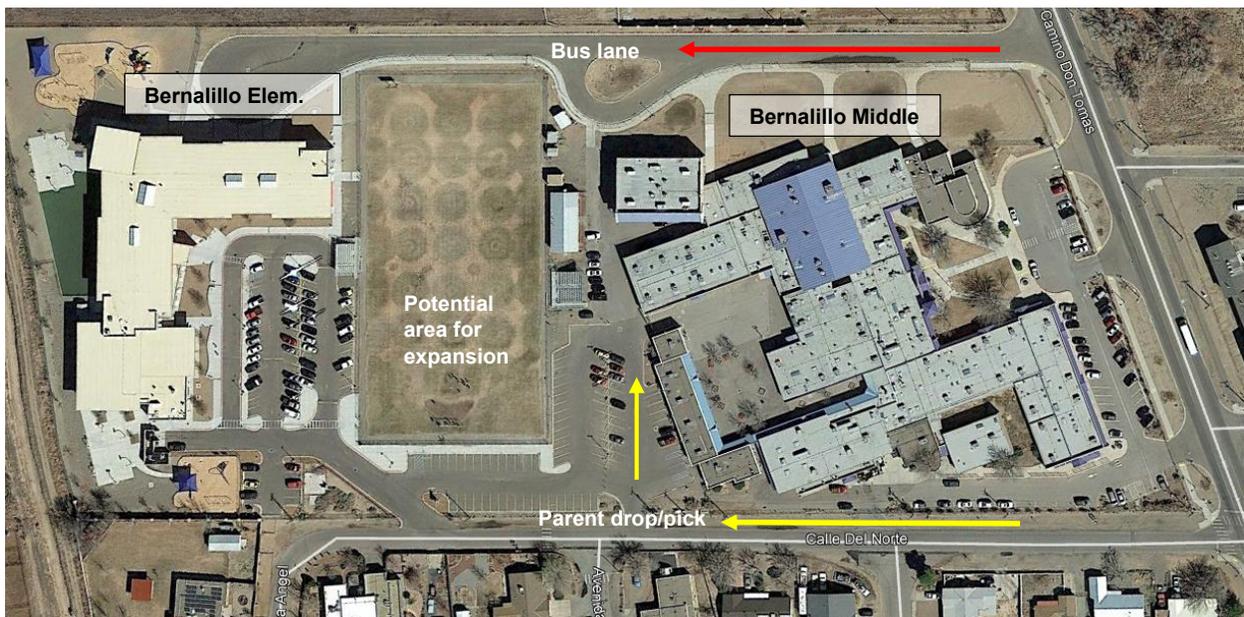
BMS shares the site with BES. The site is congested and requires reconfiguration to accommodate traffic, provide adequate parking and safe access. PSFA Site Visitation team recommends the District consider utilizing the current bus drop-off for parent loop and move busses to the shared parking lot. This modification would also require some site modifications at a loss of parking spaces.

- Parking lot improvements includes the reconfiguration of the existing site layout to address the lack of parking and vehicular traffic in the vicinity. The parent pick-up and drop off lanes are currently within the parking lot on the west side of the building posing a safety threat to pedestrians/students. The adjacent street, Calle del Norte is congested and does not provide for clear access in and out of the campus.

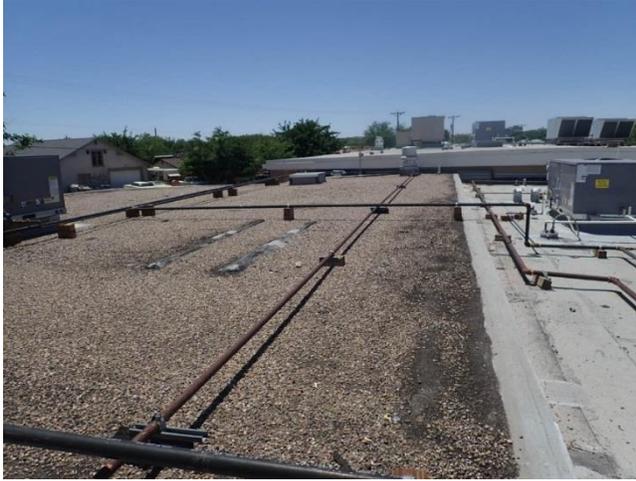
- **Roof replacement** is intended to address multiple leaks and ceiling tile staining a various locations including roof penetrations, expansion joints, equipment curbs and roof flashing. At the recommendation of the PSFA Site Assessment team, the District obtained a Roof Condition Assessment on the entire school building.

The recommendation is for a full replacement in lieu of a fluid applied membrane system.

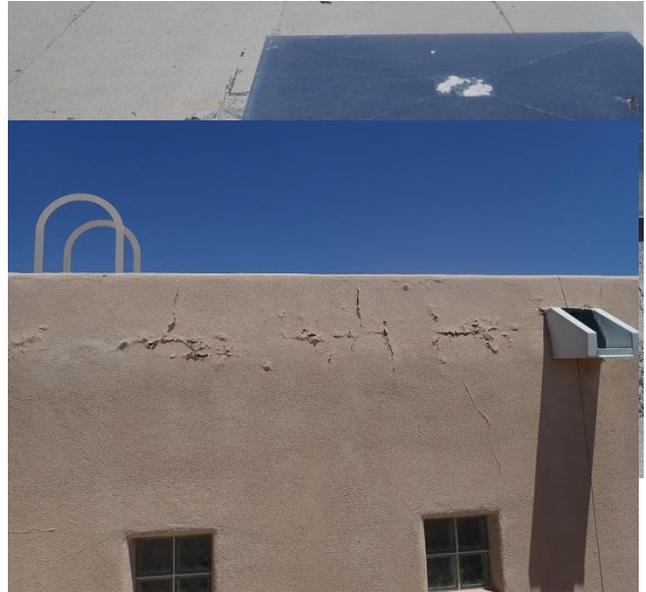
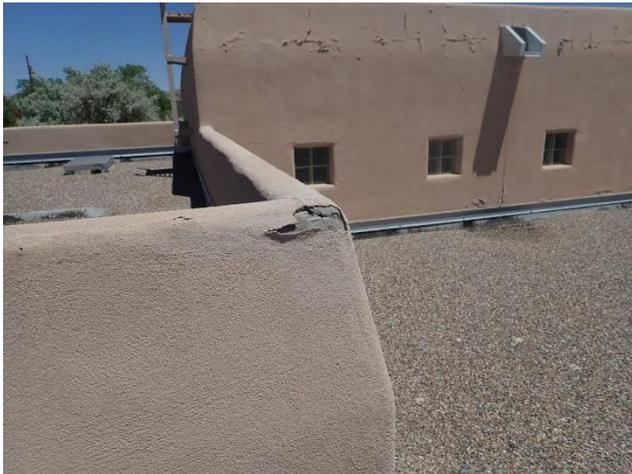
- **Exterior Stucco Repairs** at the library building are required to prevent water damage.

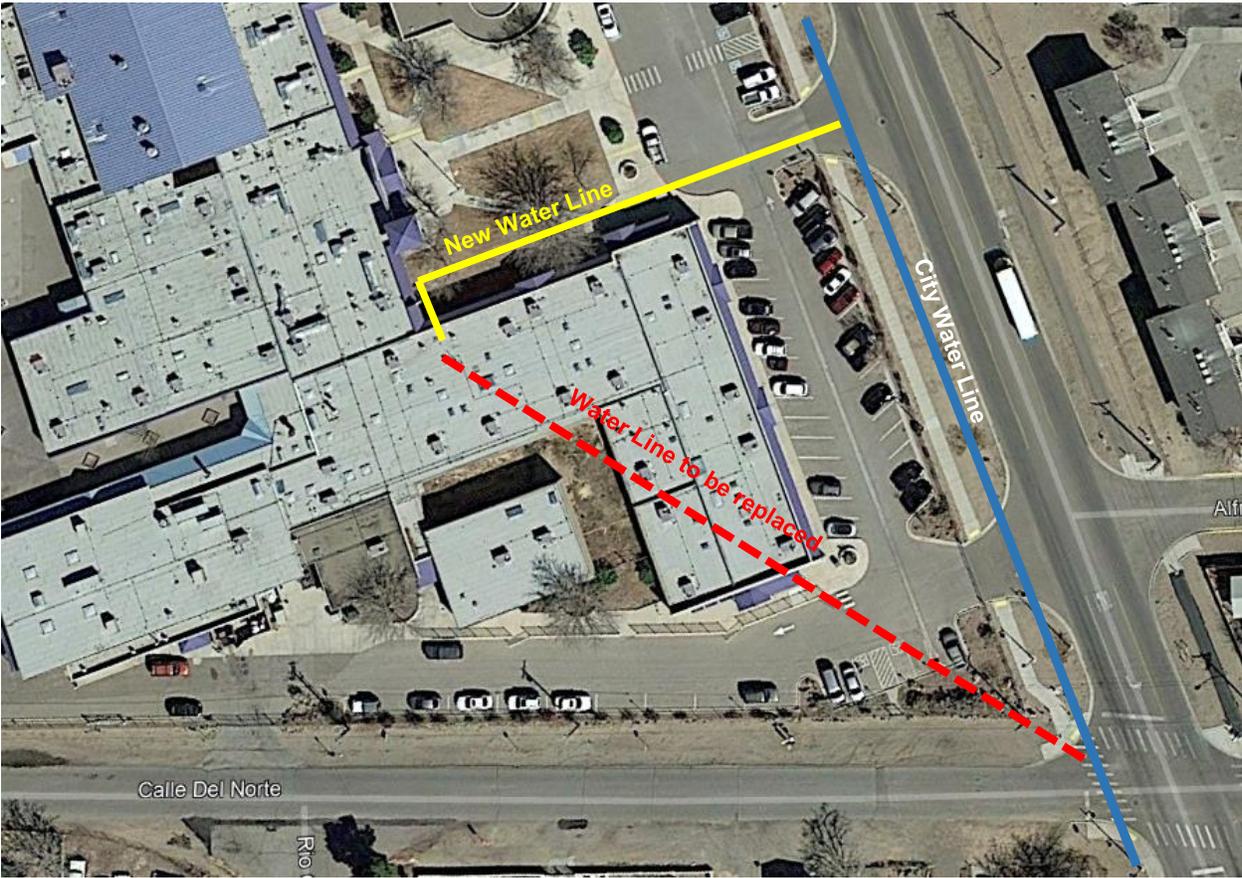
Water line replacement proposal

The existing water line runs diagonally under the building to the main equipment room. The line has ruptured in previous years and has been repaired cooperatively with the Town of Bernalillo.

to the original 1957 construction and is subject to rupture at a future undetermined date that would render the entire school unusable. As a preventive measure, the District is requesting funds to assist with the replacement of the line rerouting it to the front of the school.

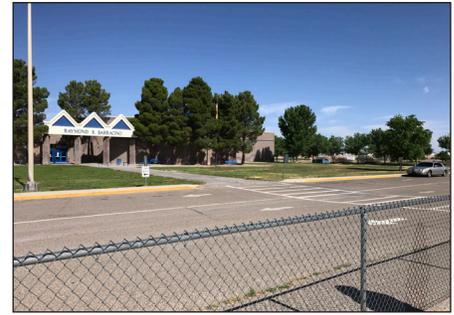
Front Parking Lot and Parent Drop

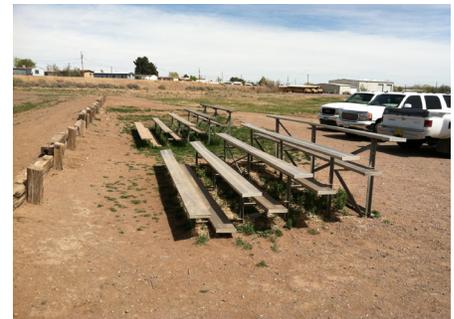
Bleachers and Unpaved Track

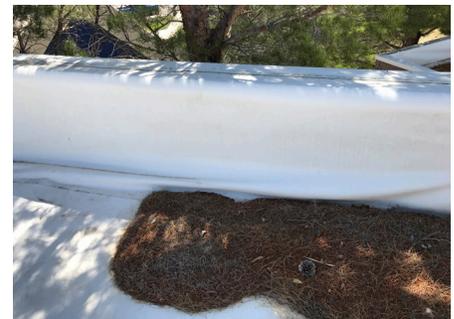
Roof Debris

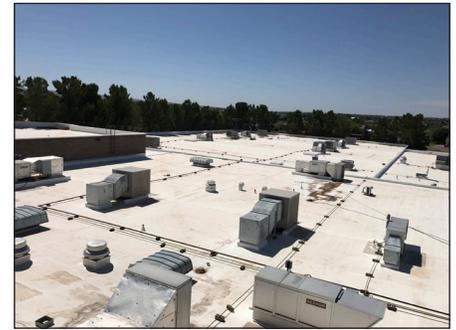
Roof Top Combo Units

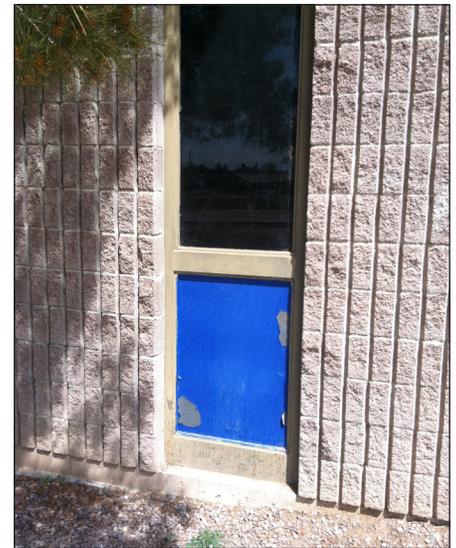
Exterior windows

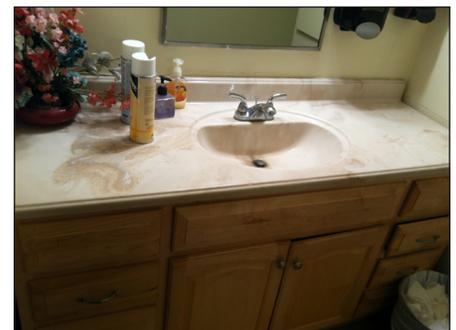
Non ADA Compliant Plumbing Fixtures

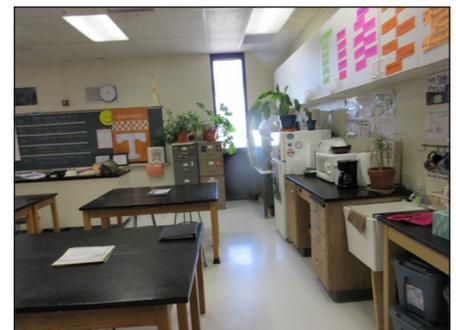
Deteriorated Science Lab Casework, Inoperable Sinks and Gas Supply. (All Science Labs)

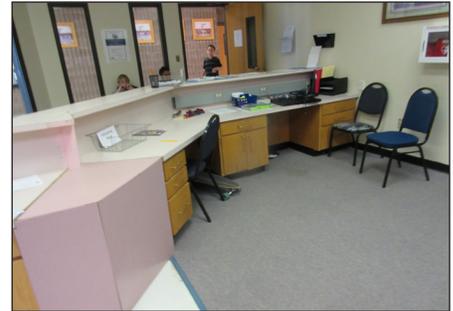
Central Office - No Direct View to Main Entry

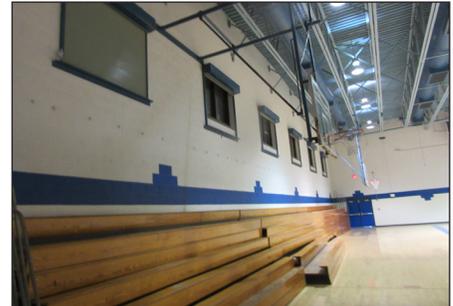
Gym Bleachers need replacement

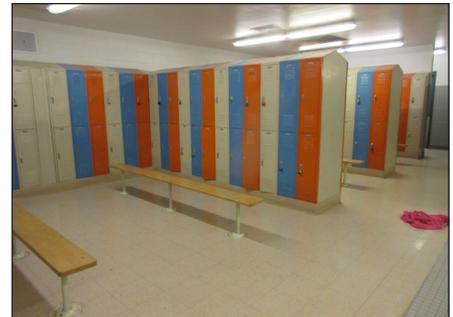
Locker Rooms Need Complete Renovation

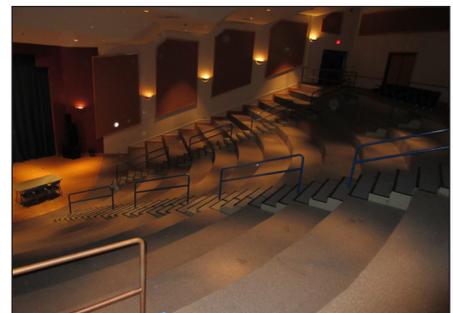
Auditorium - Needs Complete Renovation

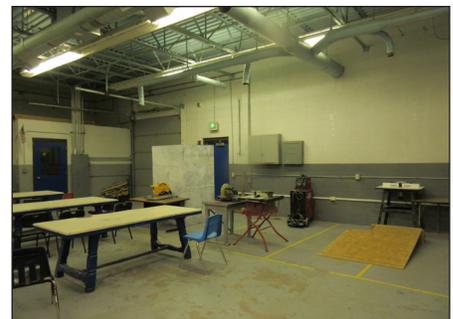
No Dust Collection or Exhaust Systems in Wood/ Metal Shop

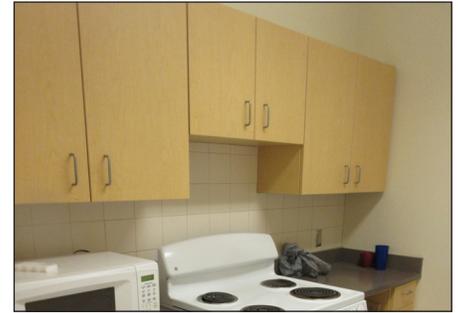
Cooking Stations do have ventilation system

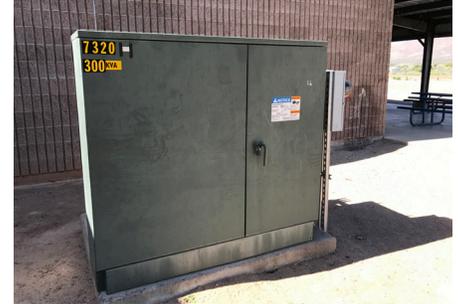
No Protection Around Transformer

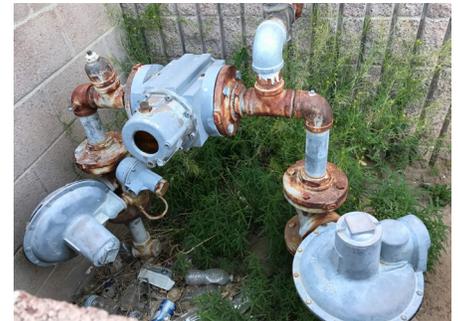
Gas Meter Needs Replacement

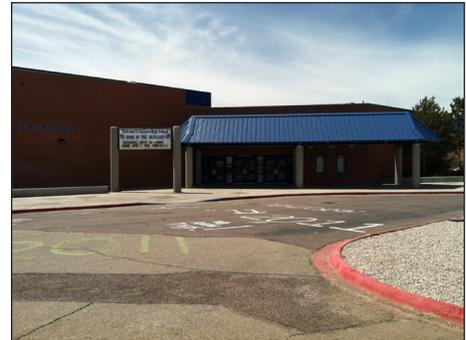
Main Entry - Deteriorated Asphalt

Parking lots at Socorro High show cracking and pot holes in various locations. While some areas are in more need of repair than others resurfacing or top coating and restriping are required.

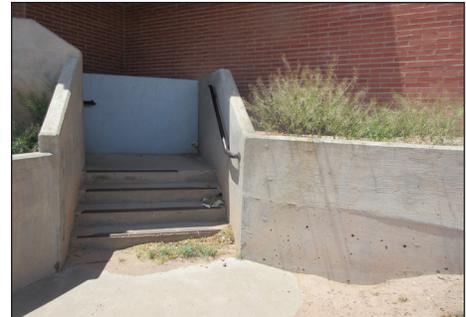
Exit needs to be cleaned and new handrails

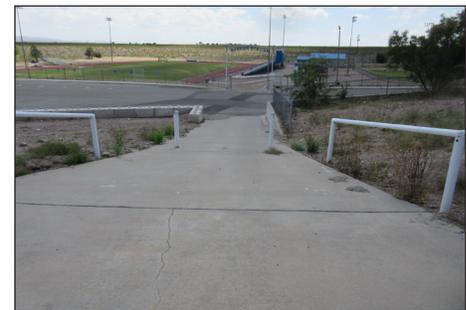
Ramp is too steep to access Playfields for ADA

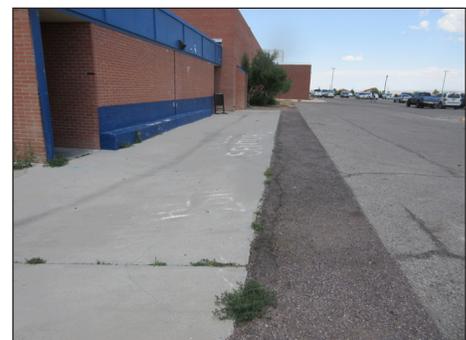
Multiple cracks and patches throughout

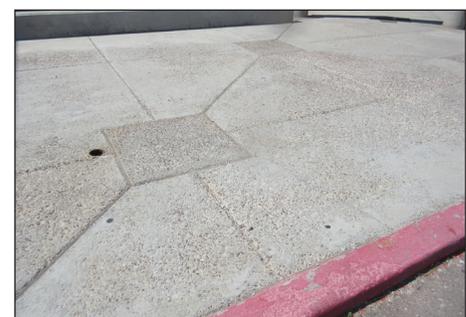
Spalled Concrete Sidewalks

Sidewalks have lifting and cracking. Many areas have spalled surfaces and are in poor condition requiring repair and replacement.

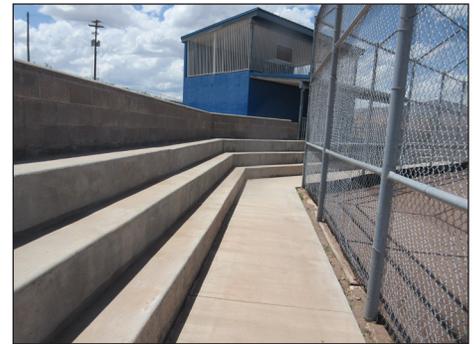
No handrails to access seating

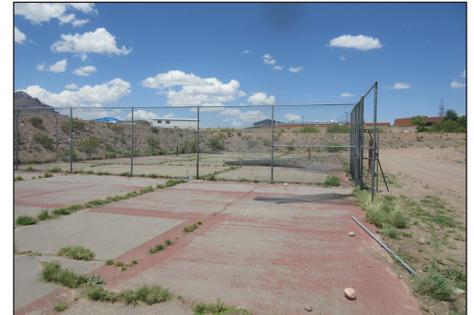
Dilapidated Tennis Court - Need Demo

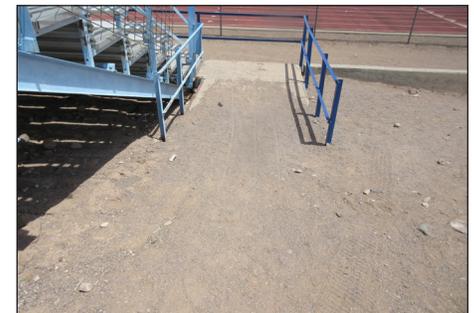
Poor ADA access to Bleachers at Football Field

Currently the school has a large developed football field with track that is in the process of having artificial turf installed and the track resurfaced as of Spring 2018. There is a fully developed baseball field with a press box and with built in bleachers, the railroad ties that are used as steps up a dirt path to access the bleachers at the baseball field are not ADA compliant nor are the concrete stairs at the bleachers. The baseball dugouts area in poor condition

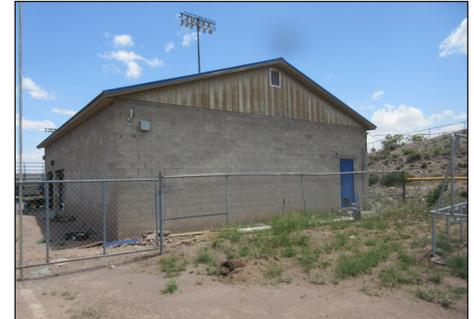
Maintenance Needed at Concession & Field House

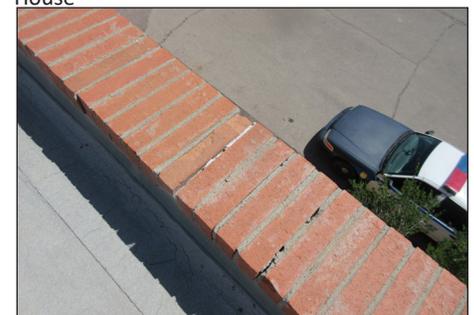
Deteriorated Brick Copings

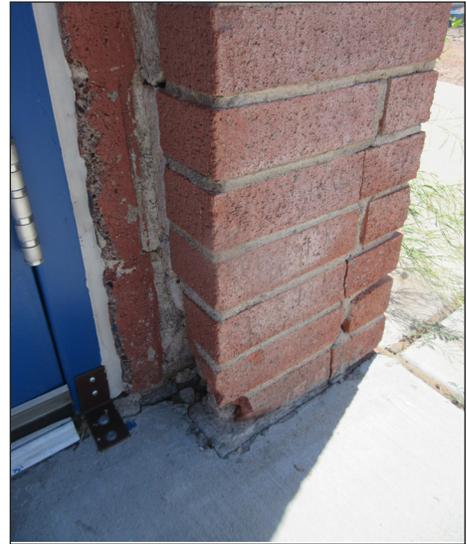
Deterioration of Exterior Brick Veneer

The exterior walls show cracking and weathering. The majority of the exterior walls were constructed in 1966. There are numerous mortar repairs and restoration to be made.

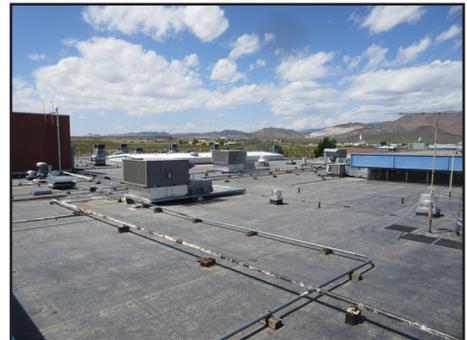
Old Roofing Areas - Need Replacement

There are four roof systems in place on the Main Academic Building: metal “R” panel’s, mechanically attached EPDM and TPO single-ply systems, and over the library the roof consists of an old “tar and gravel” asphalt roof system. There are multiple areas where punctures and patches were visible, roof drains without covers, tree debris, missing or poorly attached roof ladders, as well as several areas that have had long-term ponding. The brick parapets are deteriorated, cracked and in poor condition allowing water to infiltrate the building envelope, and there are multiple wires and conduits across the roof that need to be traced to find out what is active or not and all active lines need to be installed in conduit and properly put on roof jacks. Apart from the roof areas with TPO roofing which only need maintenance, the remainder of the entire roof needs a complete replacement and will require installation of additional insulation to meet current NM Energy Code requirements. All metal/stucco soffit/fascia panels that needs to be replaced as there are areas of continuous leaks and fascia/ flashing damage around the perimeter. The roof over the CTE Building consists of metal “R” panel’s and a single-ply asphalt system with a pea gravel ballast. While the roofing for this building was installed in 2011, it needs maintenance, all flashings/copings need to be resealed, roof drains cleaned, and the screws at the metal panel laps need to be inspected and retightened.

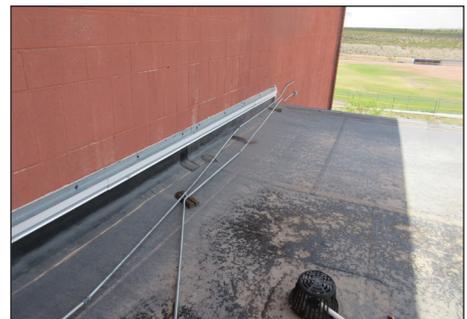
Old Roofing Areas - Need Replacement. Wires Not In Conduit

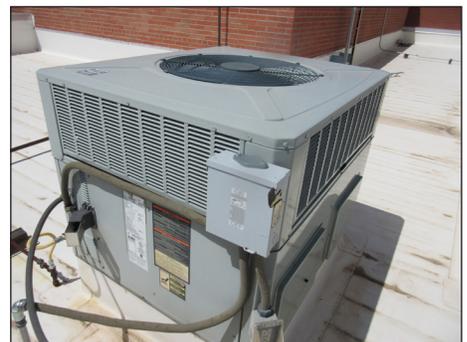
Upgraded Equipment - Band Room Area

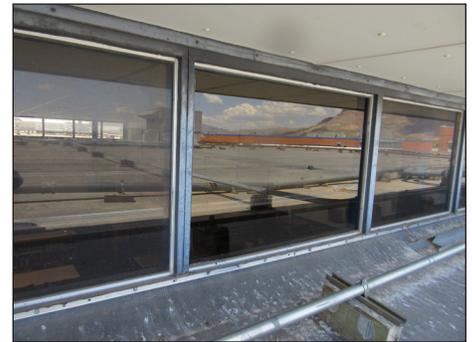
Clerestory Windows at Media Center

A majority of the Main Academic Building does not have exterior windows in the classrooms, the areas that do are the original steel single pane window units. In all other areas the window units are in hollow metal frames and are double-glazed. The windows at the south and west sides of the cafeteria have had multiple issues with leaks, and many of the glazed units have had broken seals and condensation inside. This is an on-going issue as the glazing has been replaced several times. Around the perimeter of the library is a clerestory window system that needs replacement.

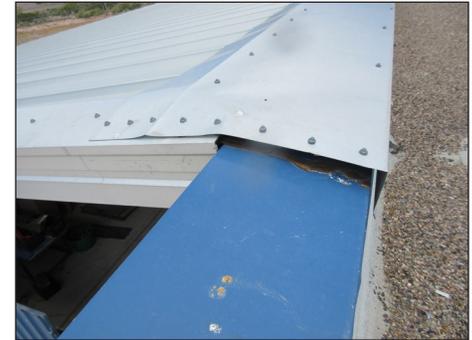
Improper Flashing At CTE Building

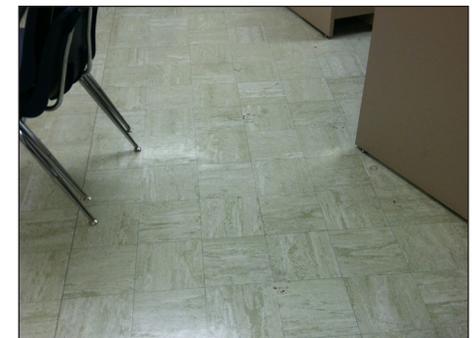
Multiple Areas with Original VAT Flooring

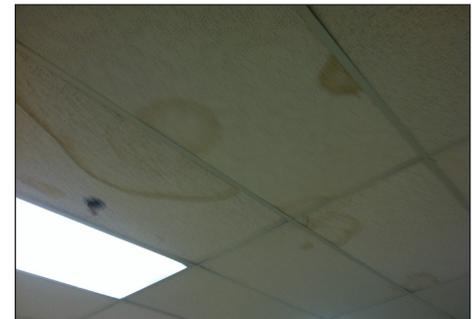
Damaged Ceiling Tiles from Roof Leaks

The ceilings throughout consist of four types: exposed structure, painted gypsum board or plaster, and 2'x4' suspended ceiling tile system. There are numerous stained ceiling tiles throughout the Main Academic Building from both current and previous roof leaks. The remainder of the ceiling system is in fair condition and should just require replacement of damaged/stained tiles.

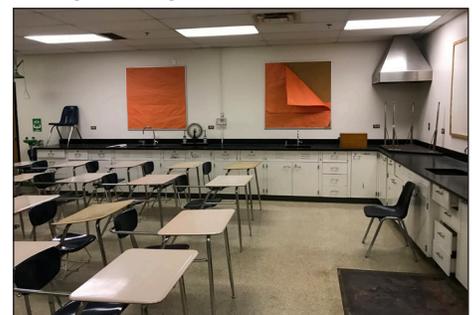
Old Science Lab Needs Renovation

in that area of the building have the original casework that needs to be replaced or no storage casework at all which needs to be installed. Security of the facility is a district priority, currently the school does not have a “true” secure entry and has installed a door bell/ camera, however it does not prevent anyone from once gaining access from the building not going directly to the Administration Office; based on the current layout of the entrance and administrative area without a visual connection, it is recommended that consideration be given to relocation the administration office into Classrooms 101 and 103 which would allow for a secure entry vestibule and visual site lines to the front doors and reconfiguration of the existing administration area into academic space such as a STEM Lab to help support the schools move towards project based learning.

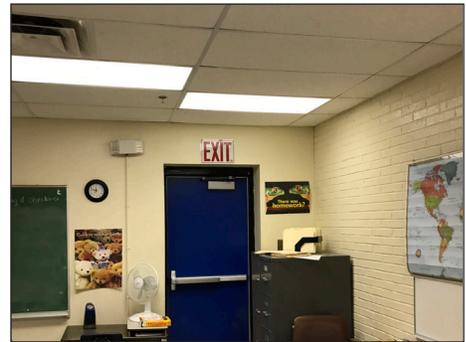
Illuminated Signage Needed

illuminated, however there are several emergency exit locations that do not have illuminated signage which need to be installed. All exterior building light fixtures should be replaced with LED fixtures with photocells as the existing is in either poor condition or non-operable.

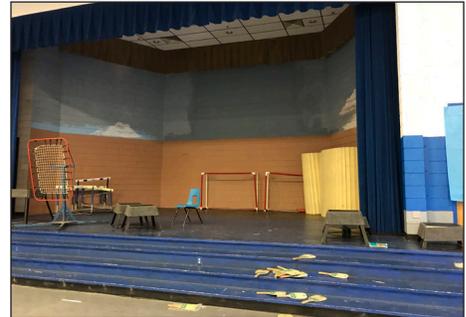
Renovation of Auxiliary Gym Needed

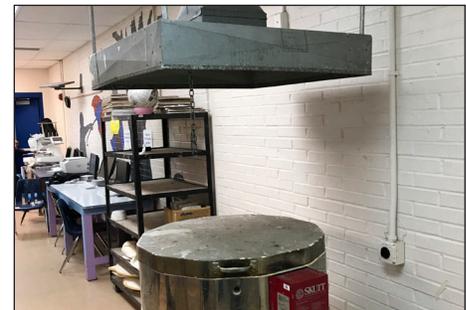
Relocate Kiln in a secure area with ventilation

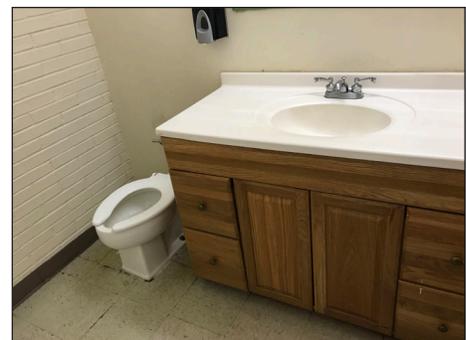
Residential Grade Casework in Admin Areas

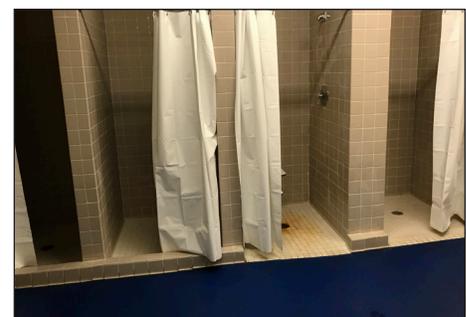
Locker Rooms only Received Partial Upgrades

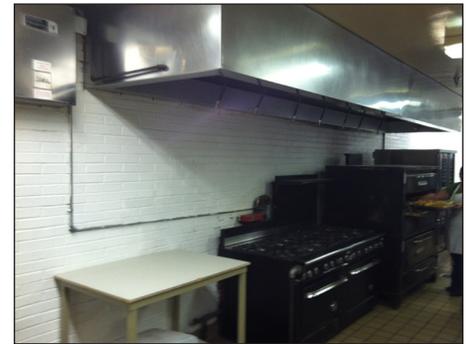
Old Kitchen Equipment - Needs Renovation

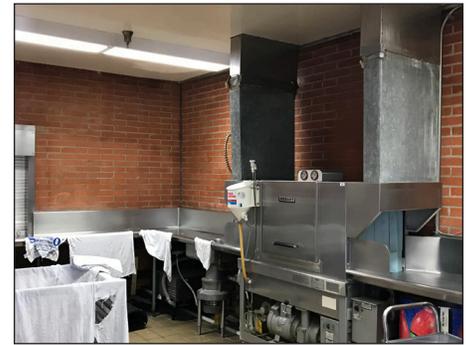
Old Kitchen Equipment - Needs Renovation

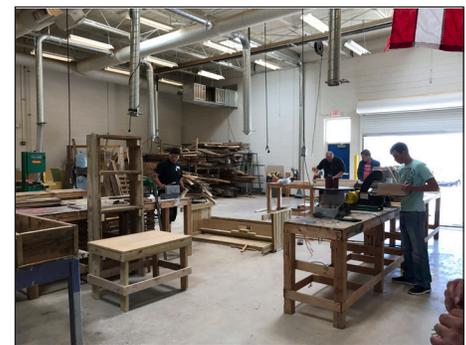
Equipment disconnected from Dust Collection System in Wood Shop

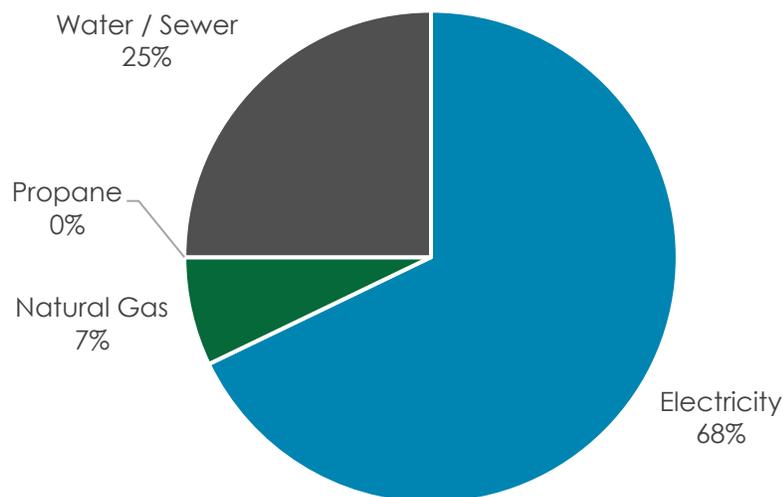
Figure 1: Baseline Annual Utility Cost Breakdown

Utility	\$/Year
Electricity	\$380,000
Natural Gas	\$40,000
Propane	TBD
Water / Sewer	\$140,000
Total	\$560,000

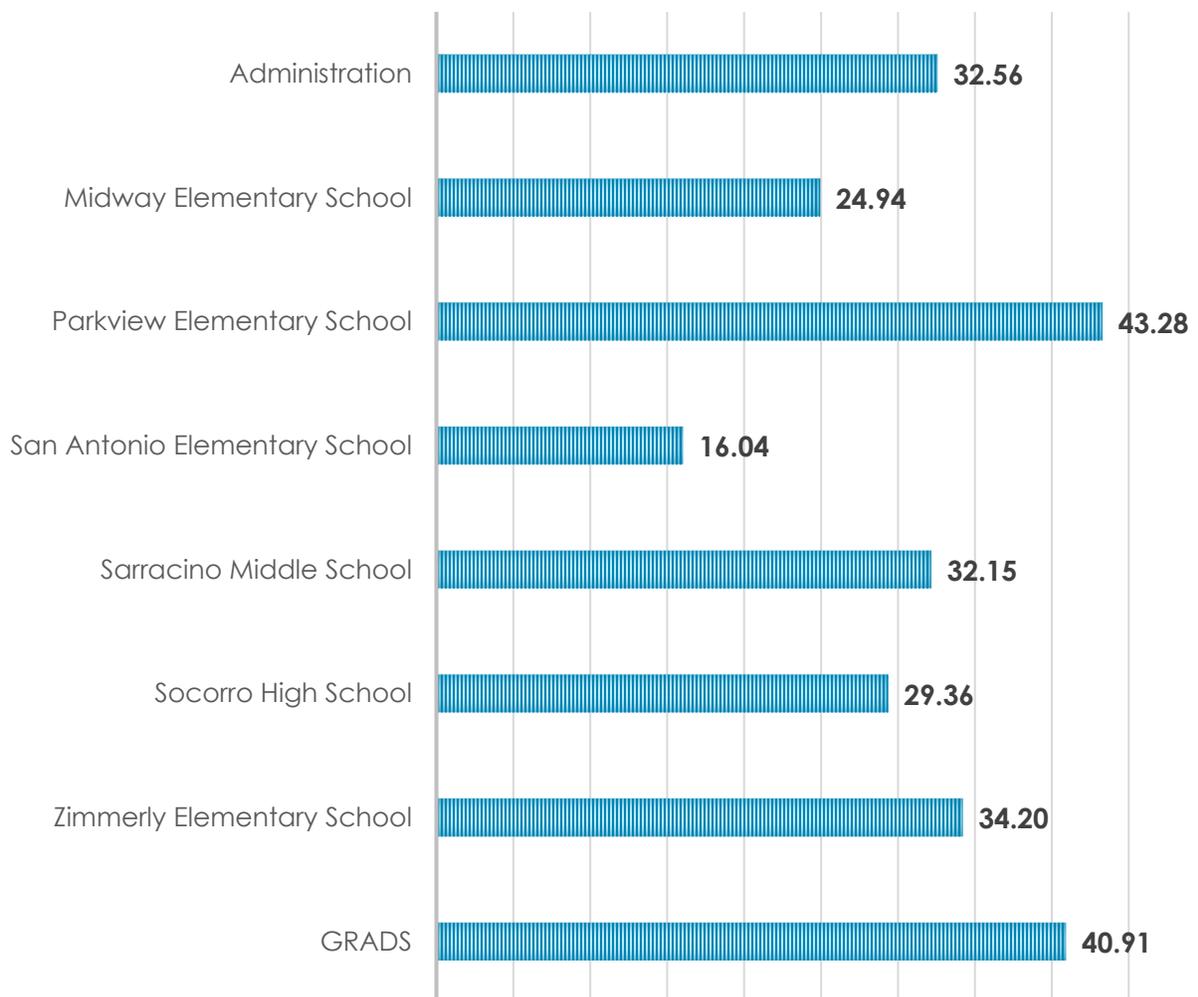
Figure 2: Baseline EUI Comparison (kBtu/ft²/Year)

A common approach to benchmarking a facility is through the comparison of the facility's Energy Utilization Index (EUI) against that of similar facilities. The EUI is determined by dividing the total annual energy consumption by the area of the facility (kBtu/ft²/Year). The lower the EUI, the better the energy performance of the facility. The following table and chart depicts the EUI for each facility included in the feasibility study.

Provided utility information was incomplete at the time of this preliminary analysis. These figures are subject to change during the Investment Grade Audit.

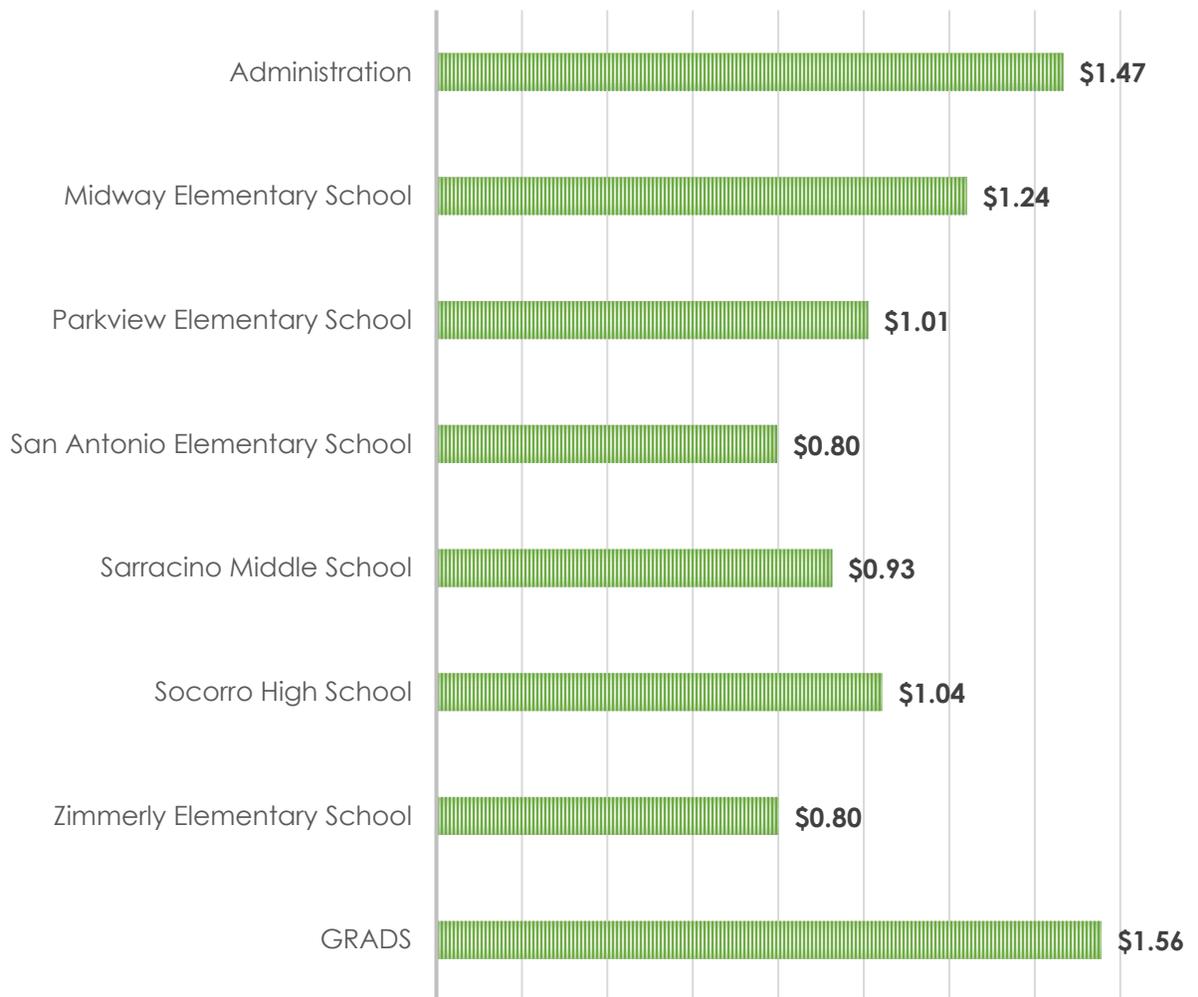
Figure 3: Baseline ECI Comparison (\$/ft²/Year)

Another common method for benchmarking a facility is through the comparison of the facility's Energy Cost Index (ECI) against that of similar facilities. The ECI is determined by dividing the total annual energy utility cost by the square footage of the facility (\$/ft²/Year). The lower the ECI, the better the energy cost performance of the facility.

Provided utility information was incomplete at the time of this preliminary analysis. These figures are subject to change during the Investment Grade Audit.

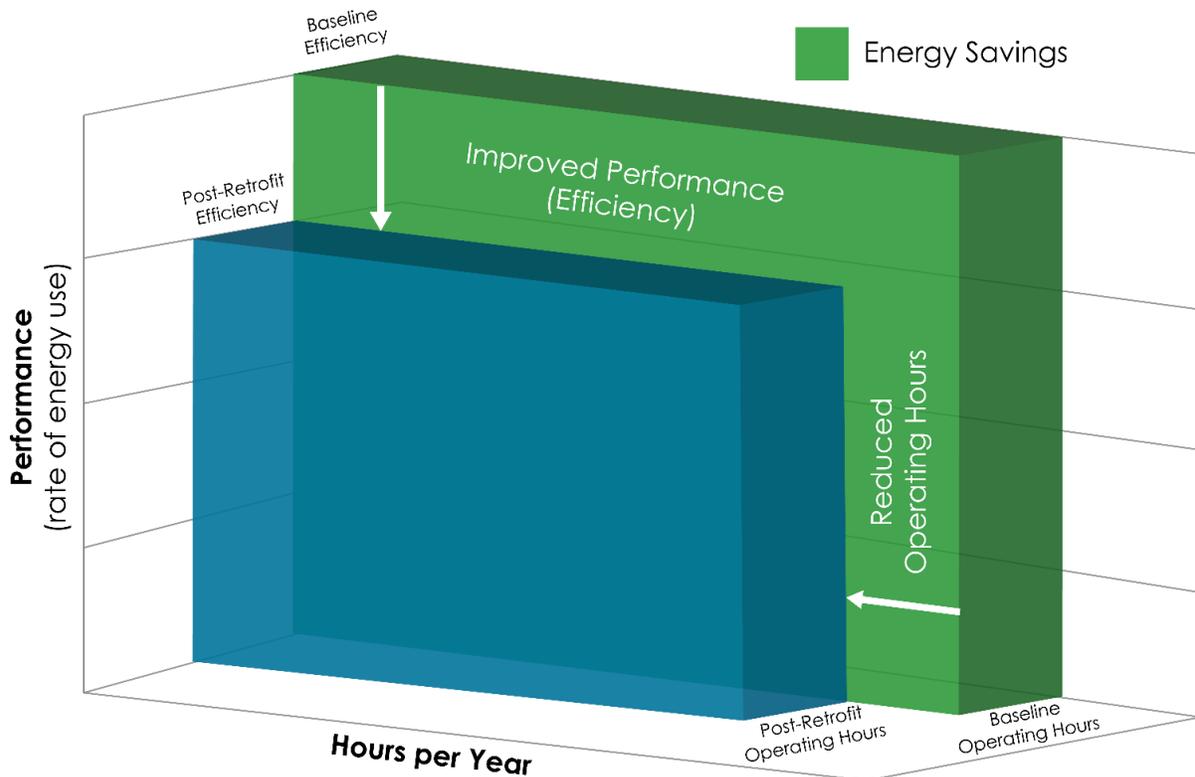
Figure 14: Energy Conservation Measures (ECM) Diagram

The two fundamental factors contributing to energy savings are performance and duration. Performance describes how much energy is being used to accomplish a task, while duration describes how much time the task operates.

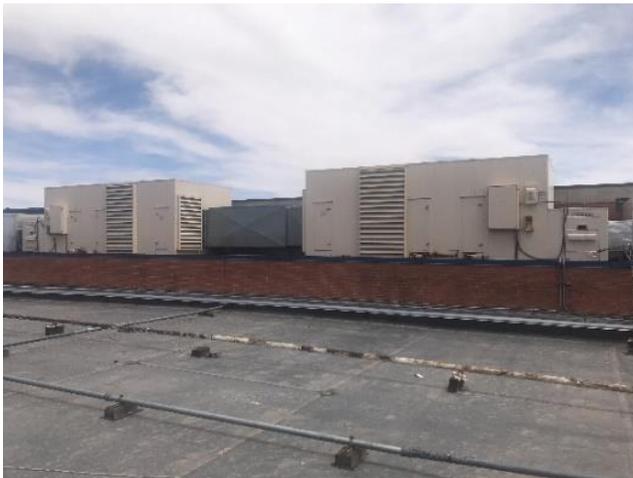
Socorro High School

These aged HVAC Units serving the High School gymnasium have met the end of their useful life and are in need of immediate replacement.

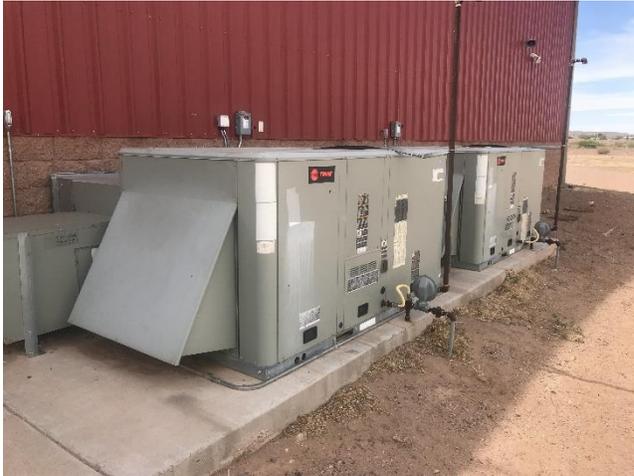
Midway Elementary School

One of the two HVAC units serving the cafeteria / gym area at this facility is currently non-operational and in need of replacement.

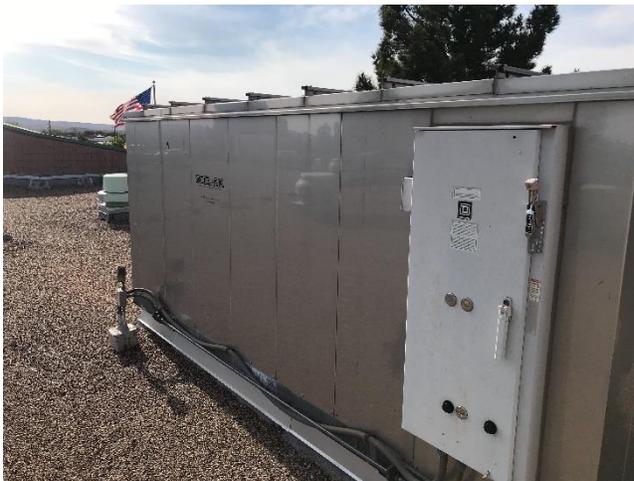
Parkview Elementary School

Several areas within this facility are currently served by aged evaporative cooling equipment. The District has a strong desire to replace this equipment with new high efficiency mechanical cooling equipment which will greatly improve occupant comfort.

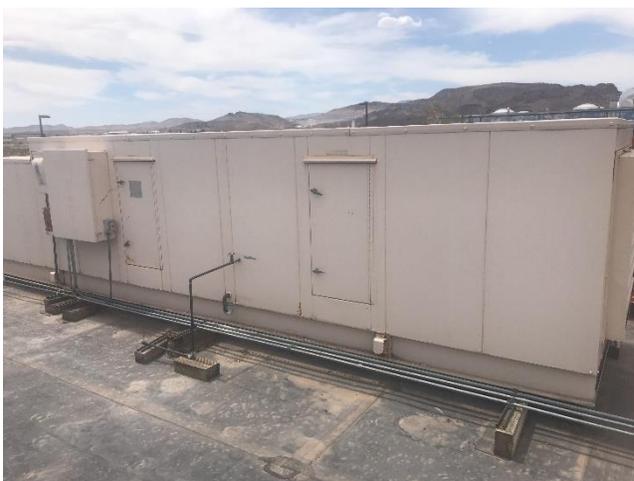
Socorro High School

This unit serving the High School kitchen is currently out of operation due to equipment failure. The occupants of this space are currently working in an uncomfortable indoor environment.

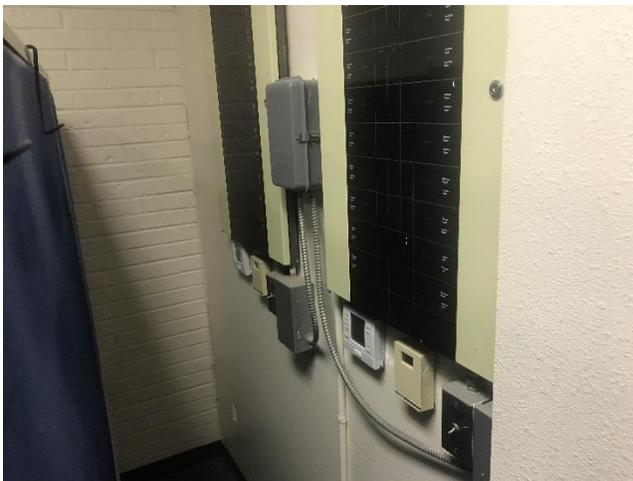
Socorro High School

The HVAC controls at the High School are aged and in need of replacement. This equipment provides no remote access to the maintenance team, requiring a visit to the facility for every service call.

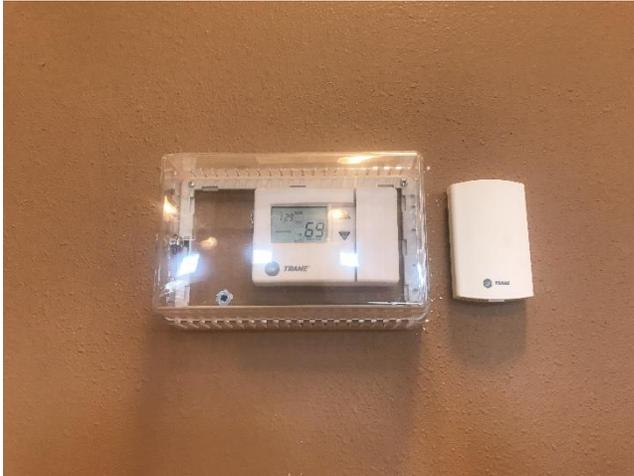
Midway Elementary School

Several of the District's facilities are currently equipped with standalone thermostats, such as the one shown in this photo, which provide no remote visibility or troubleshooting capabilities. This thermostat serving the gym/cafeteria is set to maintain a cooling space temperature of 69°F, which is much colder than what is necessary to provide a comfortable indoor environment for occupants.

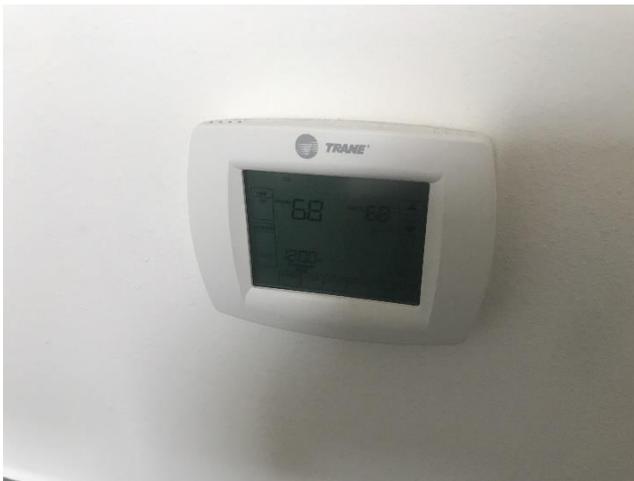
Socorro High School

This standalone thermostat serving the band area is not only set to maintain a cooling space temperature of 68°F, but is also in "permanent hold", forcing the equipment to operate during unoccupied periods.

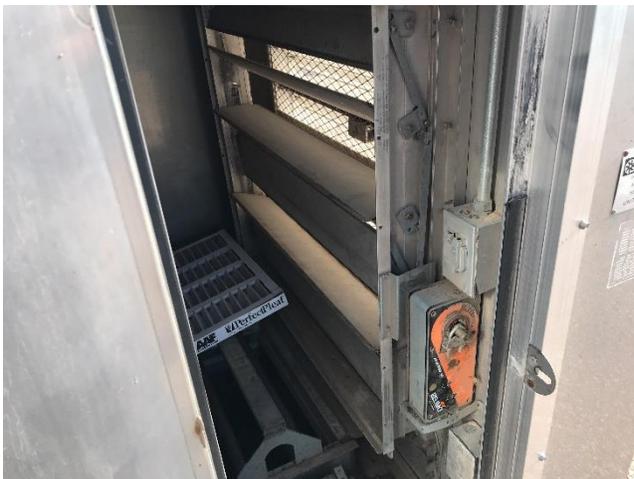
Parkview Elementary School

During the initial site visit it was observed that the damper actuator and linkages on this HVAC unit appear to be damaged and not operating correctly. This would allow for excessive outside air to be treated, increasing energy consumption and cost.

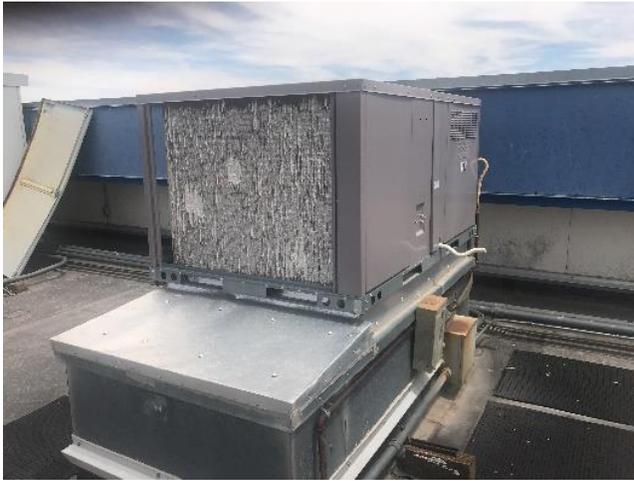
Socorro High School

A considerable amount of the rooftop HVAC equipment throughout the District have condenser coils which have been damaged by hail or other objects. When the fins are flattened, airflow through the condenser coil can be reduced, which can negatively affect the ability of the coil to transfer heat. These fins can often be combed to restore the units to pre-loss condition, which would improve performance and reduce energy consumption.

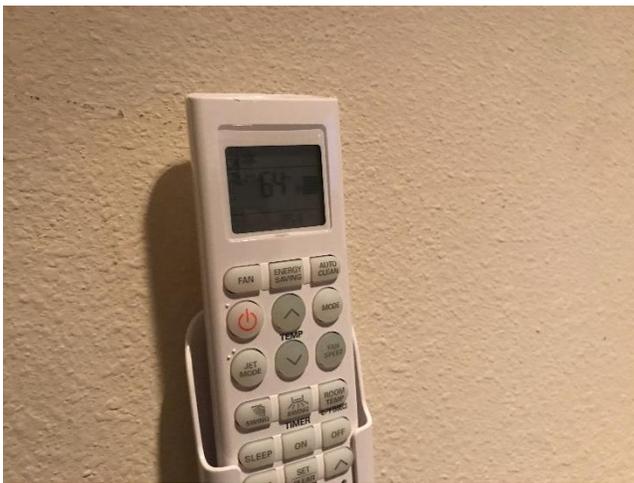
GRADs

The cooling equipment serving a small data closet at this facility is currently set to maintain a space temperature of 64 °F, which requires equipment to operate more than what is necessary to properly serve the space.

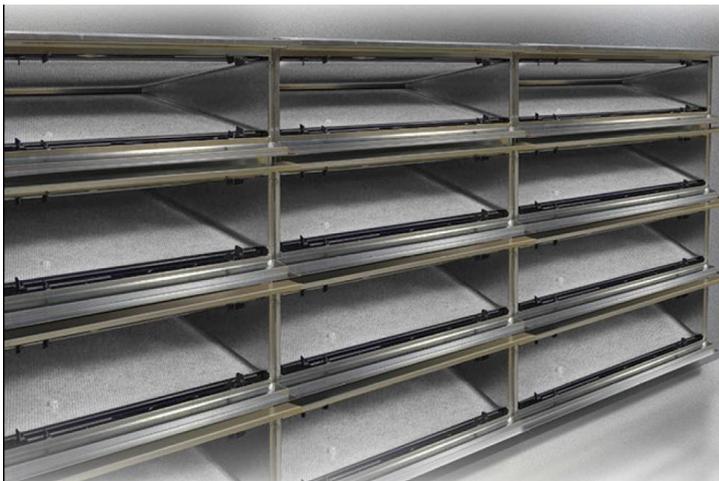
All Facilities

This photo depicts a high-efficiency air filtration system that could be installed on applicable equipment to improve indoor air quality and reduce energy consumption.

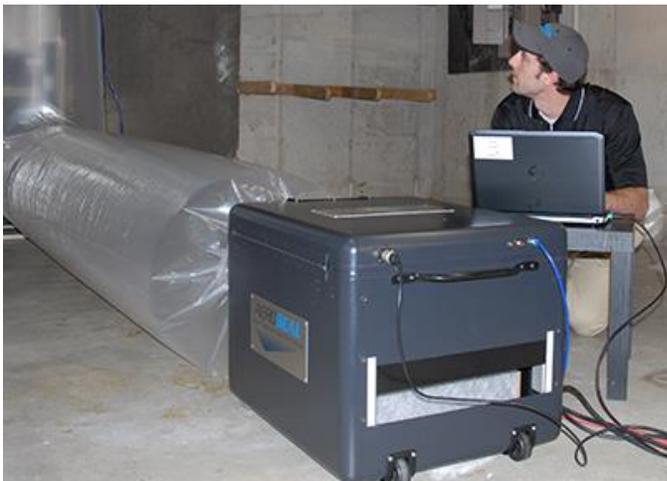
All Facilities

This photo depicts a trained technician operating the duct sealing equipment in a commercial facility. This measure will be investigated in all applicable facilities.

This measure will reduce leakage in the air distribution system which will significantly improve occupant comfort and reduce unnecessary energy losses. A sealant is dispersed into the air distribution system, where it coats the interior lining of duct work, repairing nearly all visible and non-visible leaks. Large visible repairs often need to be sealed manually by a trained service technician.

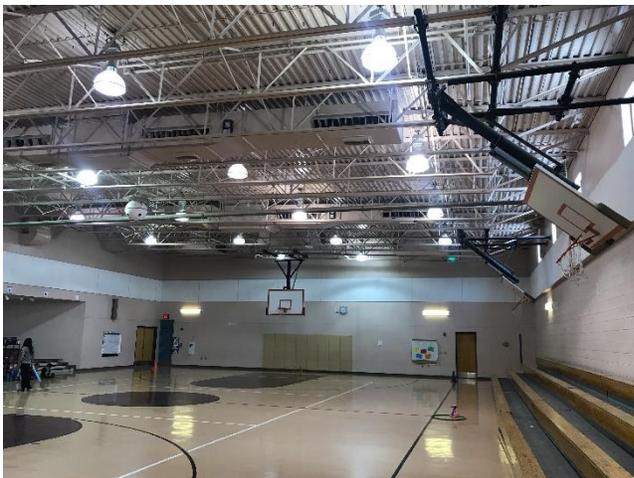
Parkview Elementary

This gym at this facility, and others throughout the District, are currently lit by inefficient 400-Watt MHL fixtures. These fixtures should be replaced with new LED fixtures to improve light quality, reduce energy consumption and lessen ongoing maintenance costs.

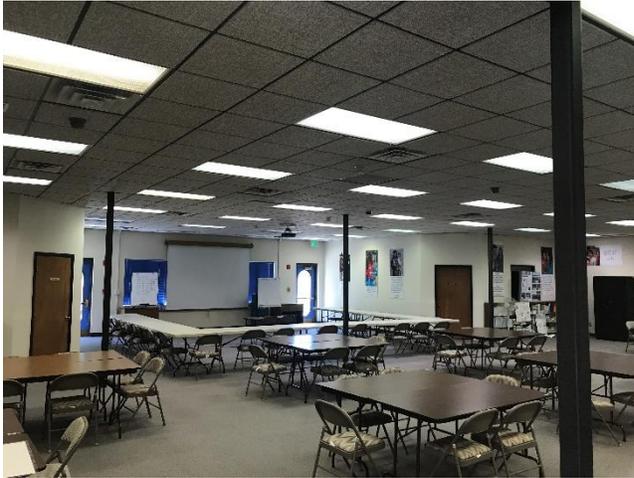
GRADS

This facility, and several others throughout the District, are primarily lit by aged inefficient T12 fluorescent lighting fixtures. These fixtures should be replaced with new LED fixtures to improve light quality, reduce energy consumption and lessen ongoing maintenance costs.

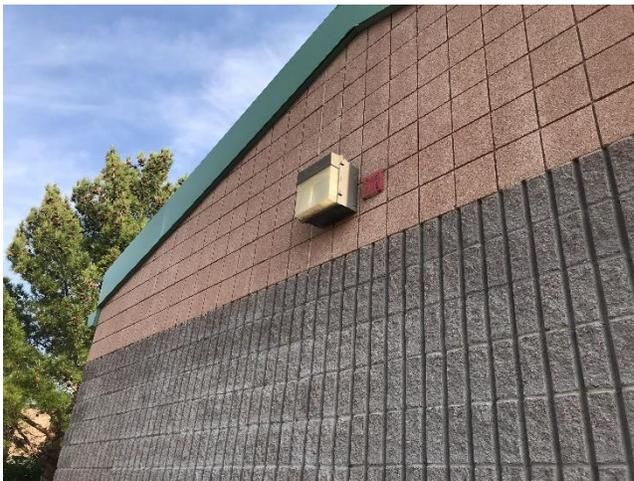
Parkview Elementary

The District has done an excellent job replacing failed exterior lighting fixtures throughout all facilities with new LED fixtures. However, there is still a considerable number of existing fixtures that could benefit from a similar upgrade to LED technology to further improve security, reduce energy consumption and lessen ongoing maintenance costs.

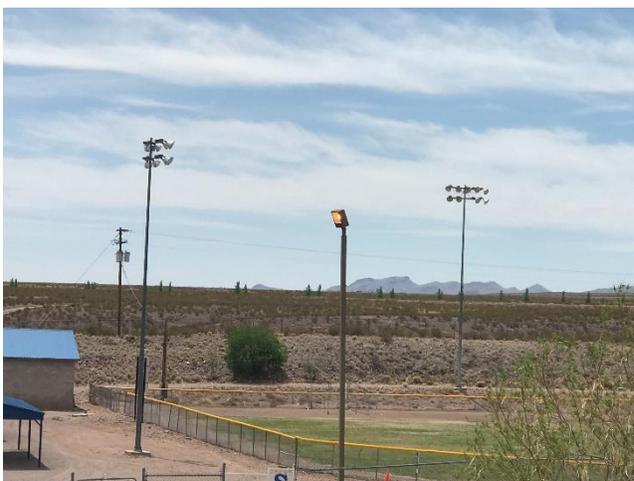
Socorro High School

The sports field lighting at this facility and others in throughout the District could benefit greatly from an LED upgrade which would significantly reduce energy consumption, improve light quality, uniformity, visual comfort and limit obtrusive light to surrounding areas.

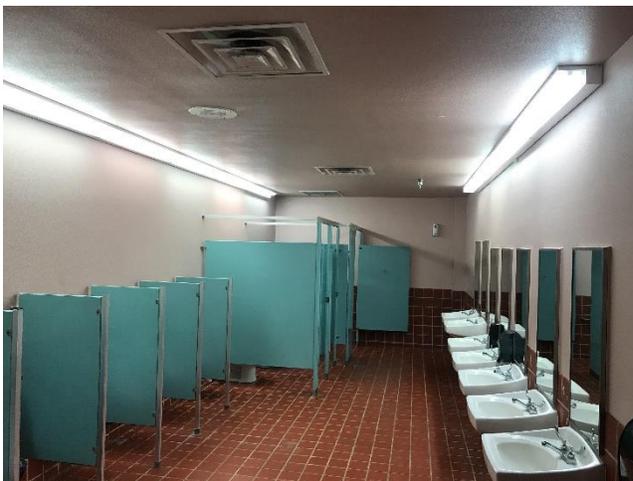
Parkview Elementary

The lighting fixtures in the restroom are currently controlled by a keyed light switch which allows for the fixtures to operate at all times, even when the space is unoccupied. Installing an occupancy sensor would disable the lighting in the space during unoccupied periods, significantly reducing energy consumption of the connected fixtures.

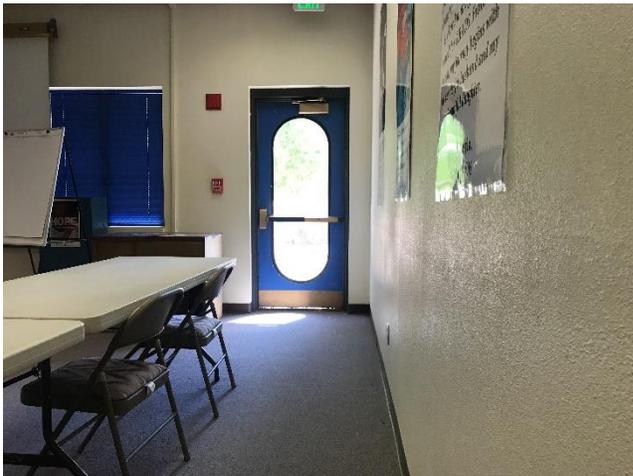
GRADs

The door in this photo has a large visible air gap which can be sealed to eliminate losses and reduce energy consumption.
