PUBLIC SCHOOL CAPITAL OUTLAY COUNCIL

**PUBLIC SCHOOL CAPITAL OUTLAY COUNCIL (PSCOC)
AGENDA**

2018 / 2019 PSCOC SYSTEMS-BASED
FUNDING REQUEST
PRESENTATION INFORMATION FOR
BERNALILLO MIDDLE SCHOOL

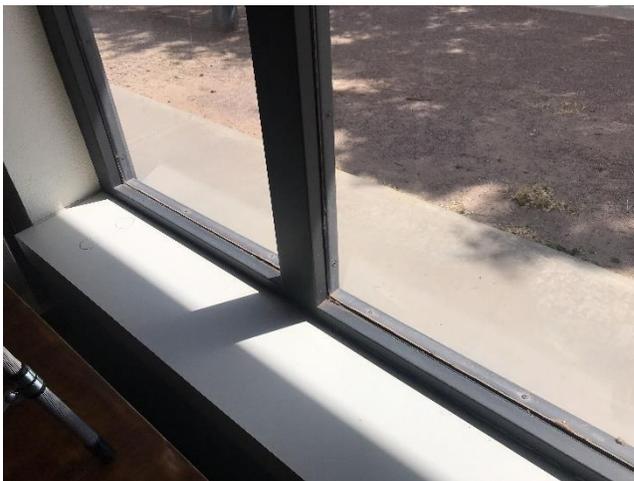
GRADs

The aged single-pane windows at this facility, and others throughout the District, will be evaluated for replacement with new more efficient double-pane windows to reduce energy consumption while greatly improving indoor occupant comfort.

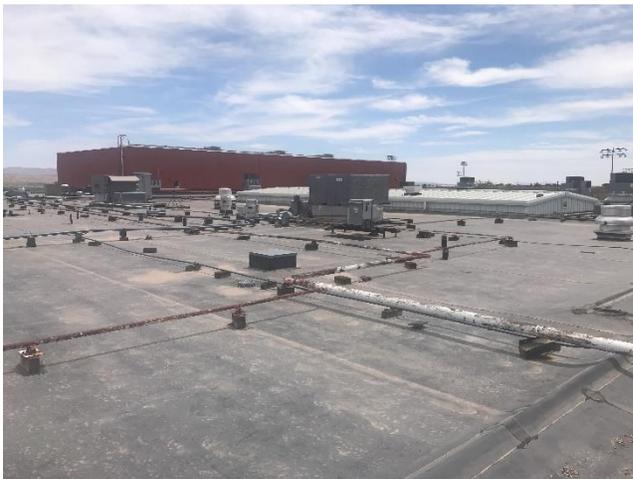
Socorro High School

The roof at this facility, and others throughout the District, are in poor condition, and should be evaluated for replacement with a new cool roof to reduce energy consumption and improve indoor occupant comfort.

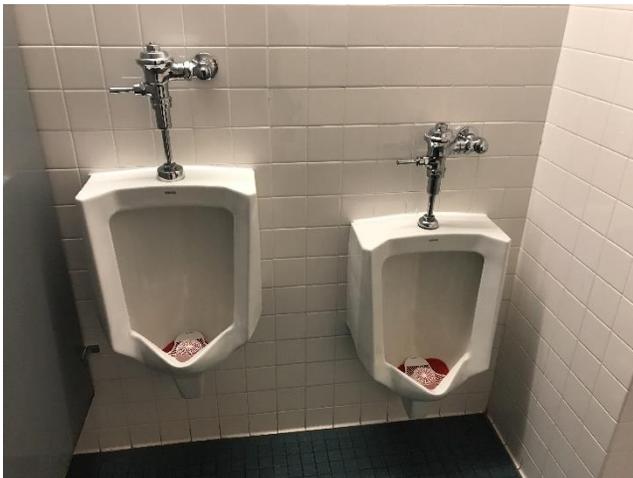
Parkview Elementary

The domestic water fixtures at this facility, and several others throughout the District, operate at higher flow rates than is necessary. These fixtures will be either replaced or recommissioned for optimal performance.

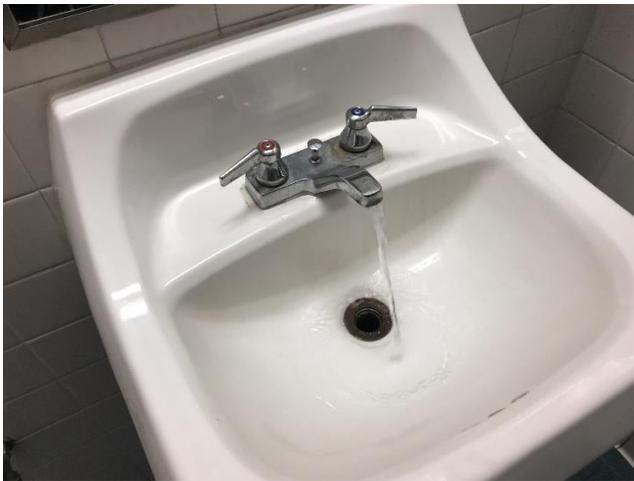
Parkview Elementary

The aerator on this faucet was removed, allowing for the fixture to operate at full flow when running. In addition, the faucet was found running while the space was unoccupied.

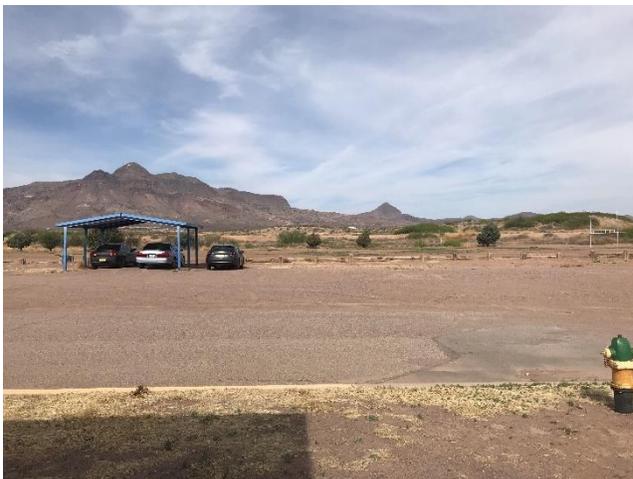
Sarracino Middle School

The District is in the process of making improvements to the football field at this facility, which will use treated water to irrigate once complete. Installing an enhanced irrigation control system with help to deliver the optimal amount of water necessary to properly serve the space, while minimizing utility costs.

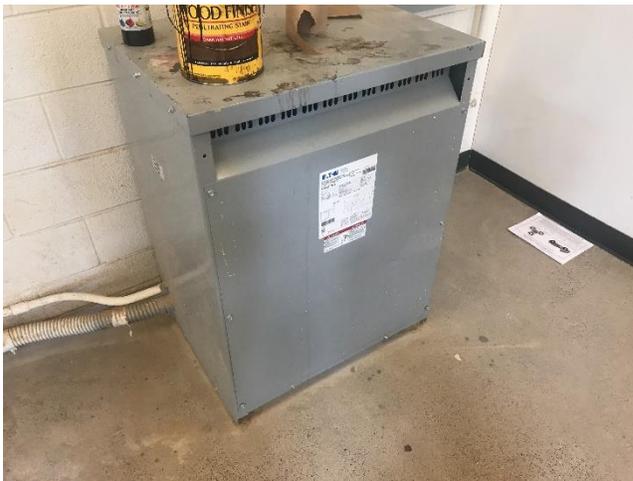
Socorro High School

This standard efficiency transformer could be replaced with a new high efficiency transformer

Replacing standard efficiency transformers with new high efficiency transformers will reduce energy consumption and help to eliminate waste. Transformer losses can account for as much as 5% of a facilities total electricity bill. This waste is converted to heat, which can further increase energy consumption in the facility if the transformer is located in an indoor conditioned space.

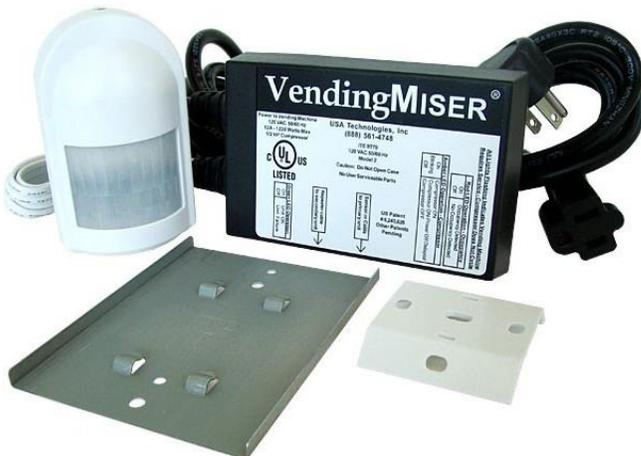
All Facilities

This photo depicts a device that can be installed on vending machines throughout the District to reduce energy consumption during unoccupied periods.

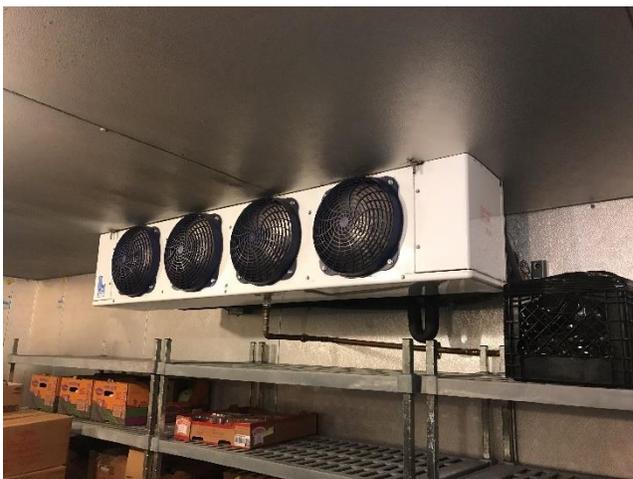
Parkview Elementary

This walk-in freezer evaporator could benefit greatly from the installation of a smart control device and replacement of its motor with a new ECM motor.

Walk-in coolers and freezers consume a considerable amount of energy in order to maintain the contained products at a desired temperature. Installing a smart controller to properly monitor and operate the evaporator in these spaces helps to: eliminate unnecessary defrosts typically associated with timed based alternatives, preserve product integrity, maximizes energy efficiency with less compressor runtime resulting from shorter defrosts, prevent ice formation on floors and ceilings and avoid excessive temperature swings.

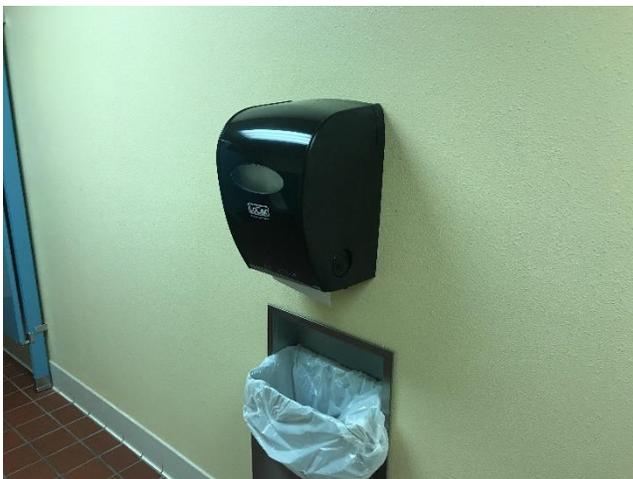
Administration Office

The paper towel dispensers at this facility and others throughout the District could be replaced with new high efficiency hand dryers to significantly reduce cost and waste generated by the district.

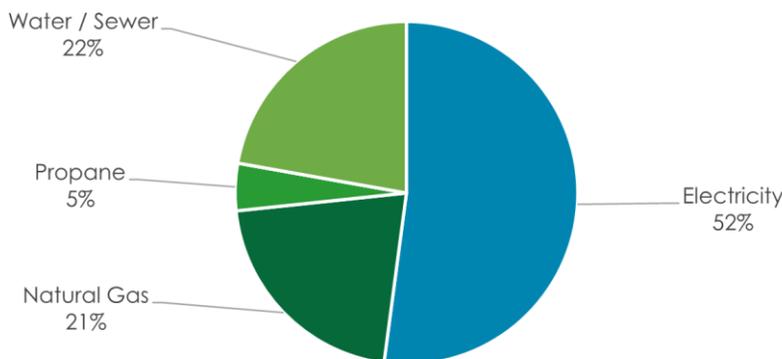
Example of a utility cost breakdown that is performed for all facilities during the Investment Grade Audit

Figure 1: Baseline Annual Utility Cost Breakdown

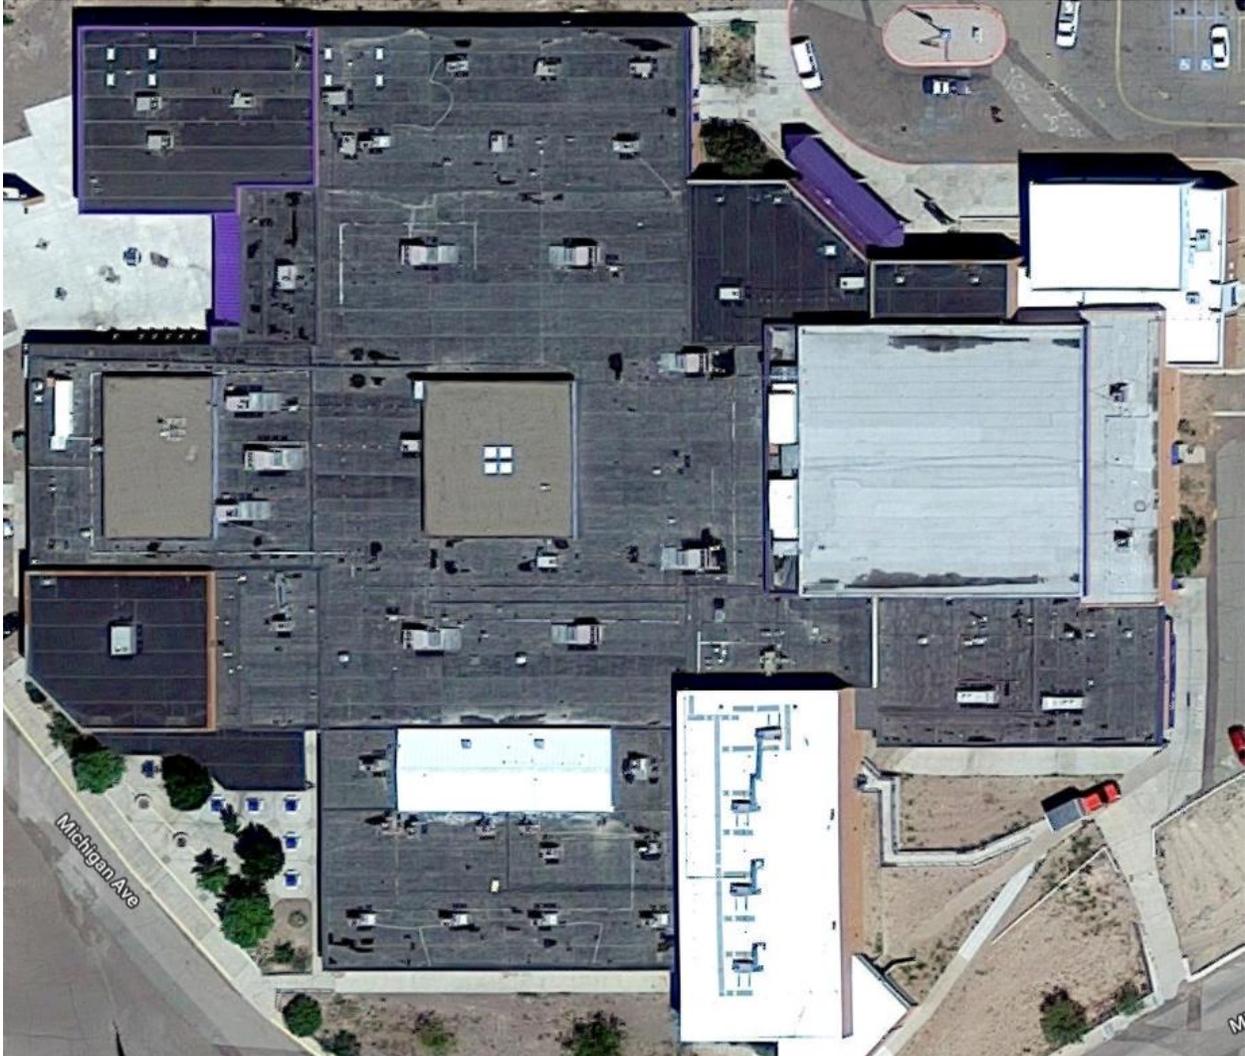
Socorro High School

- Single Ply Membrane (Rubber)
 - Areas with Single Ply Membrane (Rubber) are estimated in age from 18 to 20 + years. Overall fair to poor condition.
 - There are two relatively small areas that are newer and in fair to good condition located at the south entrance shade roof and northeast entrance.
 - Existing leaks are numerous according to school maintenance staff and evident by stained ceiling tiles throughout.
 - Significant joint shrinkage is apparent throughout.
 - Seam failure at joints and aged patches throughout.
 - Drainage appears to be working as designed. A rain had occurred the evening prior to our inspection. Normal pooling was evident and predicted to be gone within 24-36 hours.

- Parapet metal coping is in good condition. Joints are aged and separating.
- Modified Asphalt – East Gym
 - Cracking, buckling, and soft spots throughout these areas
 - Potential underlayment damage
- TPO (Thermoplastic Polyolefin) South Gym & North East Addition
 - Areas show signs of normal wear and are in good condition.
 - Staff indicated no leaks or issues had been present.
- BUR (Built Up Roofing)
 - Significant cracking with fiberglass exposure. This roof has exceeded its performance life expectancy. Fair to poor condition
- Metal
 - Areas with metal roof show normal wear for age and are in fair to good condition.

- Single Ply Membrane (Rubber)
 - Do to age and a fair to poor condition rating replacing the Single Ply Membrane (Rubber) system with a modern TPO system is recommended.
 - Single Ply Membranes (Rubber), under normal conditions, have life expectancy of approximately of 20 years.
 - When reinstalling parapet metal coping metal is in good condition and can be removed and reset using proper joint procedures.
- TPO (Thermoplastic Polyolefin)
 - Continue to maintain area keeping drains clear.
- Metal
 - Continued normal maintenance.
- BUR (Built Up Roofing)
 - Do to age and fair to poor condition rating a more modern reliable, lower maintenance, and energy efficient system is recommended, TPO.

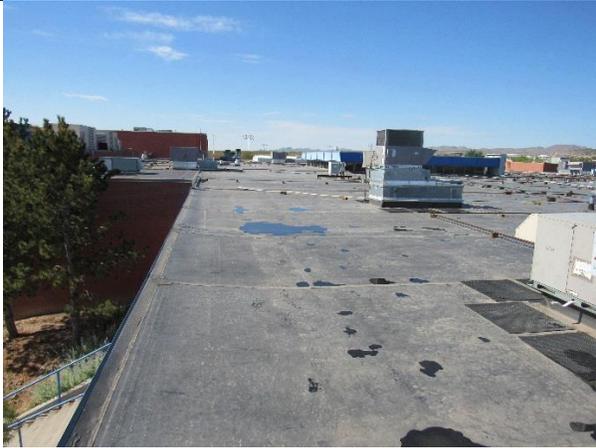
Edges are separating. Minimal ponding.

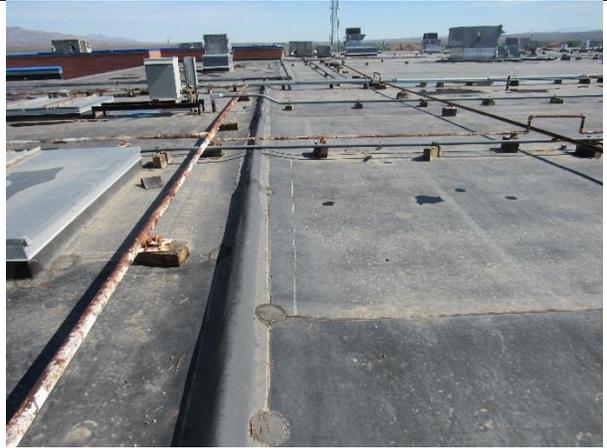
Typical expansion joint numerous areas

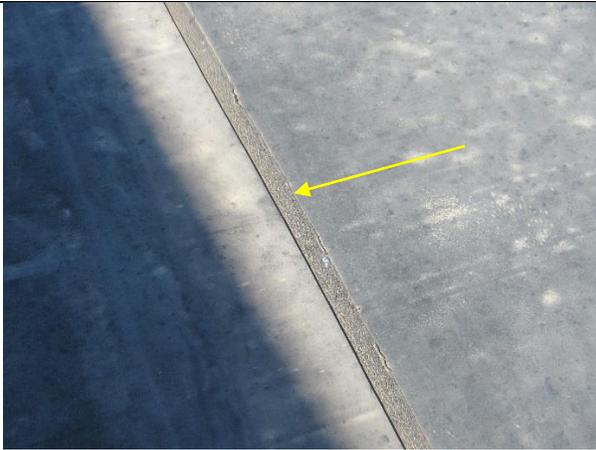
Seam shrinkage throughout - typical

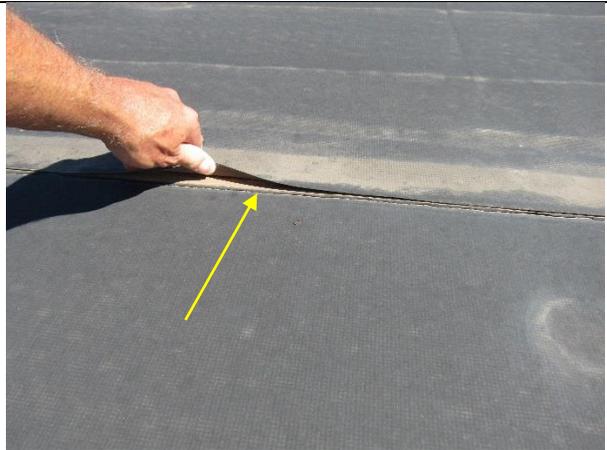
Seam failure at joints and aged patches throughout.

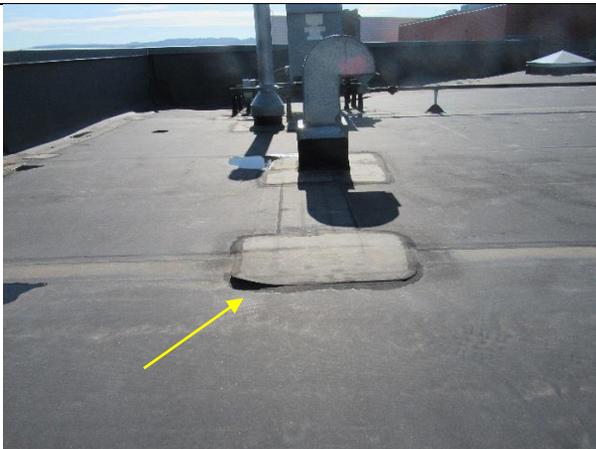
Patch repair failure - typical

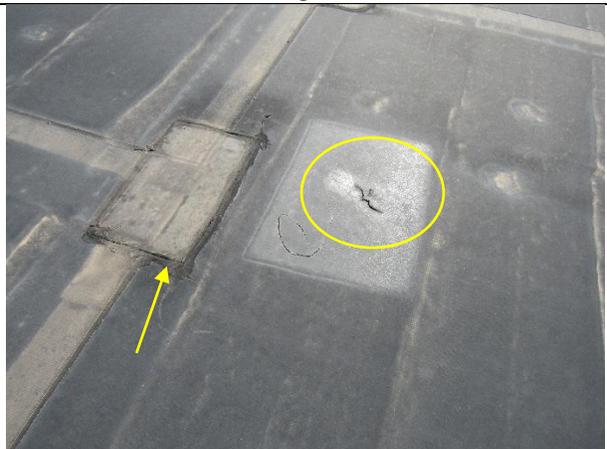
Cracking and joint failure

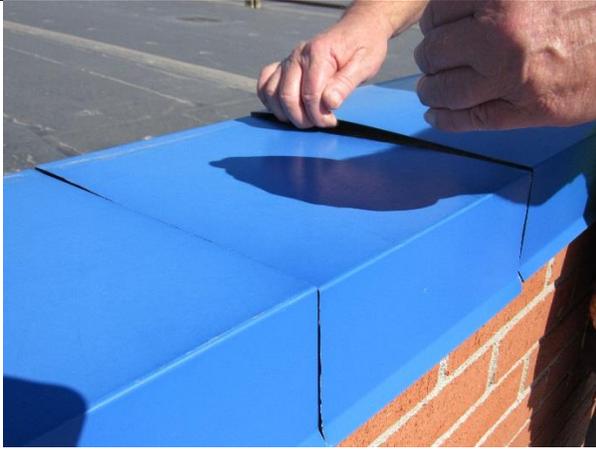
Recommend new seal all parapet coping upon reroof

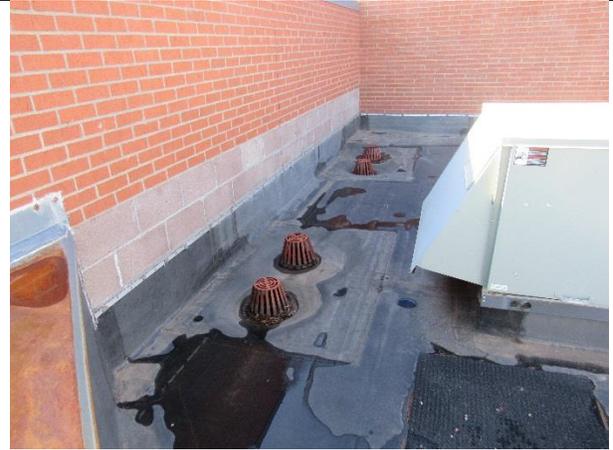
Roof drains need to be maintained and kept clear of debris.

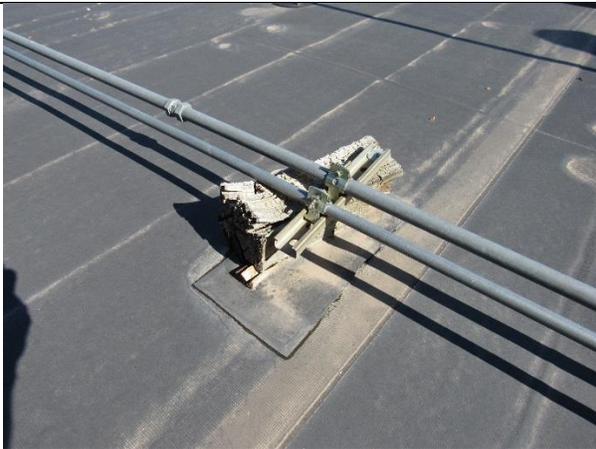
Conduits need carriers or new wood blocking

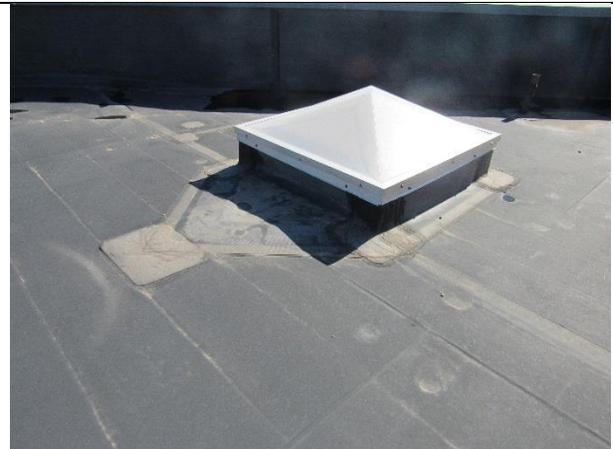
Crickets typical

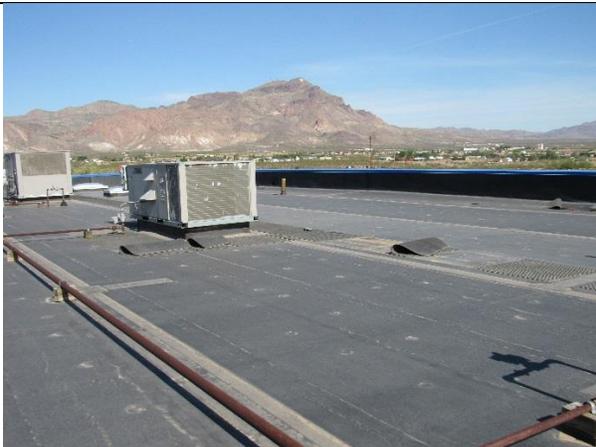
Walk pads coming up do to age

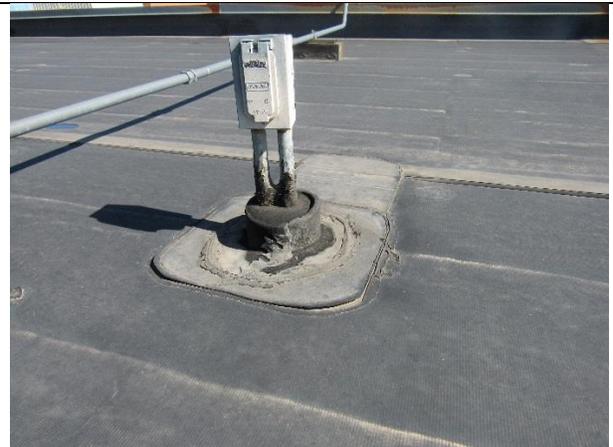
(M) Curbs need to be removed and replaced

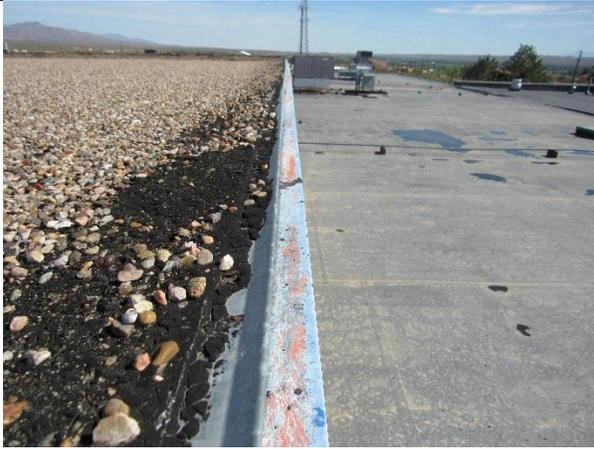
(BUR) Normal aging, edges separating from metal

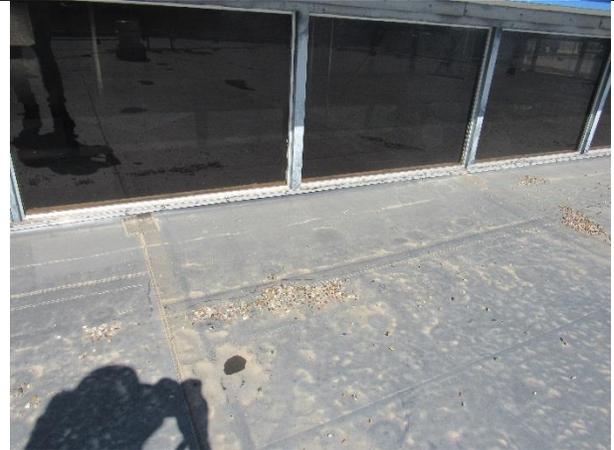
All termination bars need to be replaced upon reroof

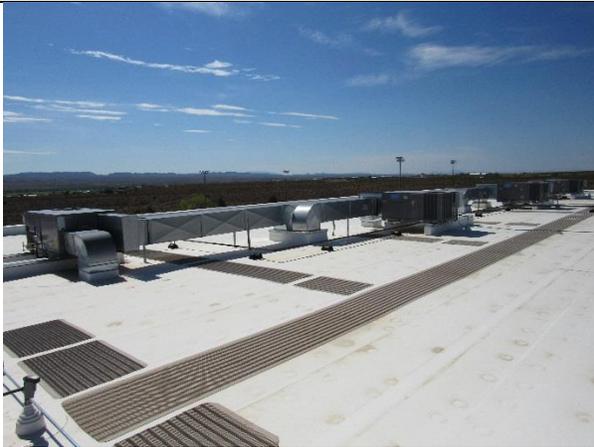
South Gymnasium – TPO good condition

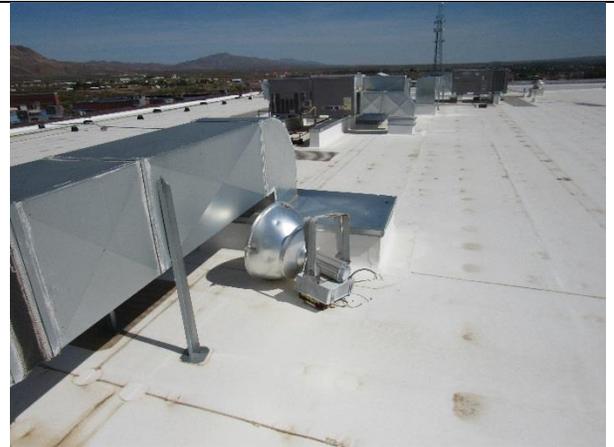
Remove loose mechanical equipment to prevent roof damage

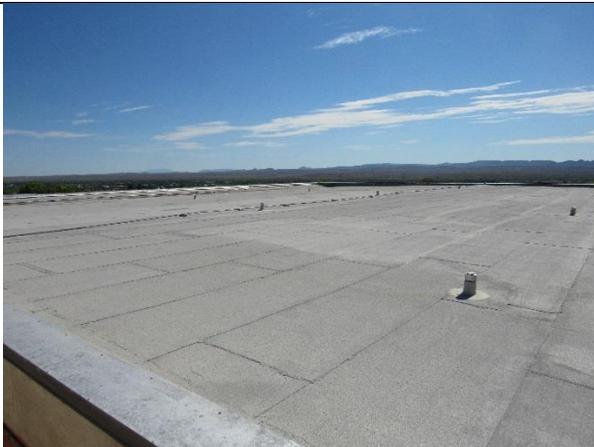
East Gymnasium modified in fair condition recommend reroof

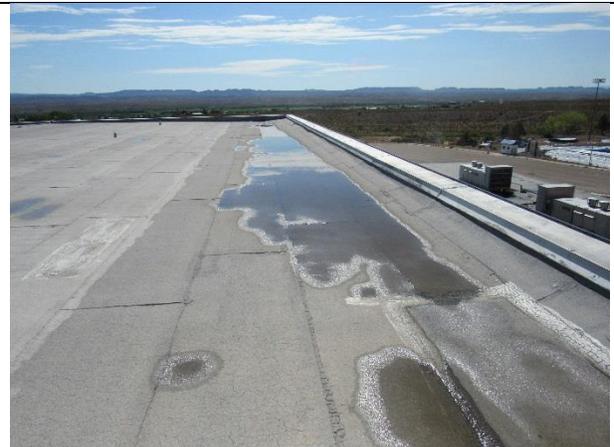
Edges failing do to accumulation of water all areas.

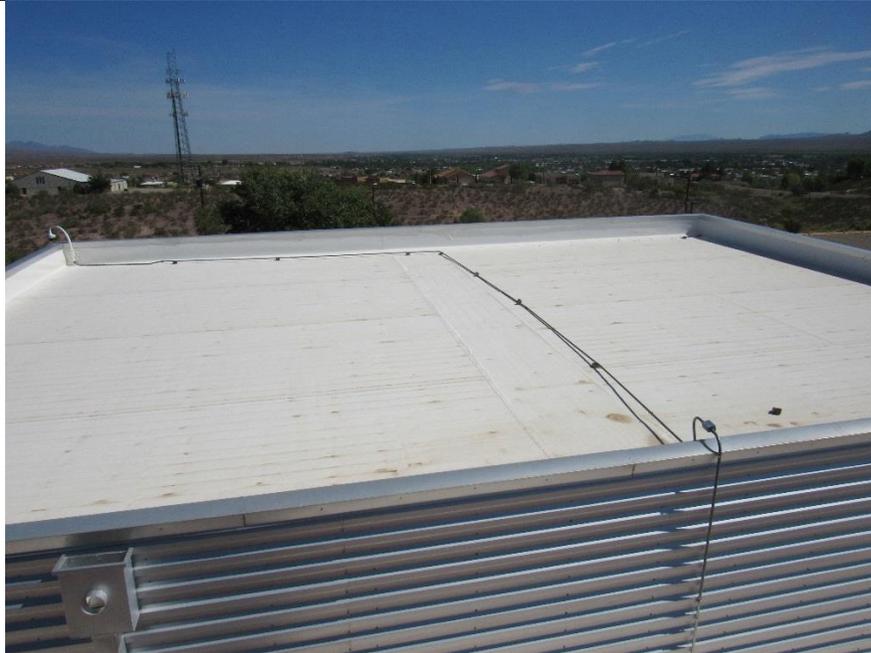
Northeast addition TPO – good condition

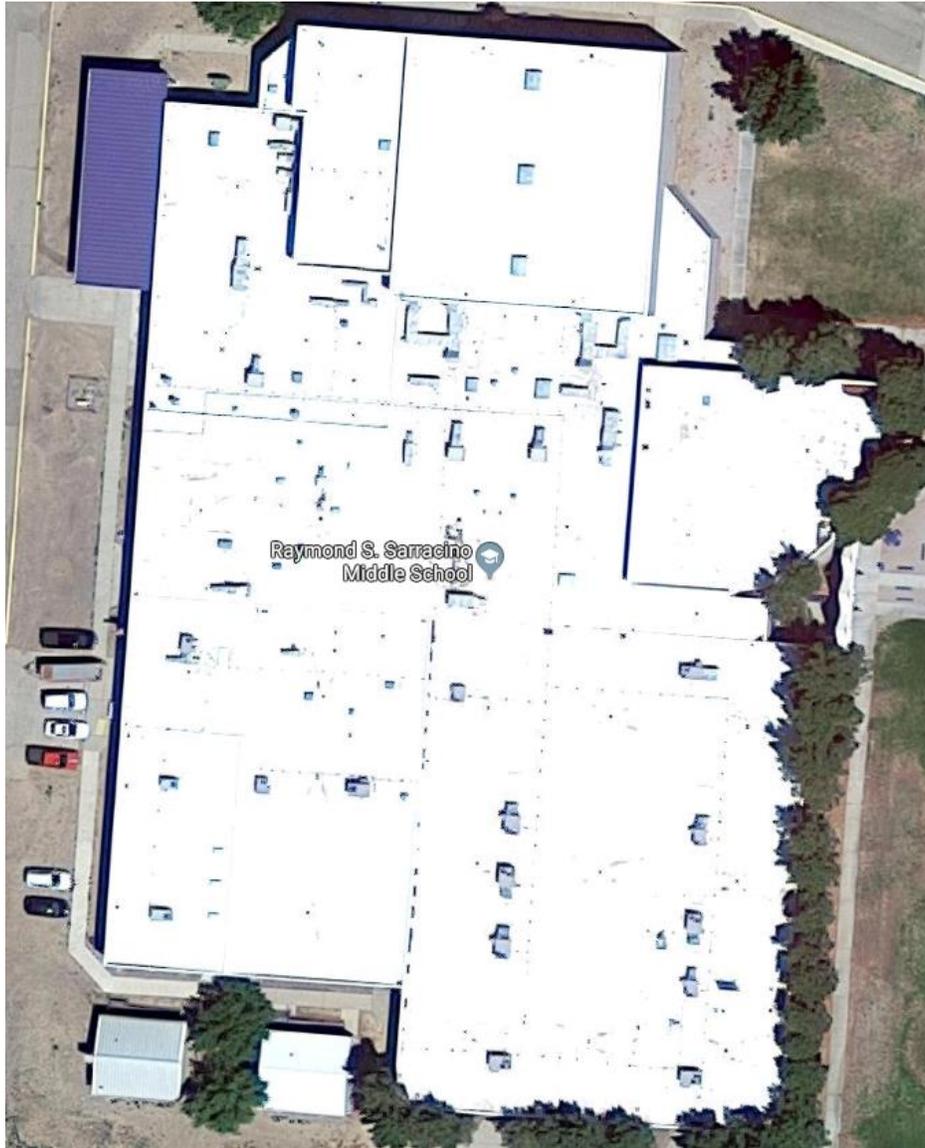
Sarracino Middle School

- TPO (Thermoplastic Polyolefin)
 - A new roof installed was completed approximately 3 months ago. Over approximately 75% of the lower roof.
 - Staff has reported the new roof is leaking midway on the west side. Contractor is being notified.
 - Band room, gymnasium and cafeteria roofs are in good condition with no reported issues.
 - Area of concern – Roof over science labs/classrooms 1-22 at the southeast of building. Fair condition.
 - Leaks are present. Reported by staff.

- Existing seam patches are deteriorating.
- Numerous patches.

- Replace roof over science labs/classrooms 1-22.
 - Maintenance issues will continue with existing roof.

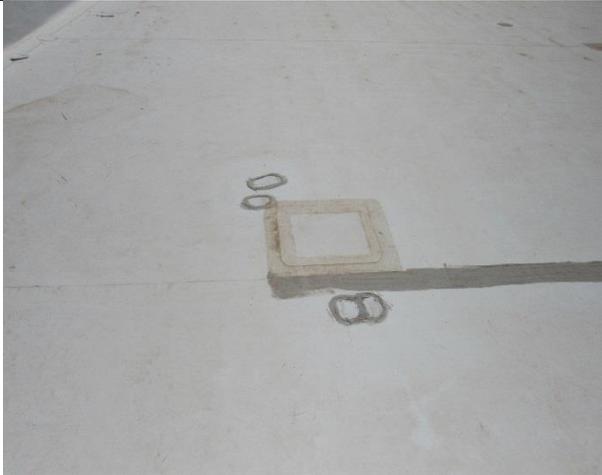
Numerous patches – staff reports failures & leaks present

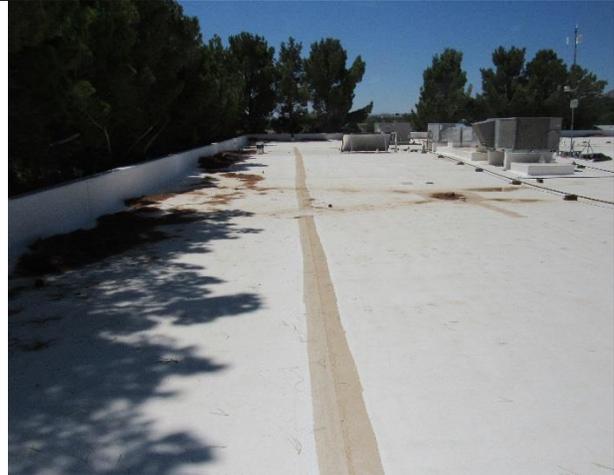
Seam patches throughout. Shaded walls with pine needles needs constant maintenance to avoid material deterioration.

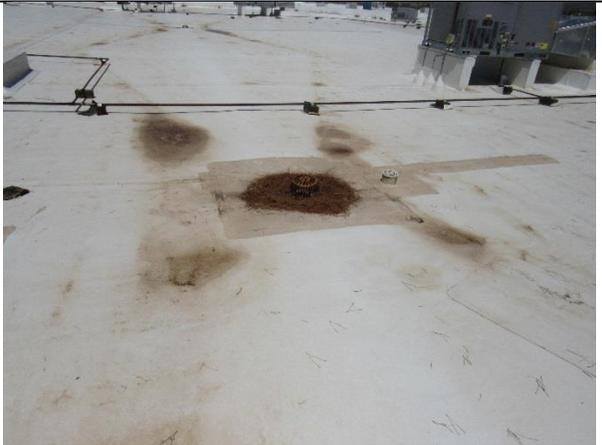
Roof drain typical – Pine needles need to be removed often.

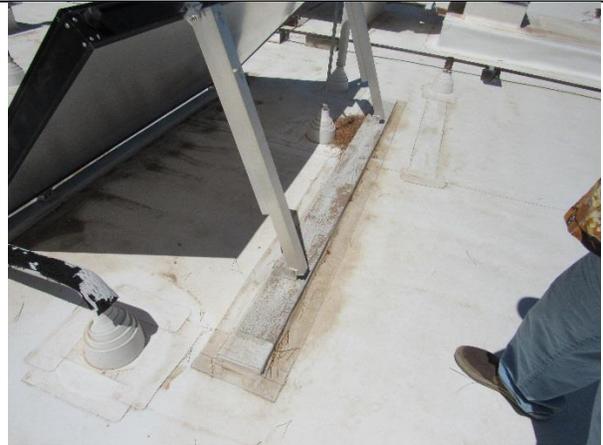
Recommend removal of 2x6 board and or cover or extension of solar panel legs

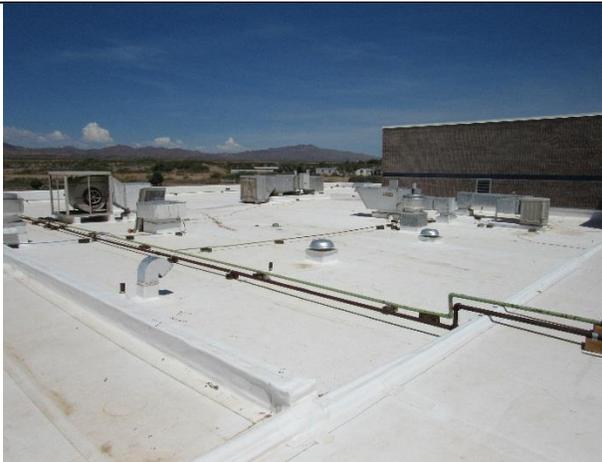
Cafeteria roof aging normally - good condition. Repairs or replace as needed

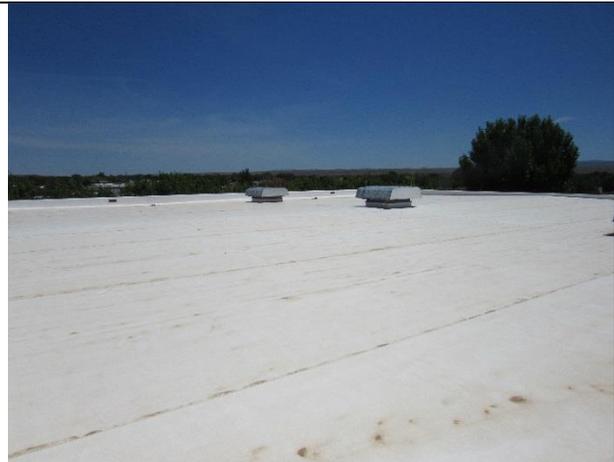
Gymnasium roof in good condition

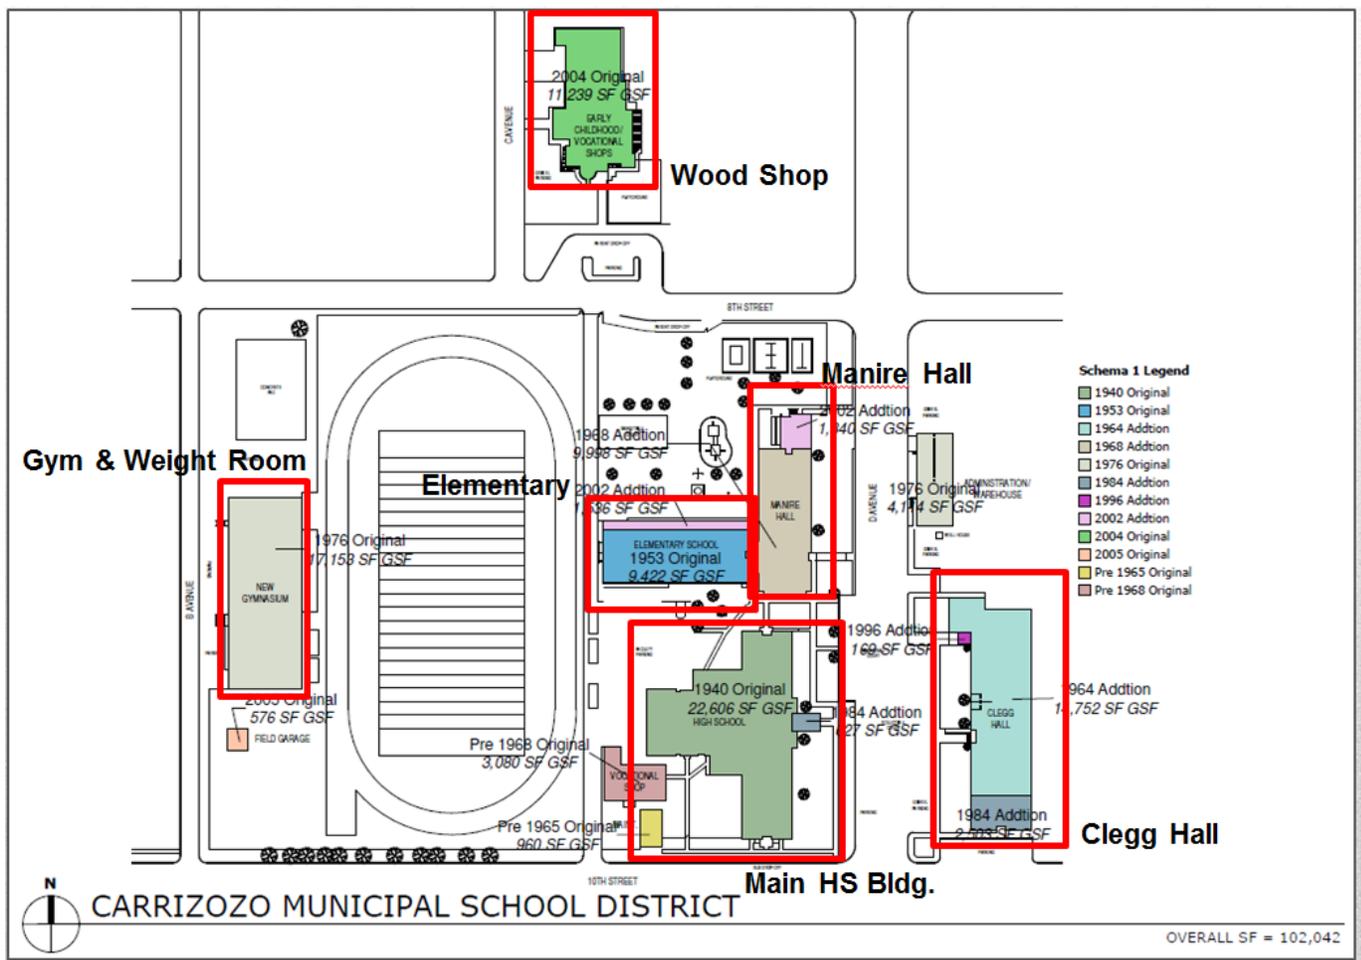
FAD Status

- Carrizozo Combined School has a FAD ranking of 10
- The New Mexico Facilities Assessment Database (FAD) shows that the Facility Condition Index is 56.42%.
- Carrizozo Combined School was originally constructed in 1940 with additions in 1953, 1964, 1968, 1976, 1984, 1996, 2002, and 2004.
- Carrizozo Combined School had a 2017 FMAR rating of 61.84%.
- During the 2015 FMP process, discussion took place concerning the future of the Carrizozo Combined School facilities. It was the desire of the School Board to keep all district facilities and to continue to update building systems as necessary to keep the facilities safe and comfortable for students, staff and visitors.

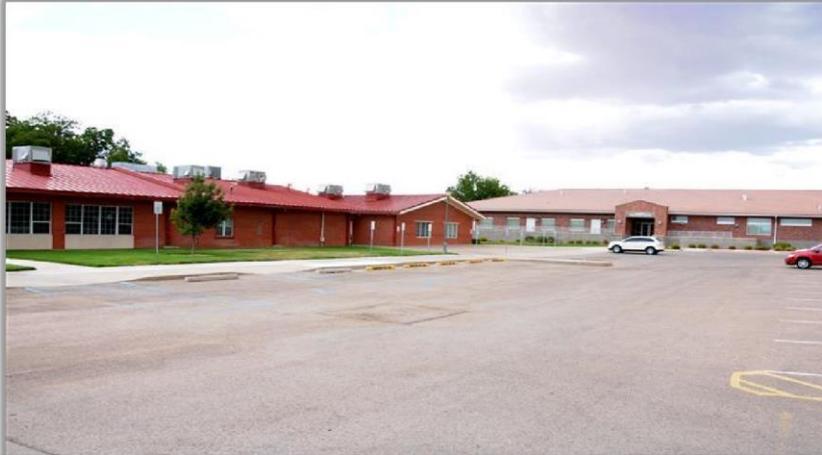
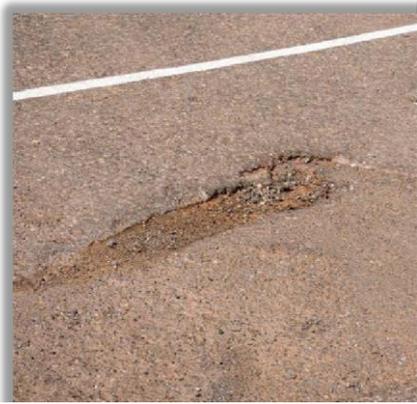
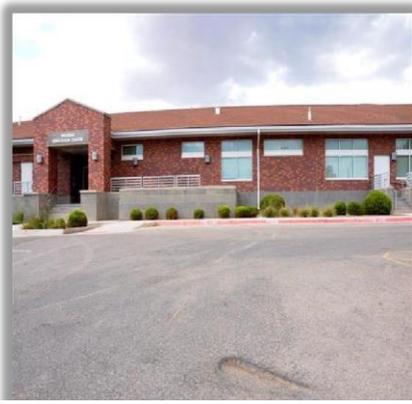
This parking lot was last repaved in 1989 during a campus-wide improvements project. Consequently, with its age, and the use of construction staging sites for two extensive projects, visible wear and tear of this parking lot has become increasingly evident.

This parking lot is heavily used by school staff transporting students directly to the Watkins Education Center and the Jack Hall Building. In addition, delivery trucks use this area for deliveries to the kitchen two to three times per week.

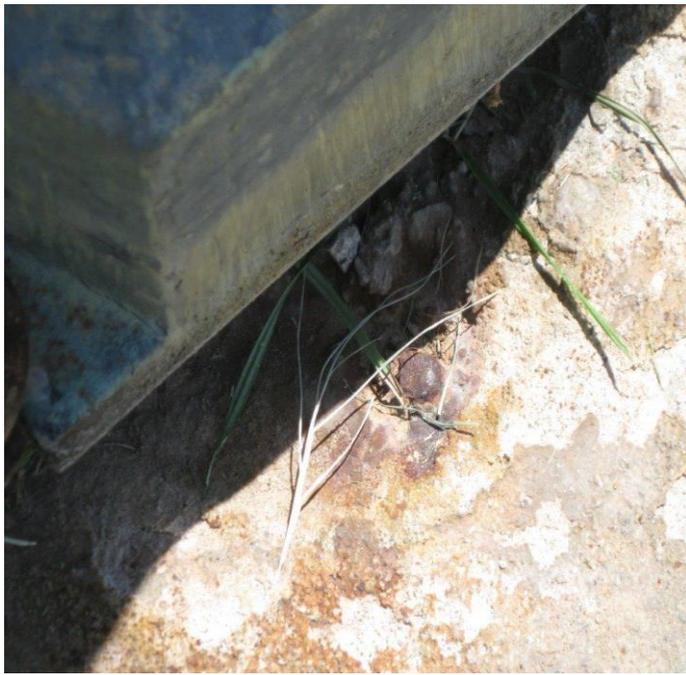
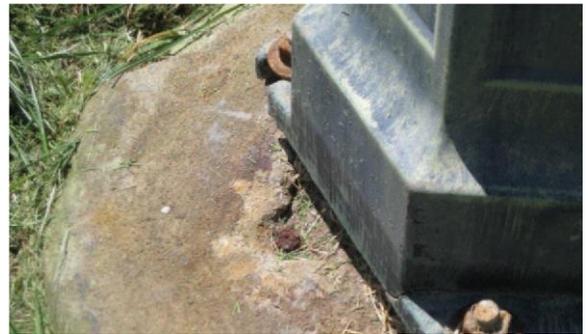
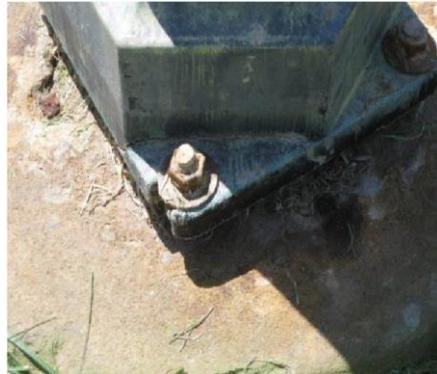
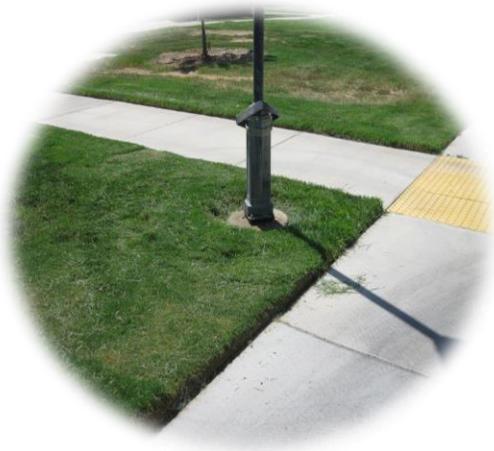
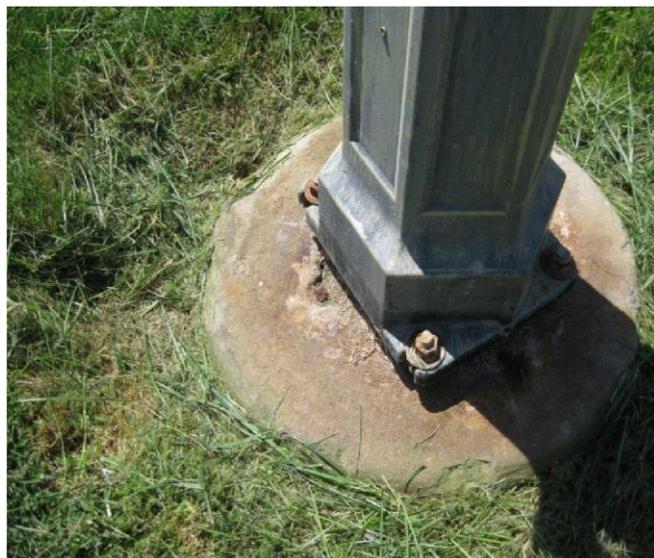
Conditions of the current sidewalk lighting poles and bases are typical throughout the campus. Because of their “at ground” level, this has caused the anchor bolts to rust and deteriorate faster due to irrigation and rainwater. NMSBVI proposes to eliminate this problem by insuring the new concrete bases are between 18-24” in height.

Photos illustrate the original bases, now rusted, cracked and with broken anchor bolts. Because of the broken anchor bolts, the pole bases had to be rotated 90 degrees and new holes had to be drilled at the existing concrete base. Anchor bolts were epoxied into the concrete base to support the pole.

The new bases will be at a height of approximately 18-24” to prevent moisture deterioration and damage to the bases from lawnmowers and other landscaping equipment. The existing bases are at ground level, or beneath ground levels, thus the excessive deterioration due to moisture and damage from landscaping equipment. The new lights will be more energy efficient LED lighting.

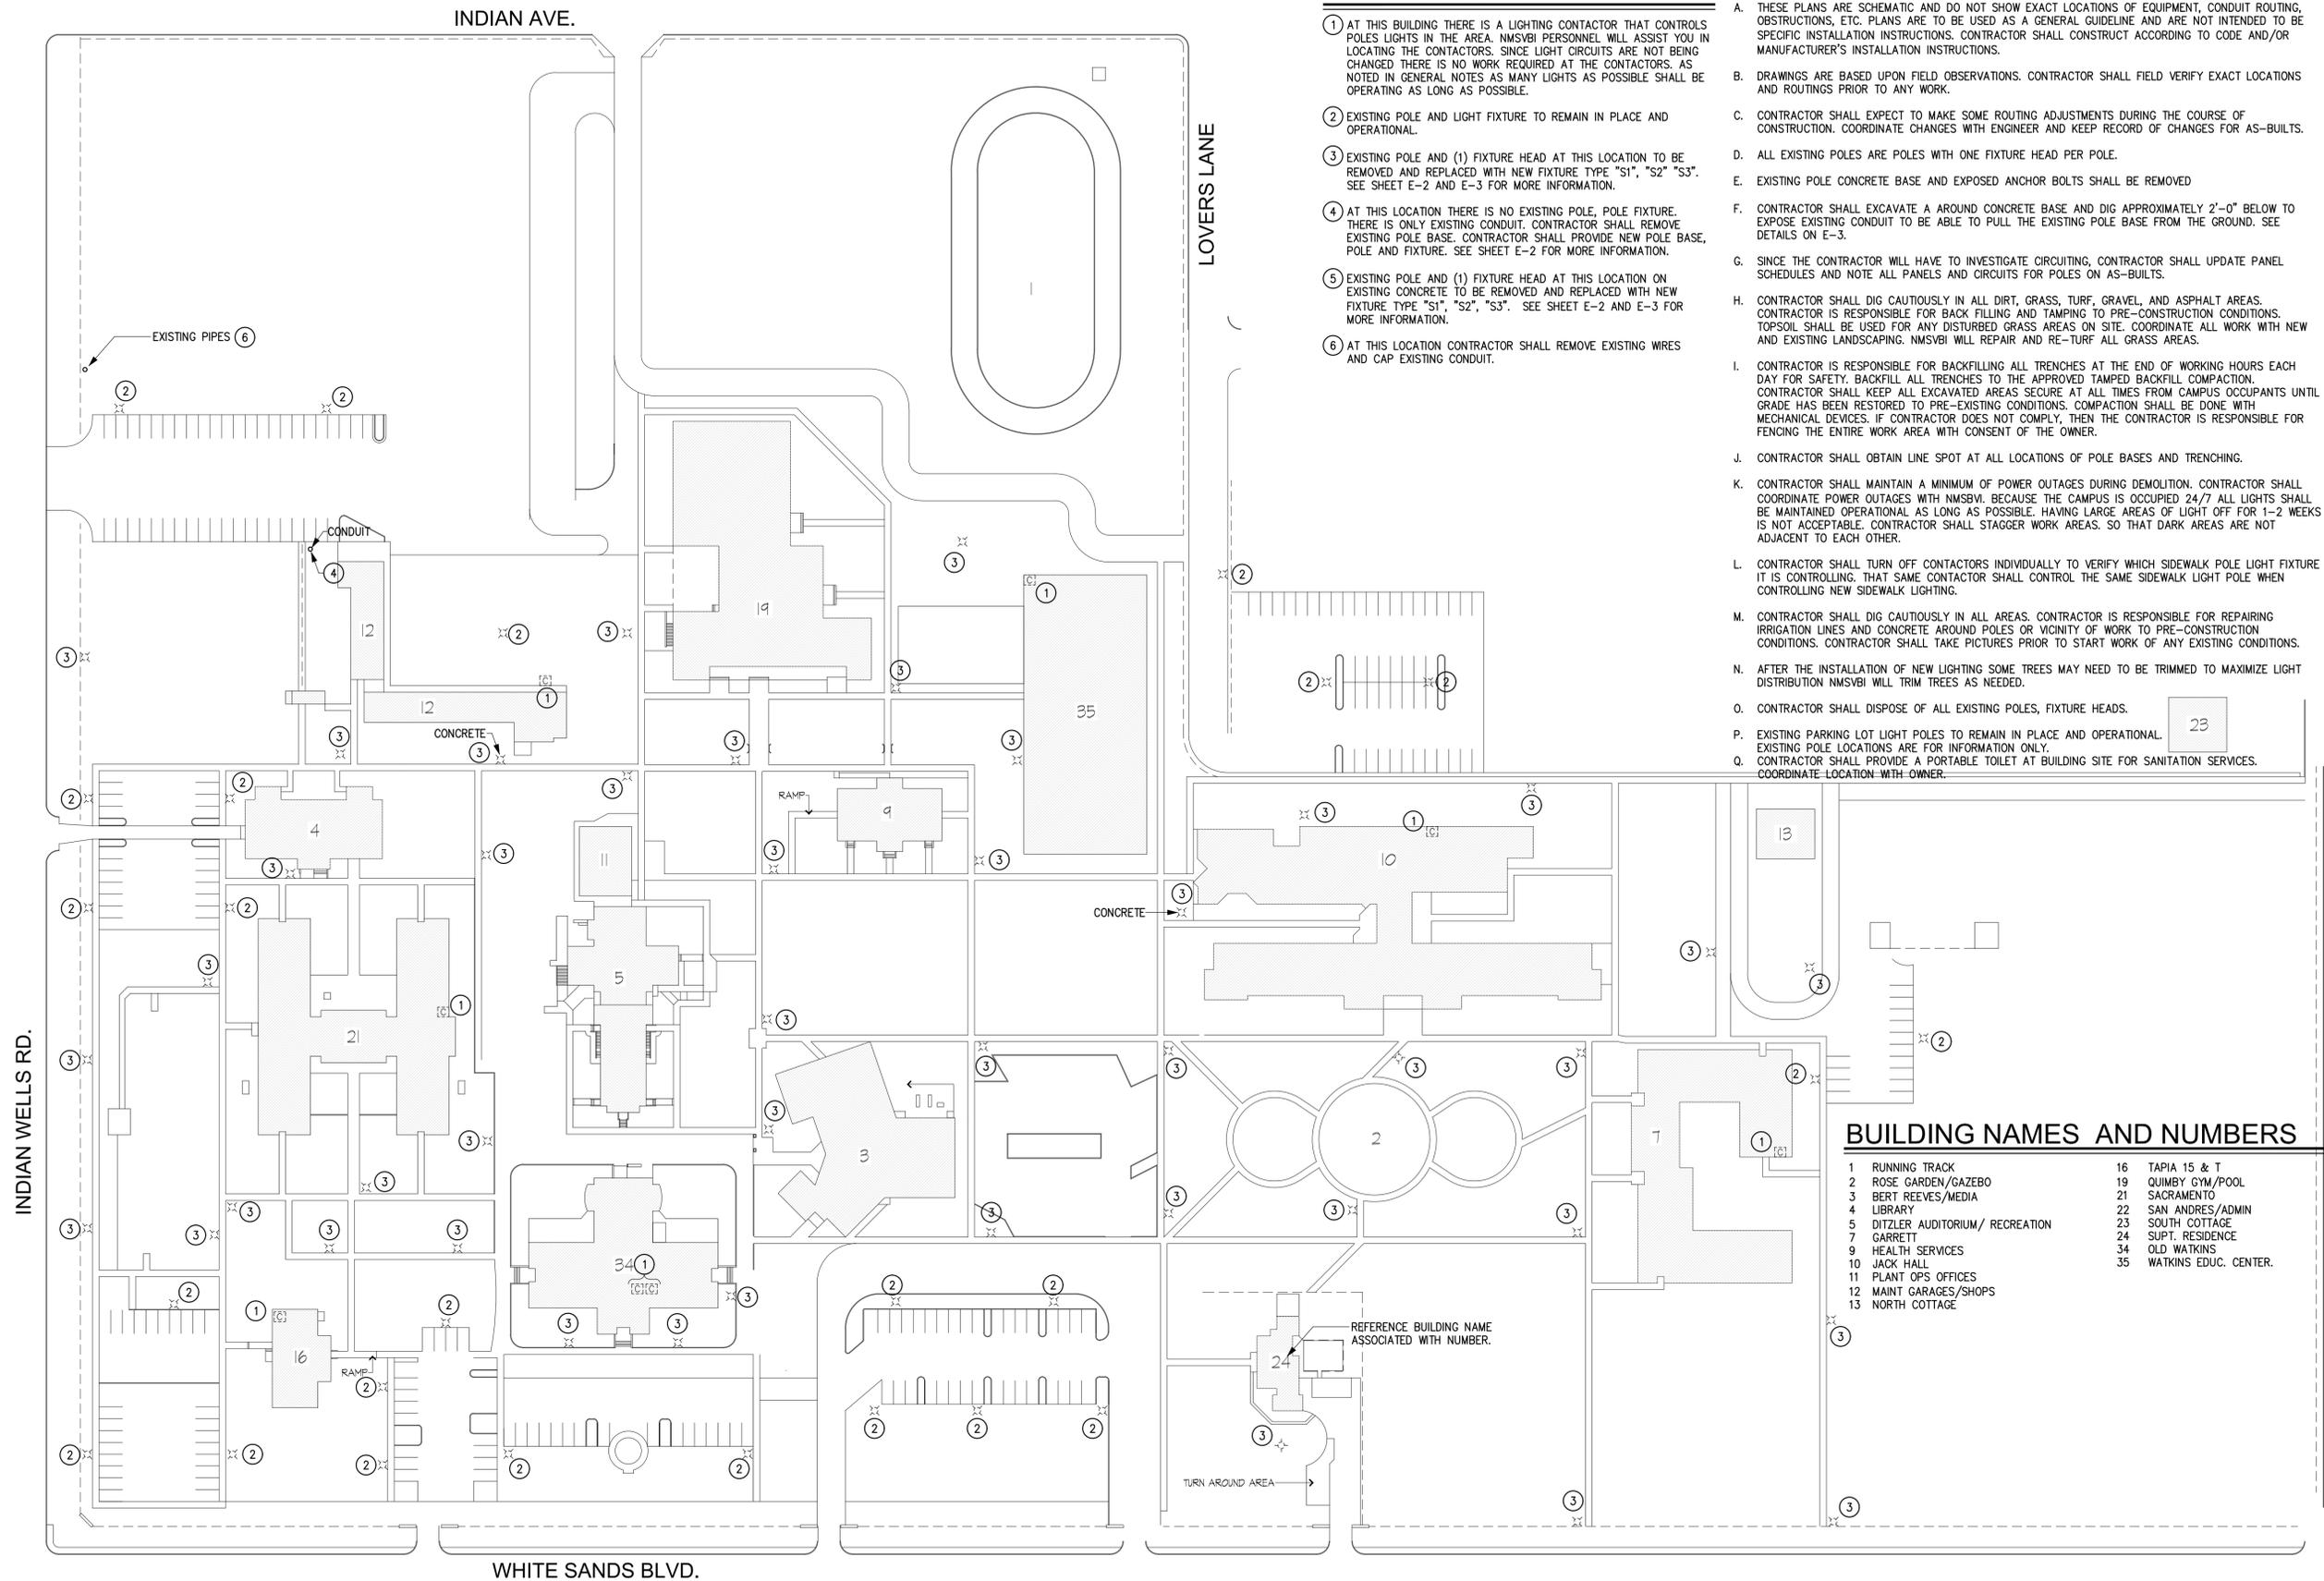
**KEYED NOTES**

- 1 AT THIS BUILDING THERE IS A LIGHTING CONTACTOR THAT CONTROLS POLES LIGHTS IN THE AREA. NMSBVI PERSONNEL WILL ASSIST YOU IN LOCATING THE CONTACTORS. SINCE LIGHT CIRCUITS ARE NOT BEING CHANGED THERE IS NO WORK REQUIRED AT THE CONTACTORS. AS NOTED IN GENERAL NOTES AS MANY LIGHTS AS POSSIBLE SHALL BE OPERATING AS LONG AS POSSIBLE.

- 2 EXISTING POLE AND LIGHT FIXTURE TO REMAIN IN PLACE AND OPERATIONAL.
- 3 EXISTING POLE AND (1) FIXTURE HEAD AT THIS LOCATION TO BE REMOVED AND REPLACED WITH NEW FIXTURE TYPE "S1", "S2" "S3". SEE SHEET E-2 AND E-3 FOR MORE INFORMATION.

- 5 EXISTING POLE AND (1) FIXTURE HEAD AT THIS LOCATION ON EXISTING CONCRETE TO BE REMOVED AND REPLACED WITH NEW FIXTURE TYPE "S1", "S2", "S3". SEE SHEET E-2 AND E-3 FOR MORE INFORMATION.
