PUBLIC SCHOOL CAPITAL OUTLAY COUNCIL

**PUBLIC SCHOOL CAPITAL OUTLAY COUNCIL (PSCOC)
AGENDA**

2018 / 2019 PSCOC SYSTEMS-BASED
FUNDING REQUEST
PRESENTATION INFORMATION FOR
BERNALILLO MIDDLE SCHOOL

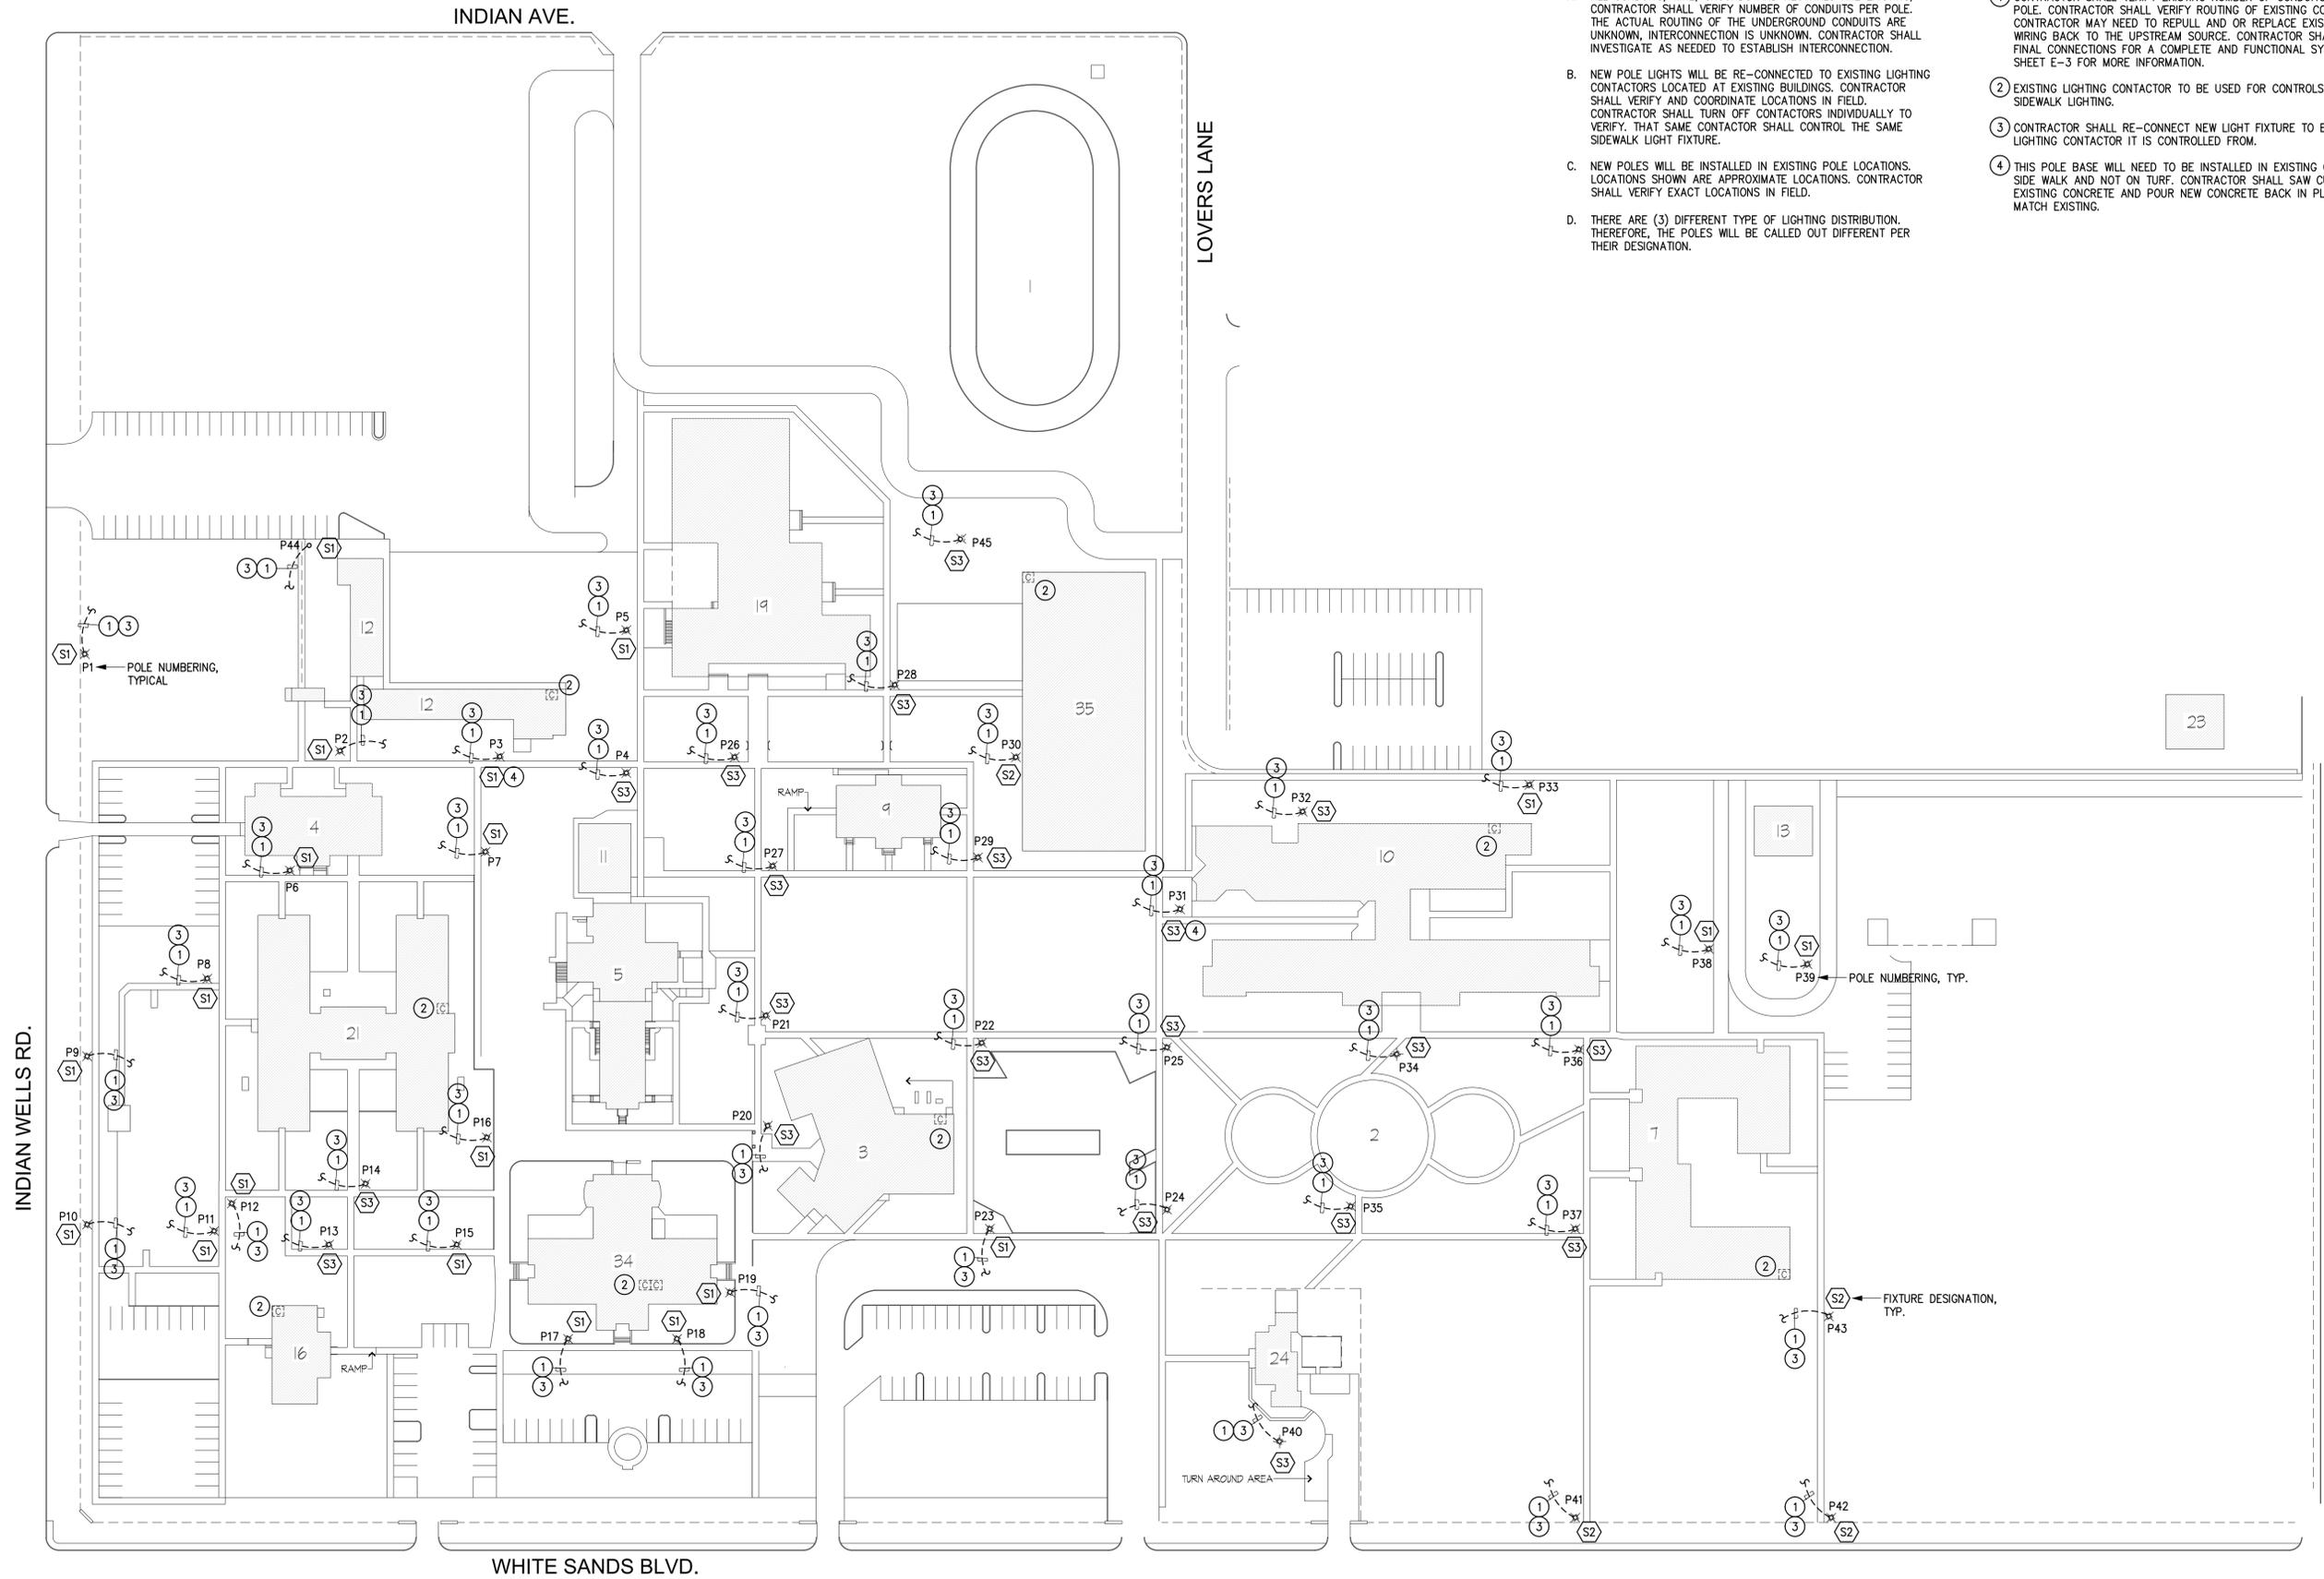
**ELECTRICAL SITE PLAN - REVISED**  
 SCALE: 1" = 60'-0"

- ① CONTRACTOR SHALL VERIFY EXISTING NUMBER OF CONDUITS PER POLE. CONTRACTOR SHALL VERIFY ROUTING OF EXISTING CONDUITS. CONTRACTOR MAY NEED TO RE-PIPE AND OR REPLACE EXISTING WIRING BACK TO THE UPSTREAM SOURCE. CONTRACTOR SHALL MAKE FINAL CONNECTIONS FOR A COMPLETE AND FUNCTIONAL SYSTEM. SEE SHEET E-3 FOR MORE INFORMATION.
- ② EXISTING LIGHTING CONTRACTOR TO BE USED FOR CONTROLS OF NEW SIDEWALK LIGHTING.
- ③ CONTRACTOR SHALL RE-CONNECT NEW LIGHT FIXTURE TO EXISTING LIGHTING CONTRACTOR IT IS CONTROLLED FROM.
- ④ THIS POLE BASE WILL NEED TO BE INSTALLED IN EXISTING CONCRETE SIDE WALK AND NOT ON TURF. CONTRACTOR SHALL SAW CUT EXISTING CONCRETE AND POUR NEW CONCRETE BACK IN PLACE TO MATCH EXISTING.

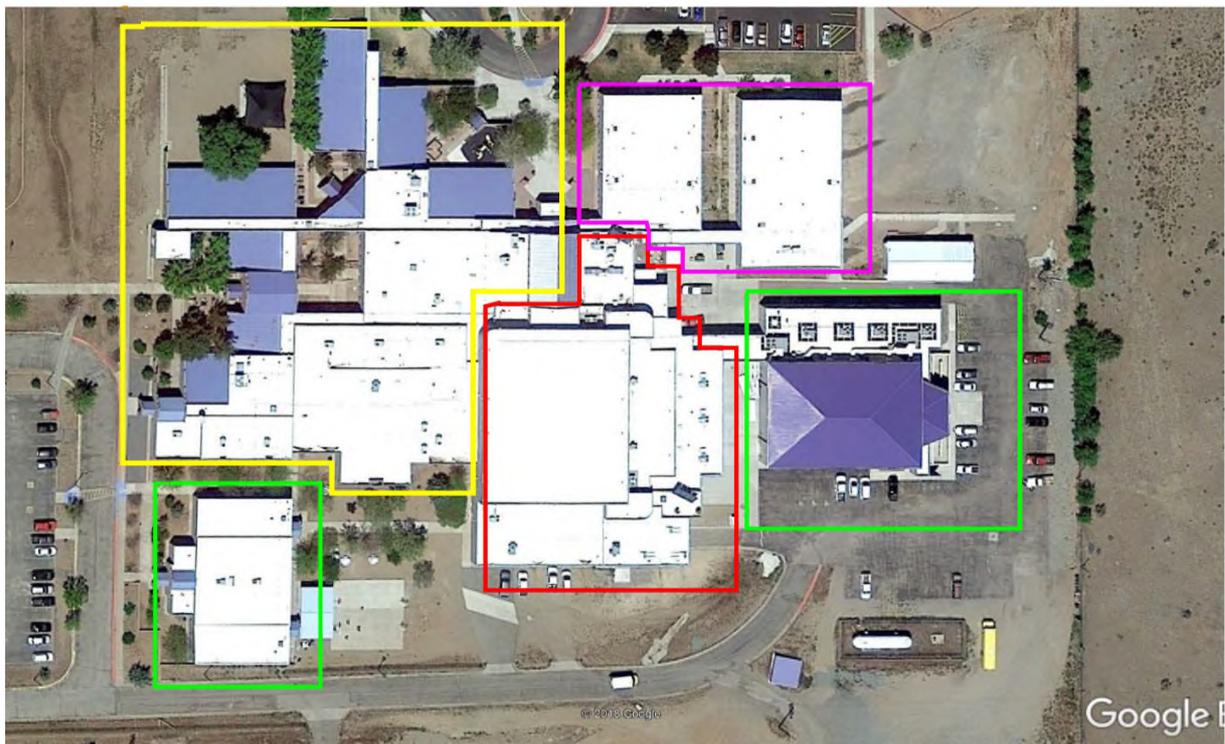
## Magdalena Schools June 2018

- GREEN ROOF AREAS ARE NEWER ROOF AREAS AND SHOULD REQUIRE STANDARD M&R
- YELLOW ROOF AREAS ARE MEDIUM RANGE TPO ROOFS THAT SHOULD BE MONITORED
- PURPLE ROOF AREAS WILL NEED T BE COATED WITHIN 5 YEARS TO ENSURE PERFORMANCE FOR 20+ YEARS
- RED ROOF AREAS ARE OLDER STEVENS TPO ROOFS THAT HAVE BEEN CRACKING AND SPLITTING AND HAVE HAD PAST REPAIRS. RECOMMEND COATING SOON TO PRESERVE ROOF PERFORMANCE AND EXTEND SERVICE LIFE AN ADDITIONAL 10-15 YEARS

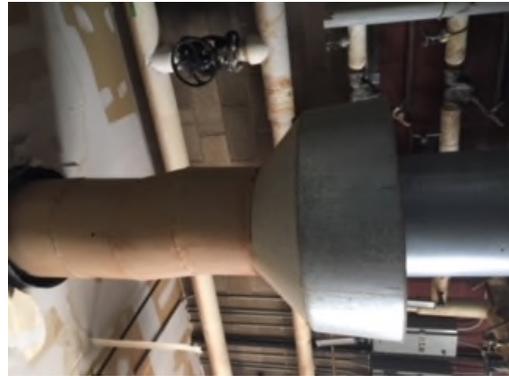
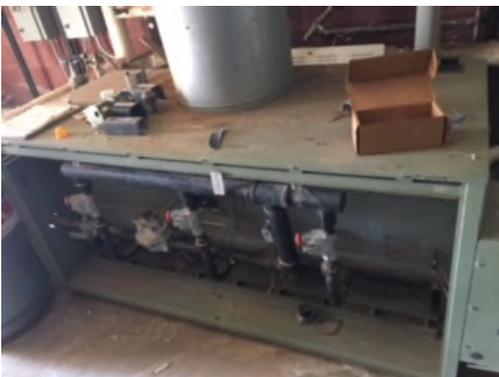
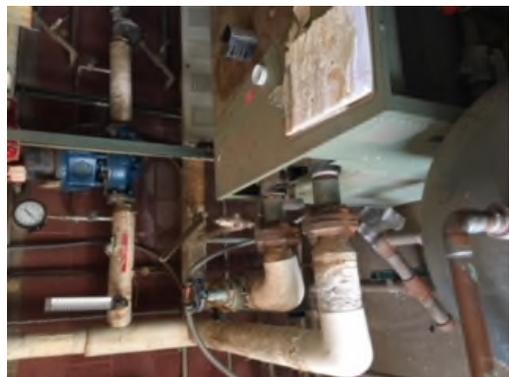
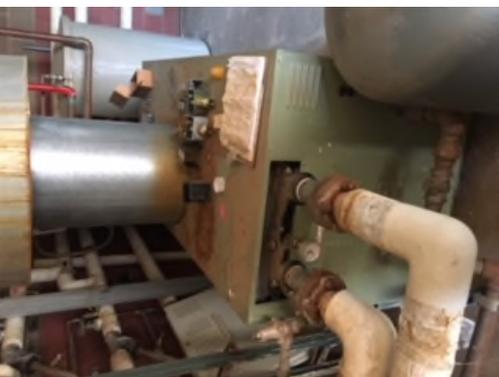
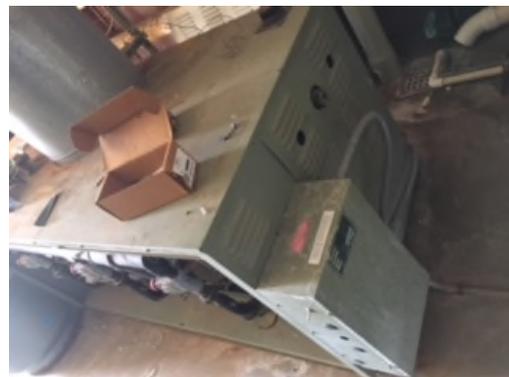
At your request the TLC boiler team performed an inspection and subsequently provided a quotation for the purpose of replacing the RAYPACK BOILER MODEL H1-1125C-CDARCAA currently located near the gymnasium. This boiler was purchased over 35 years ago and our technicians have determined that due to age and the fact that parts for this unit are no longer available as well as the current need for service on this unit, the prudent course for the district would be to replace the boiler with a comparable unit. It is our further recommendation that the district consider an annual maintenance contract which would cover all three boilers for the district as well as the HVAC units on all existing buildings. Quotes have been provided for both. TLC appreciates the opportunity to work with you on this and any new projects for the district.

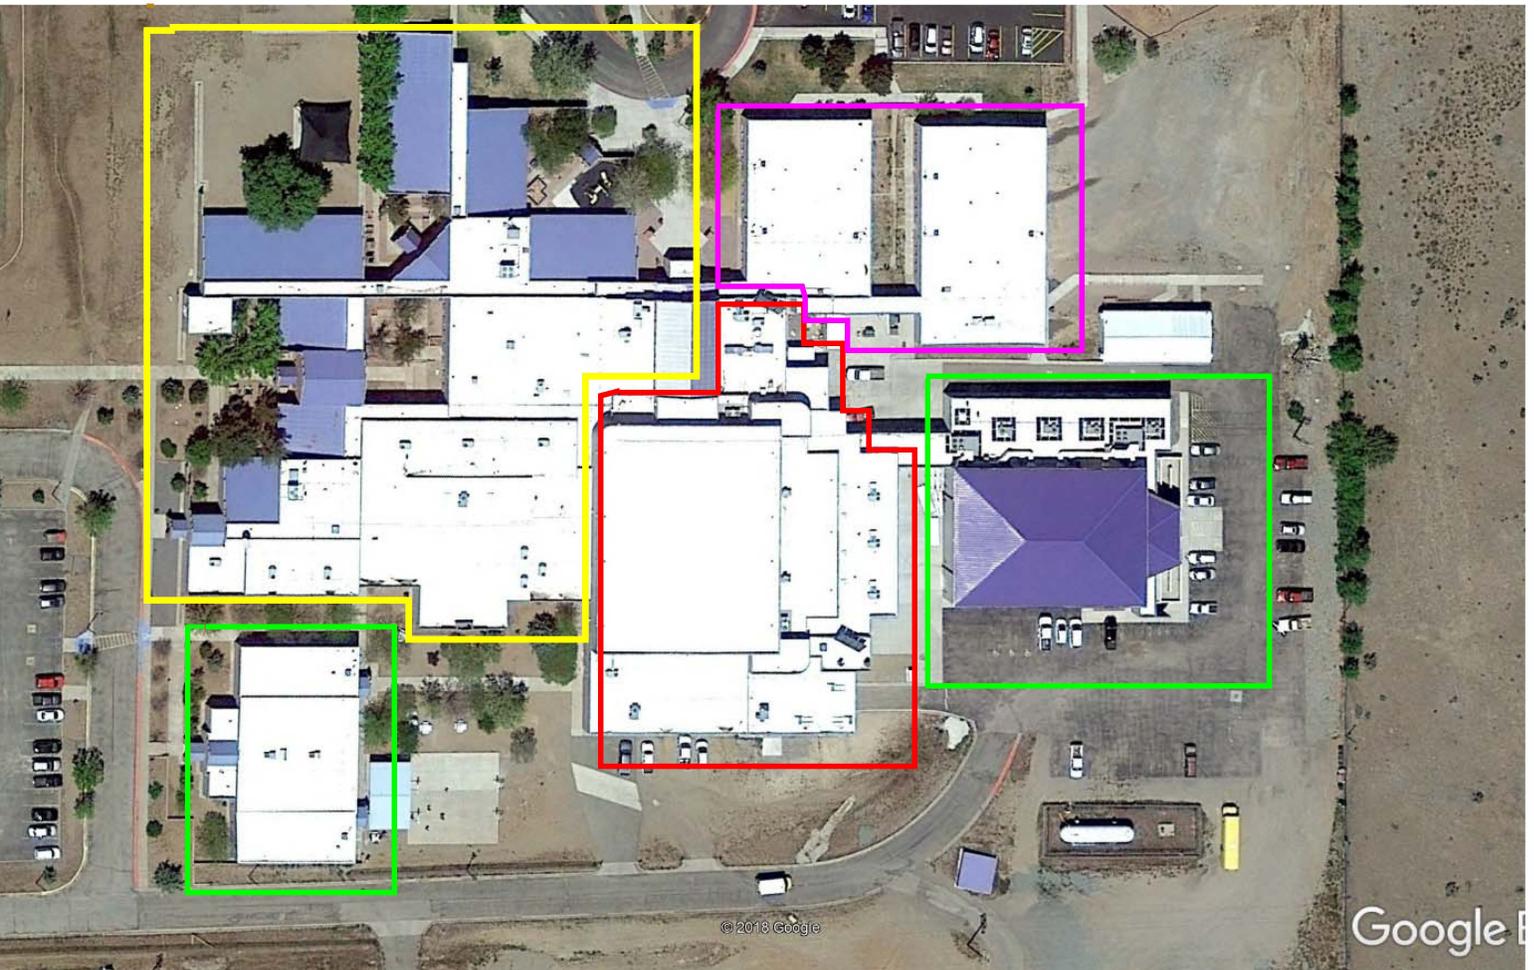
**PURPLE ROOF AREAS WILL NEED T BE COATED WITHIN 5 YEARS TO ENSURE PERFORMANCE FOR 20+ YEARS**

**RED ROOF AREAS ARE OLDER STEVENS TPO ROOFS THAT HAVE BEEN CRACKING AND SPLITTING AND HAVE HAD PAST REPAIRS. RECOMMEND COATING SOON TO PRESERVE ROOF PERFORMANCE AND EXTEND SERVICE LIFE AN ADDITIONAL 10-15 YEARS**

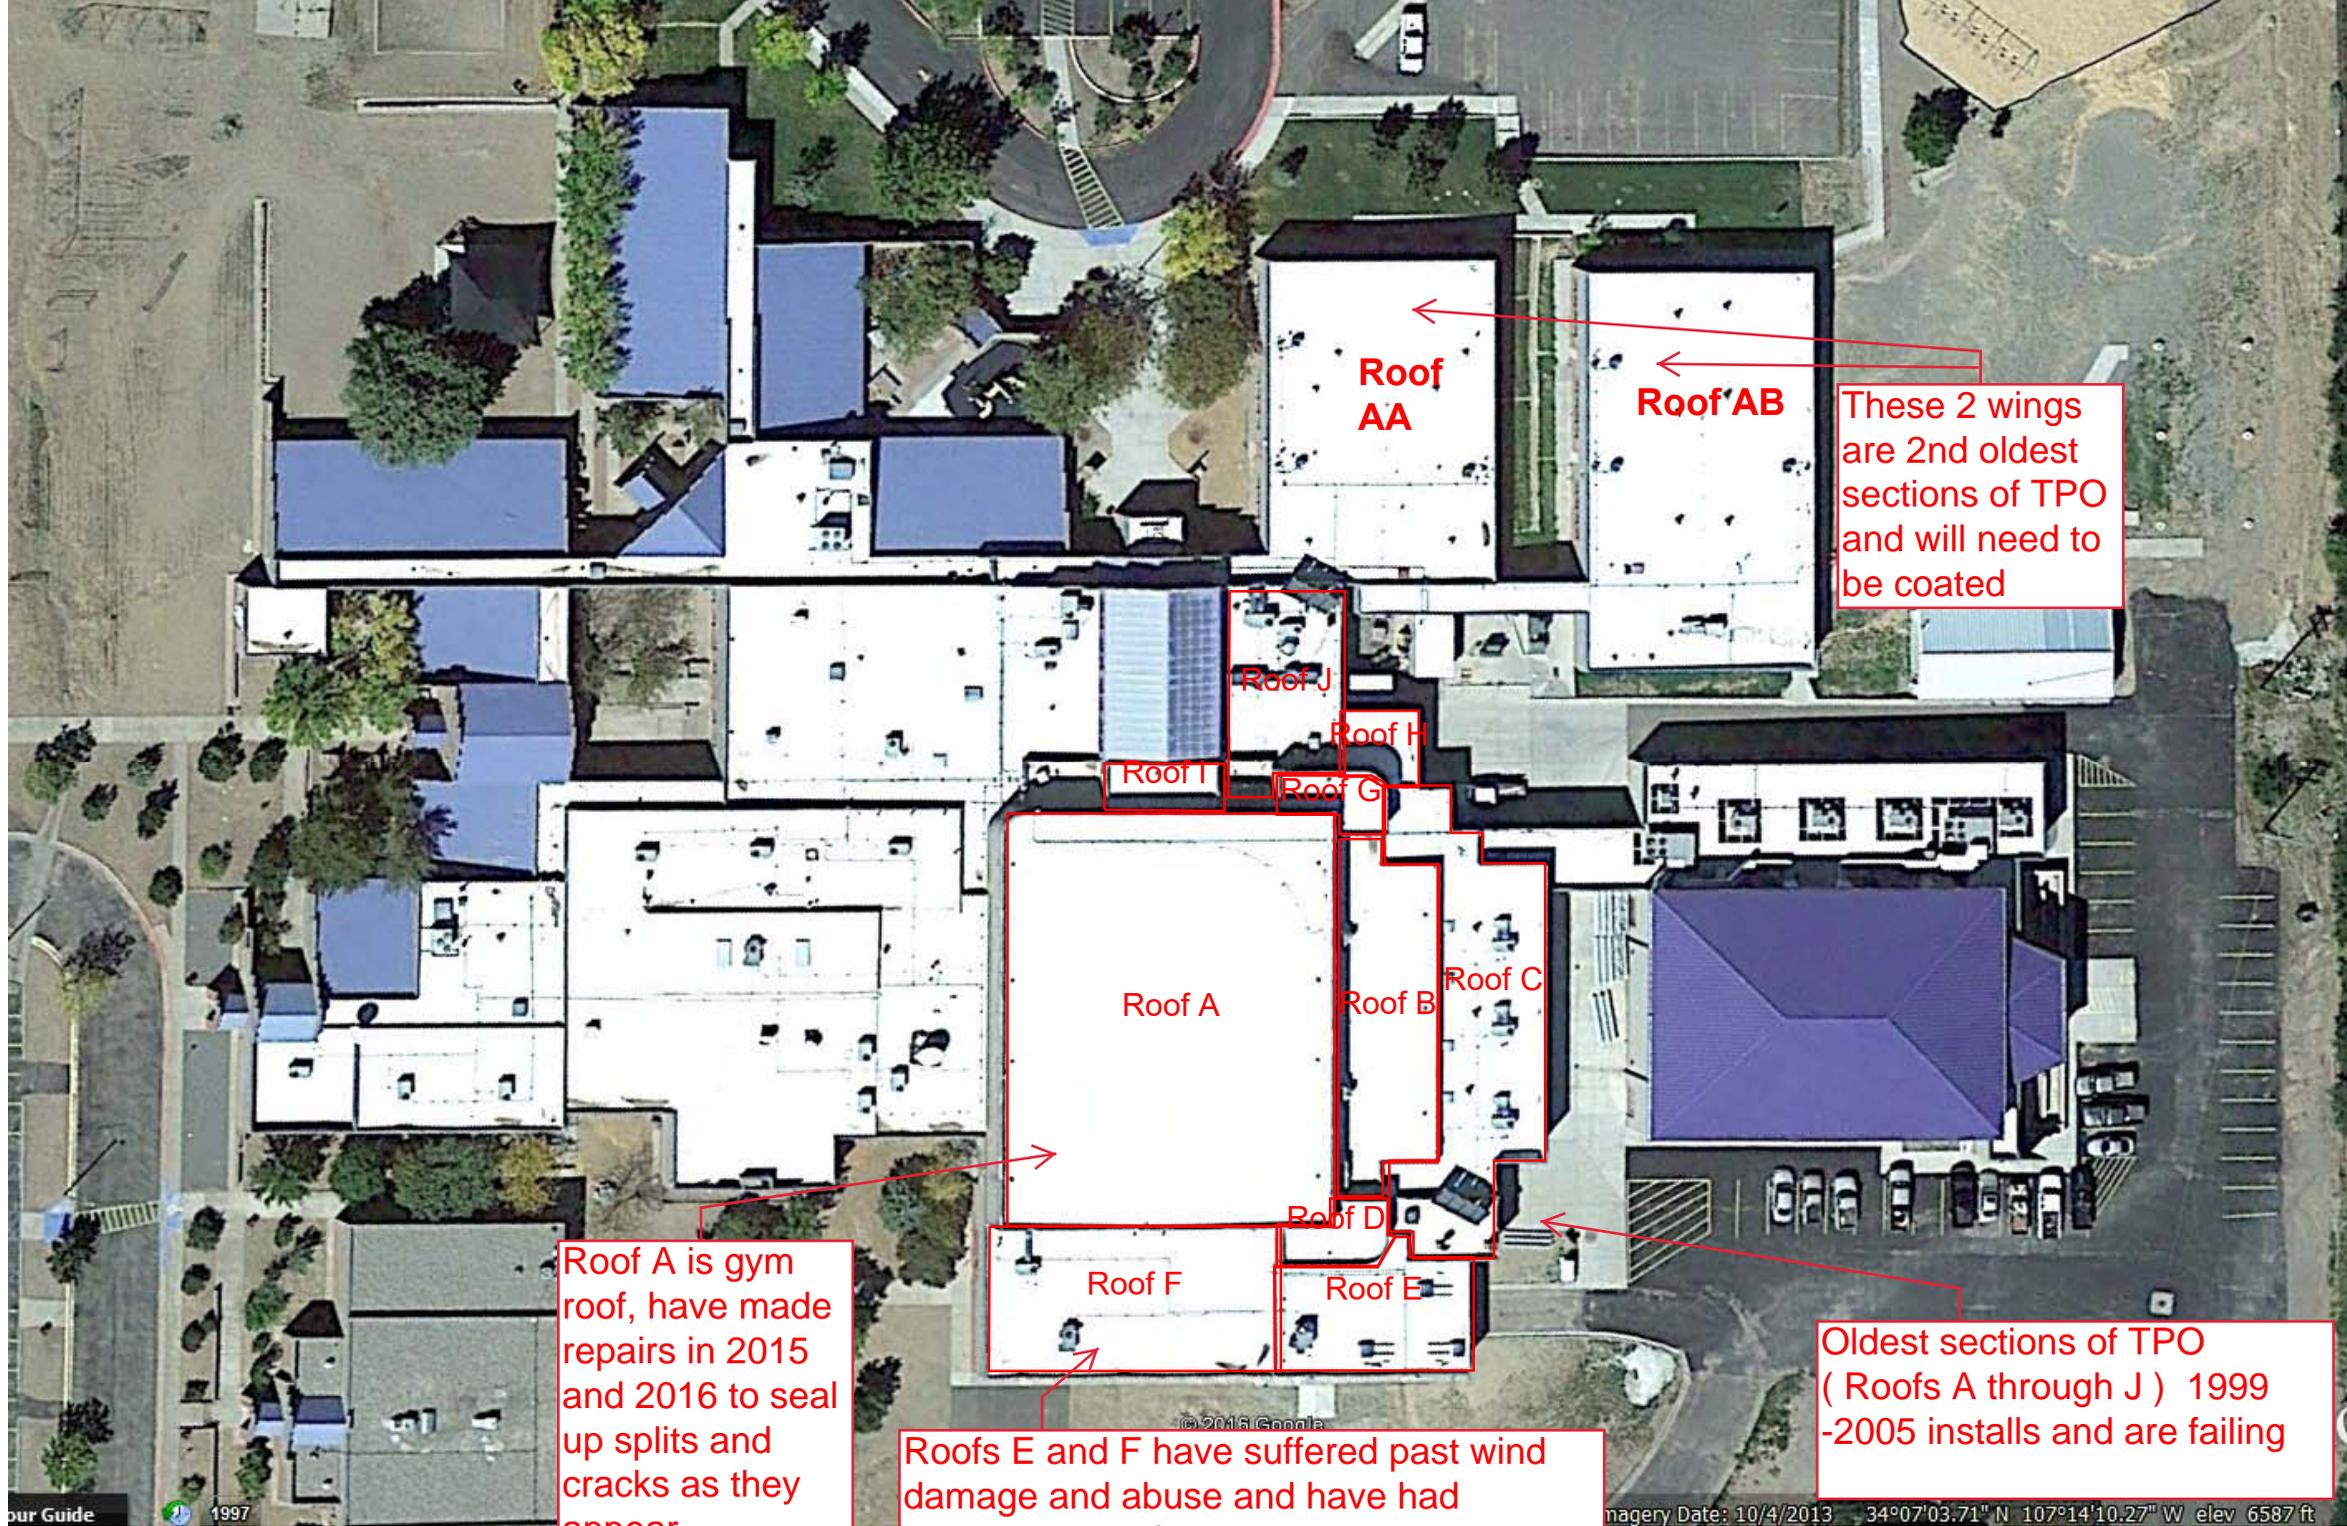
## **2017 repairs and coating to roof J area**

**Note that Roof areas AA and AB ( NE classroom wings will also need to be coated within the next 3 years installed 2005-2006)**

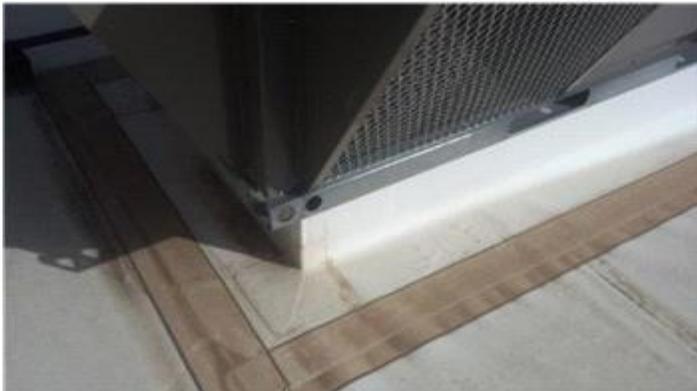
# 3

2014-12-02\_13-39-14\_365  
GAF TPO installed on other manufacture roof and taped in in lieu of heat welded  
By HVAC team in 2012

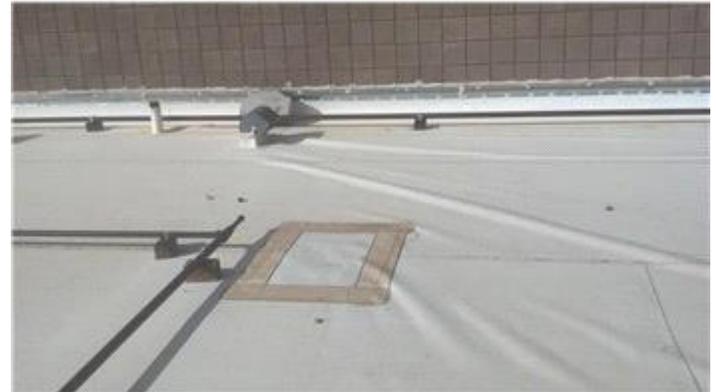
# 6

temporary repairs on south low roof of old gym area

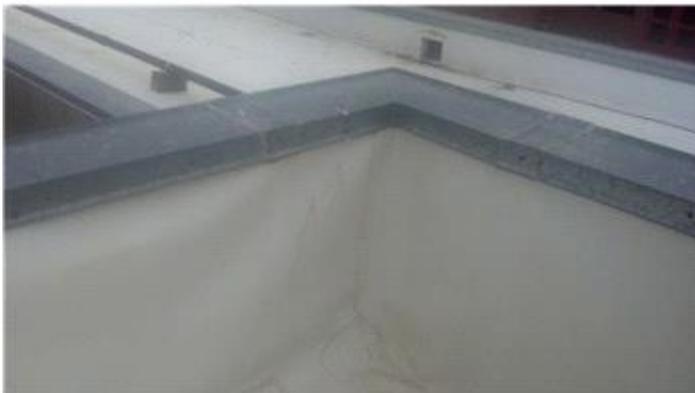
# 7

2015-03-04\_10-54-08\_68  
wall flashings loose from wind

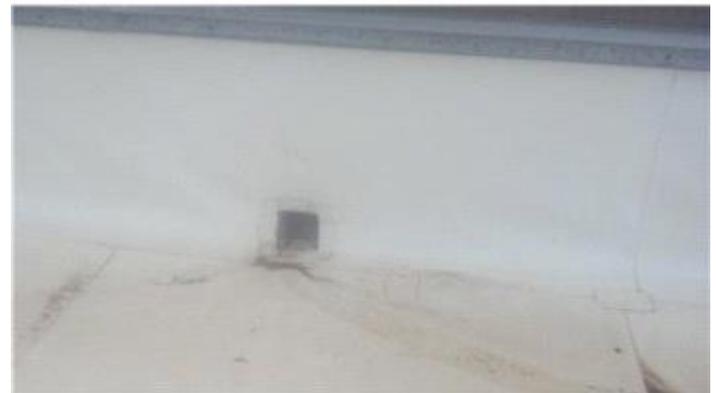
# 8

2015-03-04\_10-54-59\_873  
Damage at scupper on south low roof

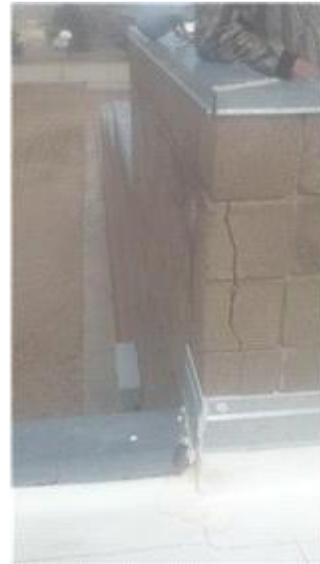
# 10

Cracked CMU at gym roof

- Some CMU failure of the block at various walls

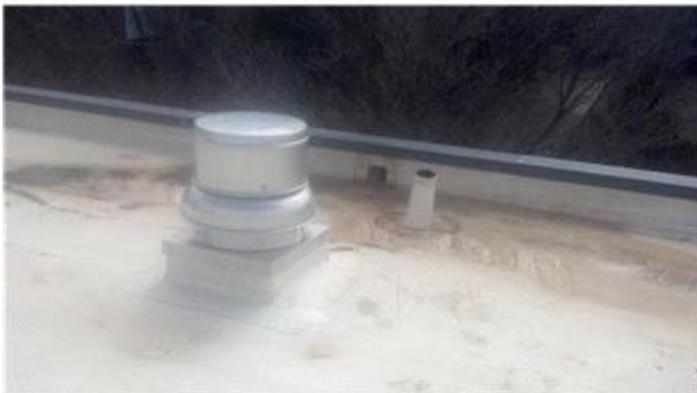
# 11

ponding on low roof area and membrane starting to crack at ponding

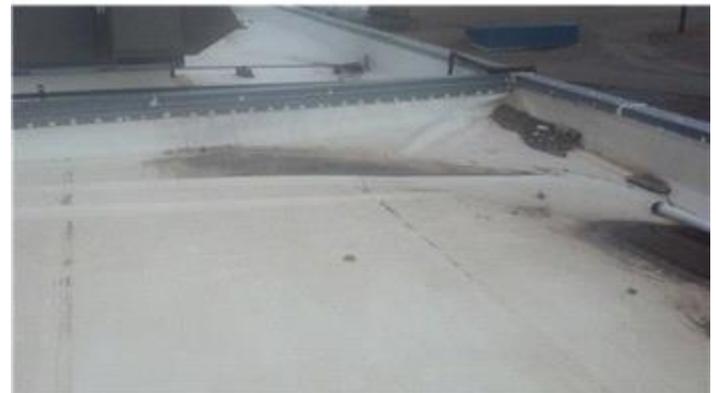
# 12

wind damage

We have identified wind damage on a couple of the roof sections estimate at 4,200 – 4,800 sq ft of roof that will need to be repaired to prevent a potential loss of the roof covering. Cost to repair the wind damage estimated at \$ 17,675.00. **THIS COSTING IS NOT INCLUDED IN THE ABOVE REFERENCED SCOPE OF WORK.**

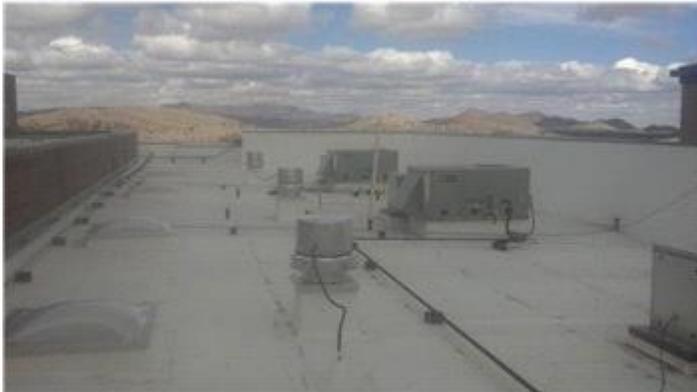
2015-03-04\_12-13-54\_40 # 21  
low east roof of old gym.. this is 2000-2001 roof materials and is starting to fail

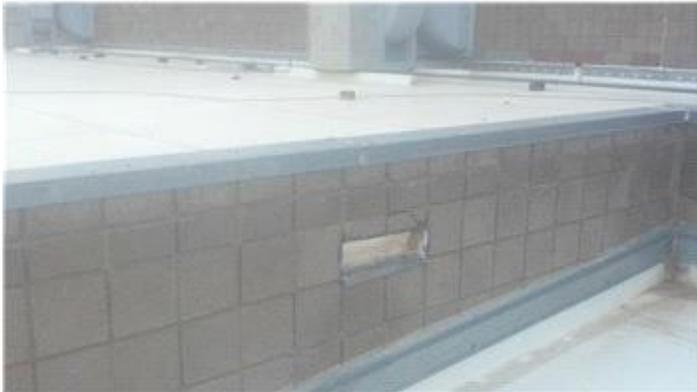
# 25

2015-03-04\_12-22-12\_93  
Cracked CMU at scupper to be sealed

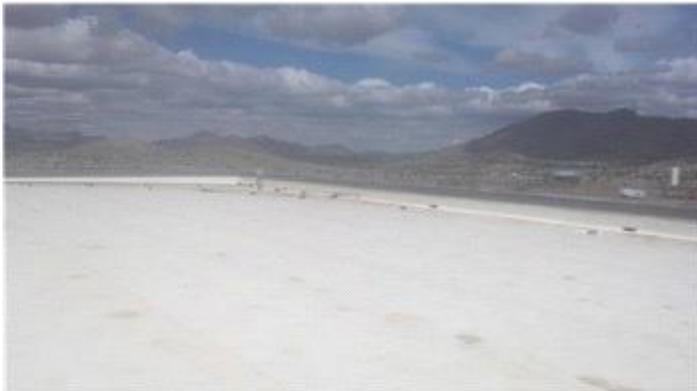
# 27

2015-03-04\_12-24-21\_677  
Old gym roof 2002. This is 2nd roof and is starting to crack and split.  
Made temp repairs while on site

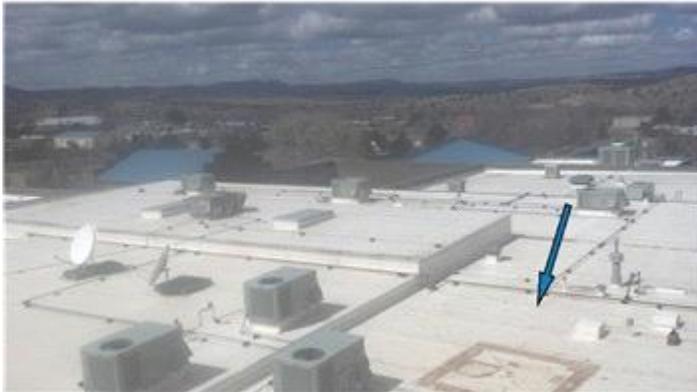
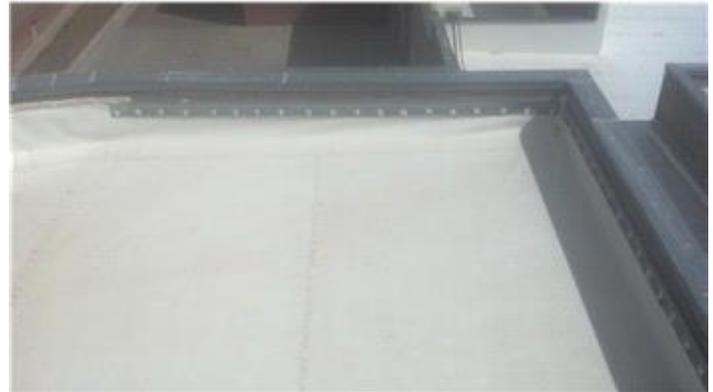
# 29

Looking down on West main roof. Note repairs made by others with tape and dissimilar materials  
No warranty

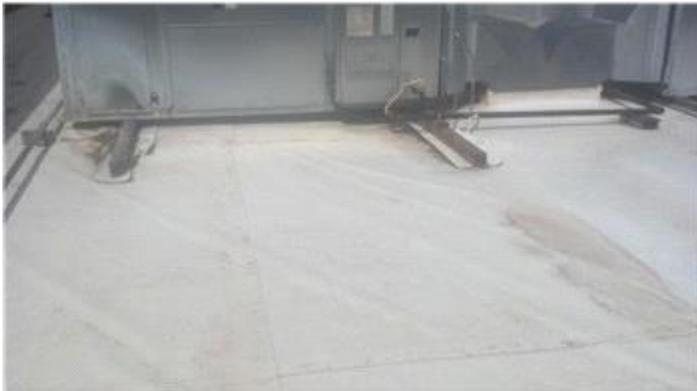
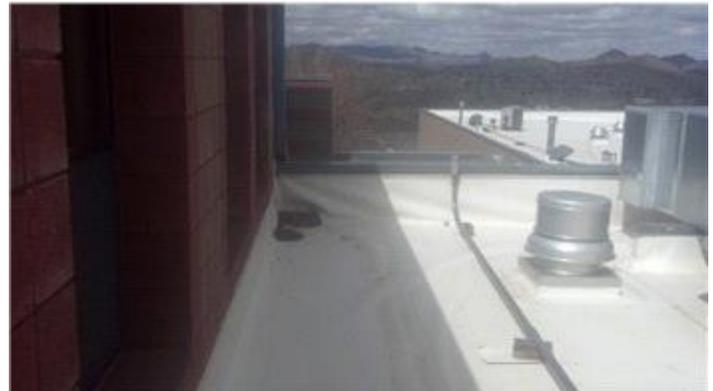
# 31

Roof to be coated ASAP.. Wind damaged and numerous holes by others

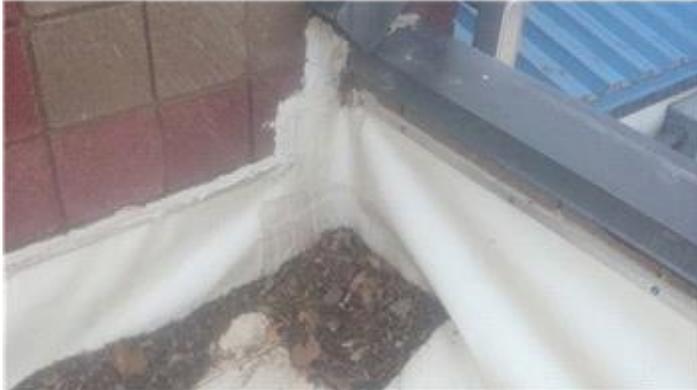
# 33

Membrane cracked and splitting, and wind damage

Roof repaired and coated to extend performance of this section of roof out an additional 10 or more years

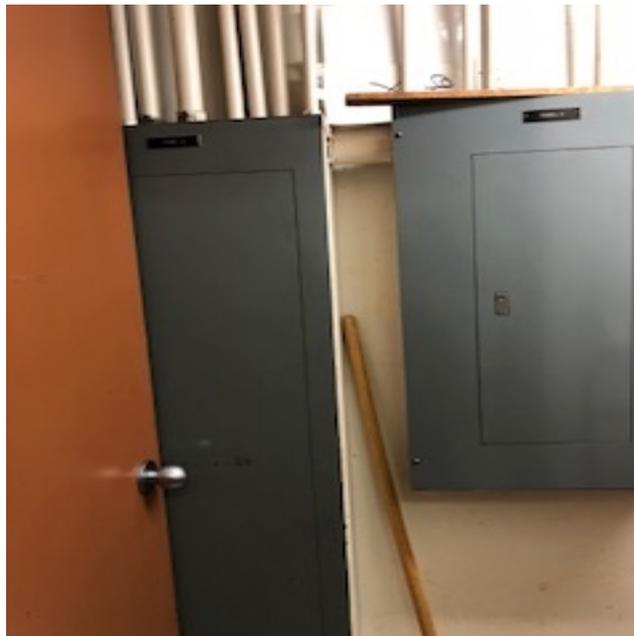
Electrical Panels

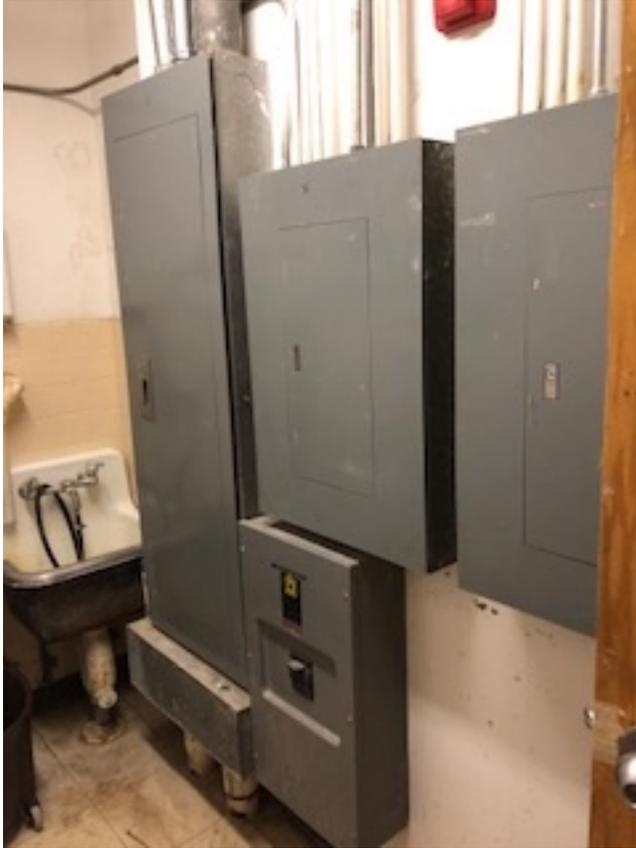
Electrical Panels

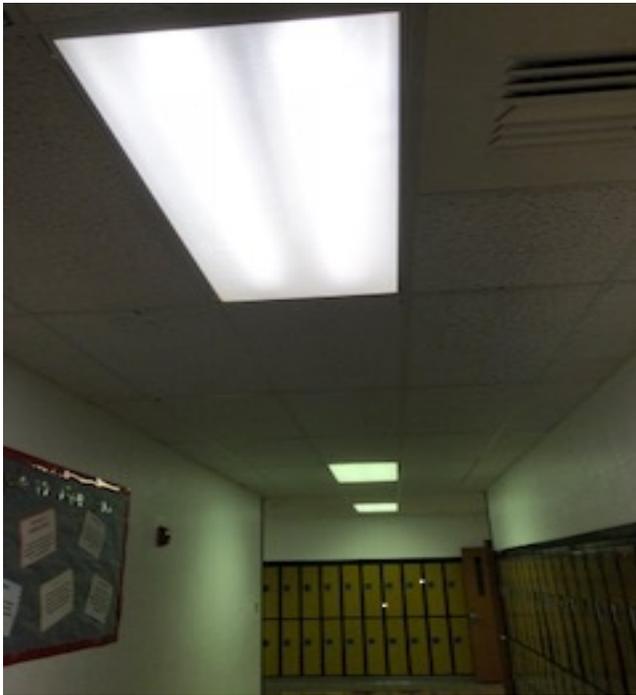
Hall Way Lighting

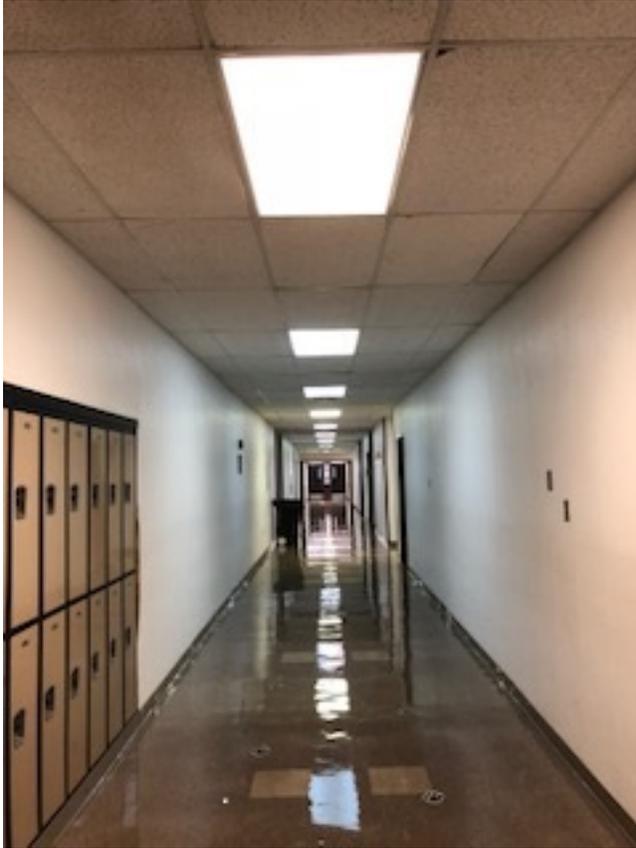
Hallway Lighting

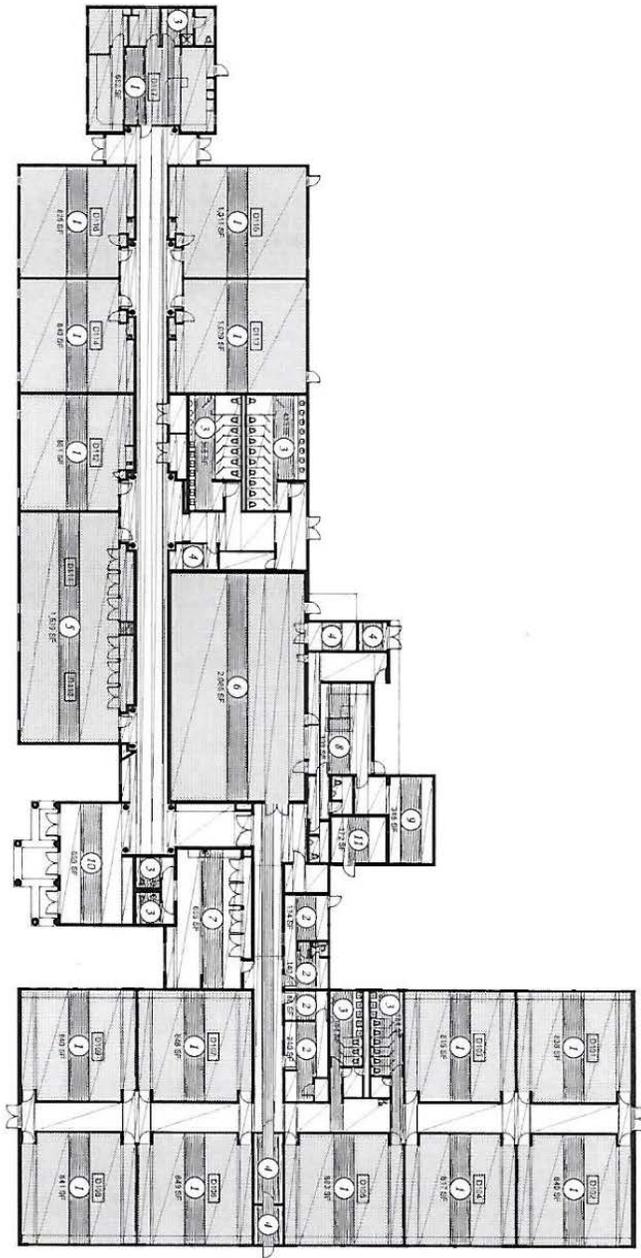
- 1. CLASSROOM
- 2. OFFICES
- 3. RESTROOM
- 4. STORAGE
- 5. LIBRARY
- 6. CAFETERIA/MULTI-PURPOSE LOUNGE
- 7. FOOD SERVICES
- 8. FOOD STORAGE
- 9. LOBBY
- 10. MECHANICAL
- 11. MECHANICAL
