2019-2020 PSFA Summary of Applicant Campus

Gallup – Crownpoint Middle School (MS) **Rank: 124** **wNMCI: 35.46%** **FCI: 61.63%**

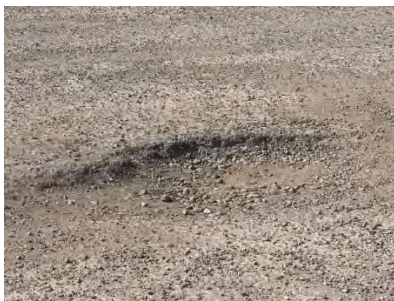
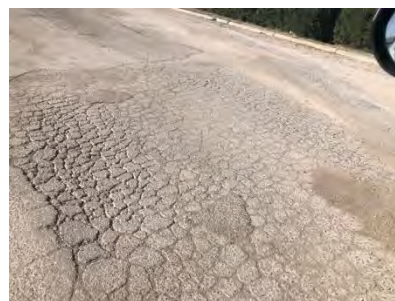
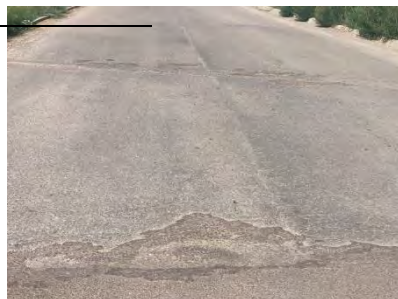
Parking lots and driving surfaces are heavily worn, have deep ruts and potholes, and striping is faded. Areas of student parking are graveled.

Replace concrete walkways where needed.

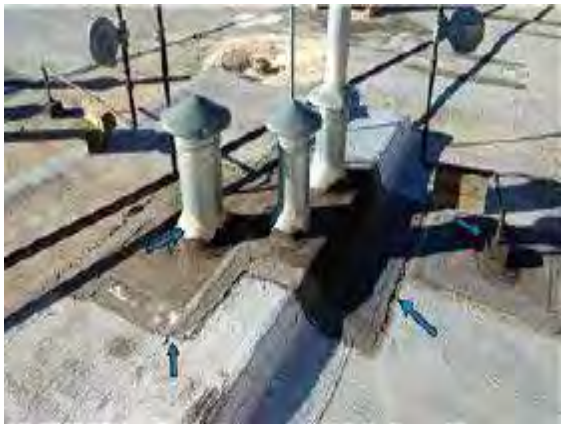
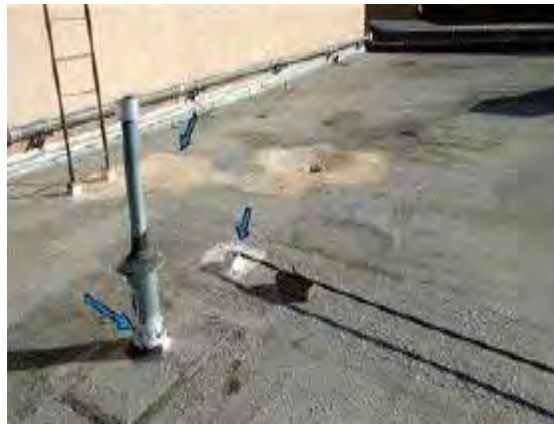
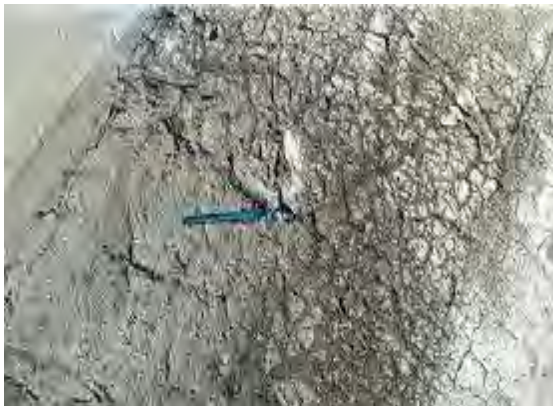
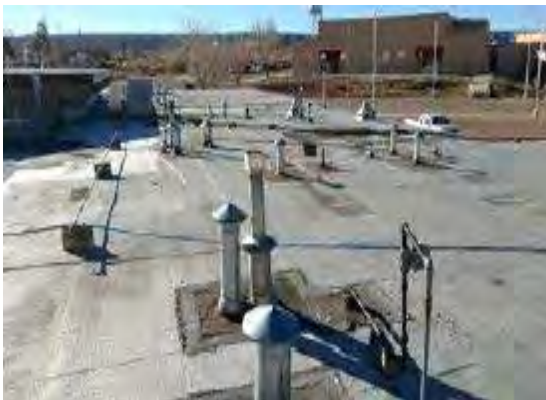
Gallup-McKinley County School District had J3, a roofing company and consulting firm, inspect Crownpoint Middle School. They determined to conduct immediate repairs to Roofs A, B, C D, E, and F. All roofs should be repaired for immediate leaks. These six roof sections should be prioritized for re-roofing in 2019.

Roof replacement through-out the building

The FMP describes the roof as past its useful lifecycle. Alligating and cracking are evident and numerous tar patches cover the decaying surfaces.

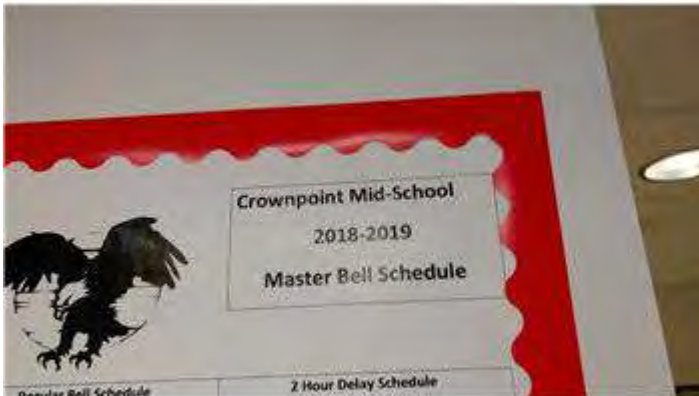
1

Site visit 12-20-18

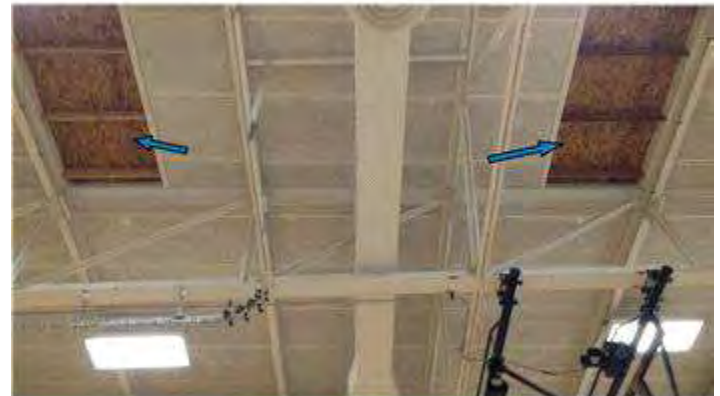
2

Gym roof from interior, This is a tectum deck and need to be protected and kept dry, due to deck and to wood floor
Wood framing is from skylights that were removed and roof capped

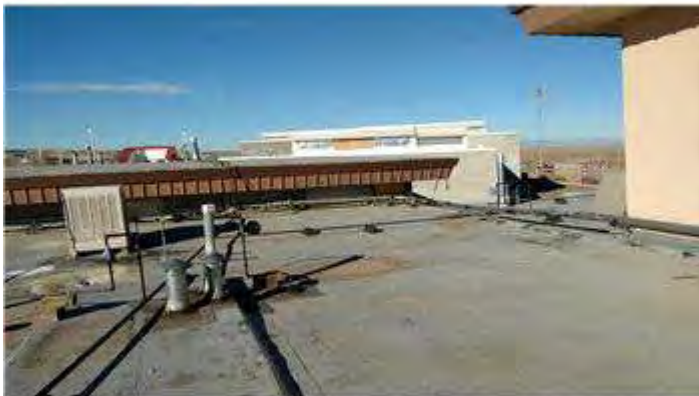
3

Main roof of school
Torch down APP and saturated. Deck is LWC deck

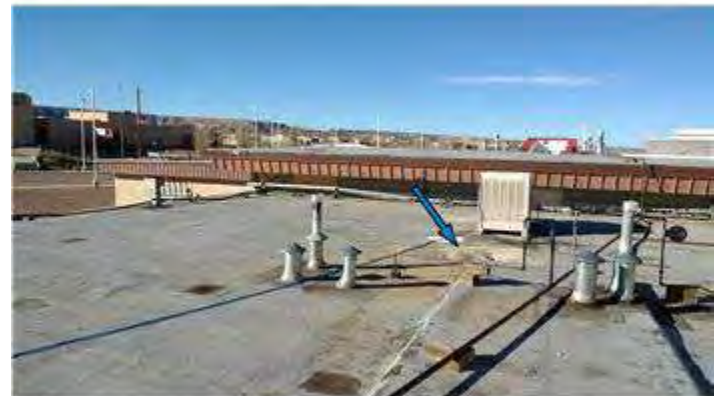
4

Additional views of main roof.
Lack of drainage and drains not effective. Roof will need new drainage strategy and drains

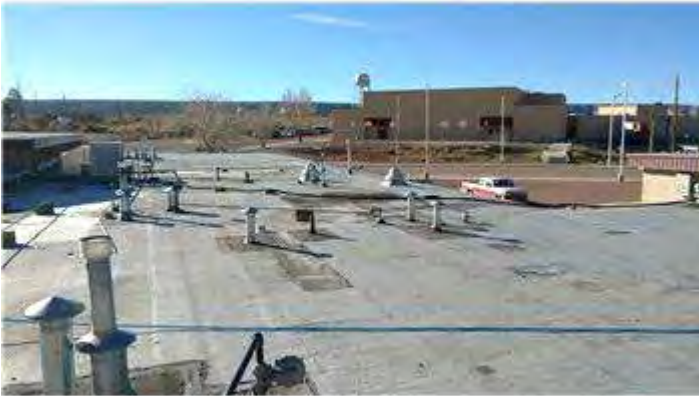
Main roof view of existing conditions

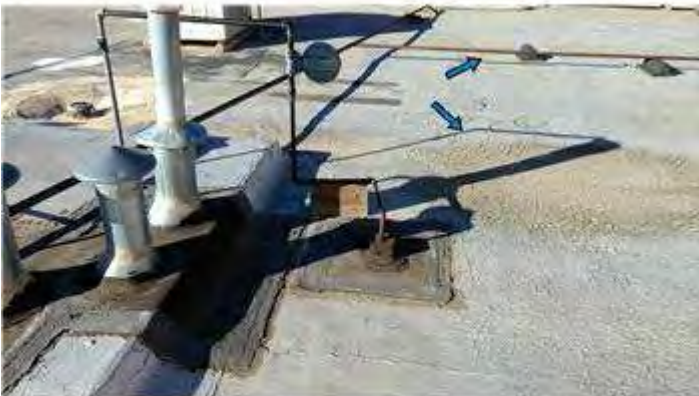
7

Note staining of cap sheet from ponding water.

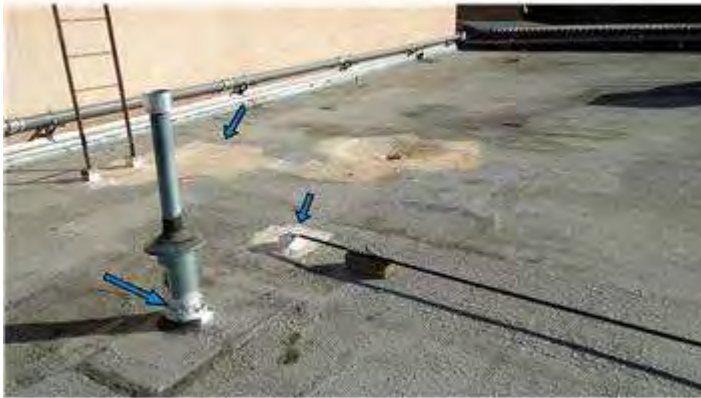
9

Past repairs using various products.. Cap sheet roofs need to be repaired with asphaltic products and not coatings and silicones

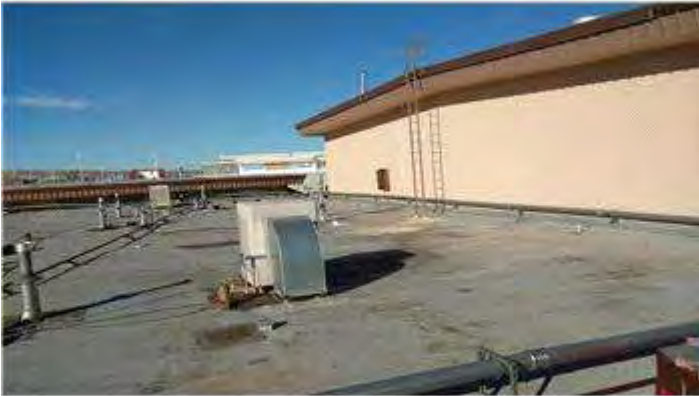
13

Walls and flashing heights are adequate overall, and no major mechanical or other remedial work should be necessary

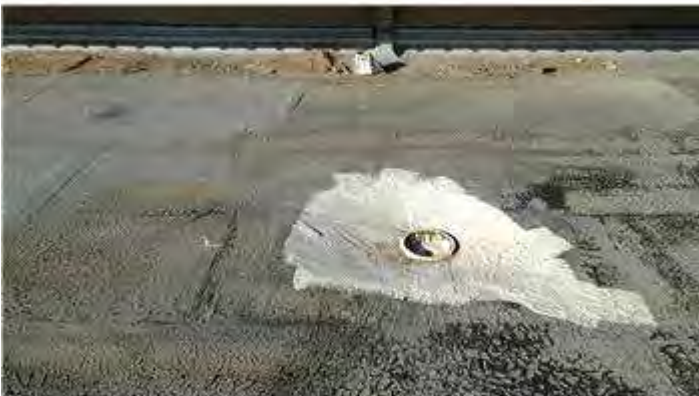
15

Silicone or similar used to try to stop ongoing leaks
May need to flood test drains for loose fittings

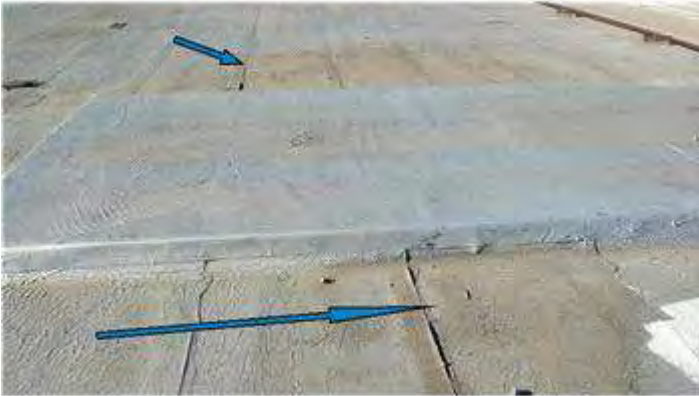
17

Old curb location that was capped and roofed over. This should be removed when re-roofed and patched back with deck and fill to prevent future ponding at this location

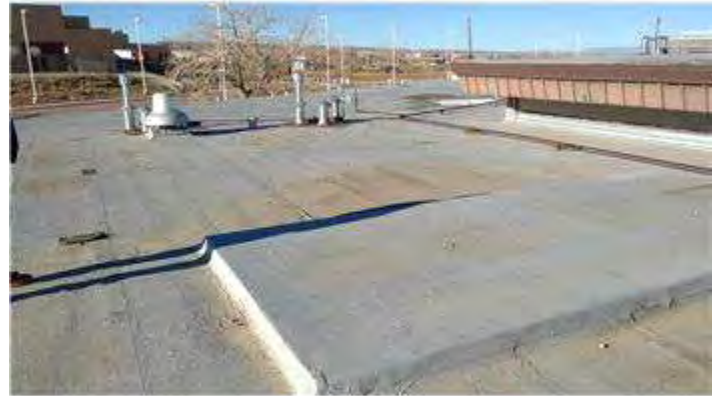
18

Additional view of capped curb

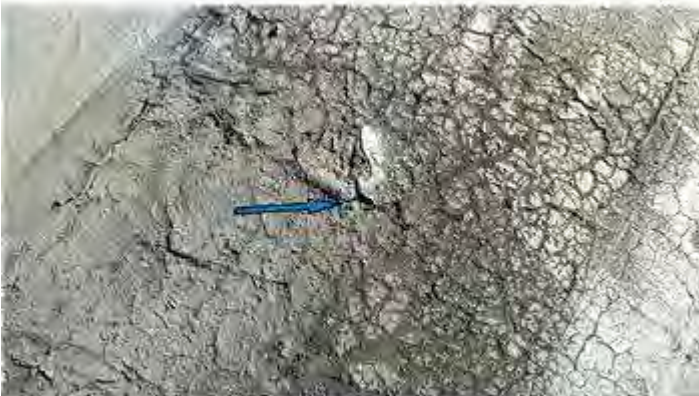
19

Alligatoring and mud cracking from sheet movement and ponding.. Split in roof

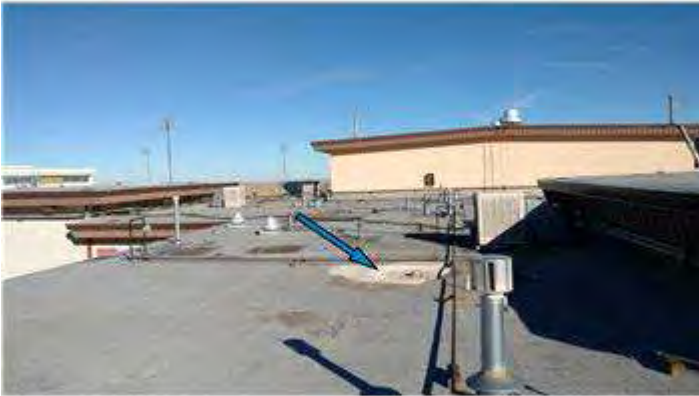
21

Additional main roof view. We suspect drains were installed after roofing and in an attempt to address ponding water due to lack of slope

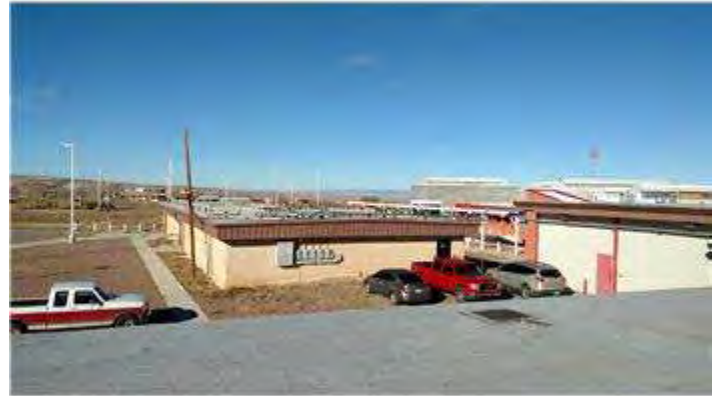
22

Edge has no gutter or other for drainage control

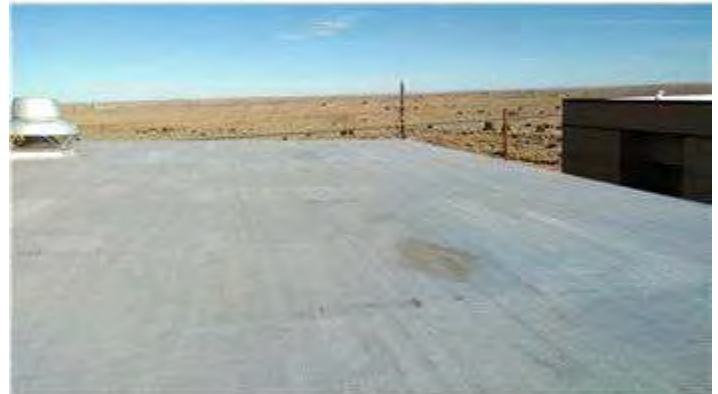
24

Gym roof. Overall good condition, should be overhauled, prepped and re-coated

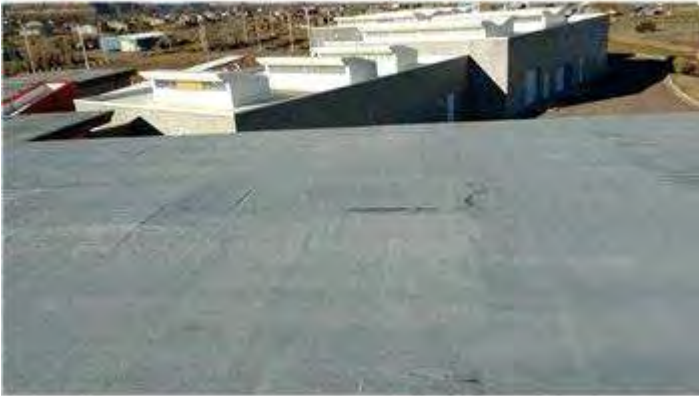
29

Gym roof has very good slope which is why it is performing properly

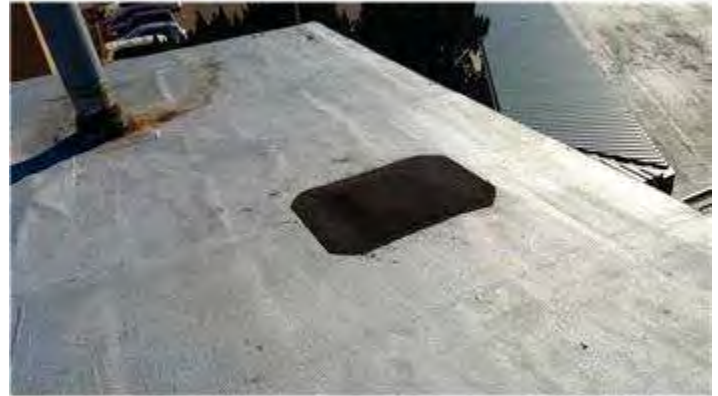
30

patch on gym roof to be repaired properly

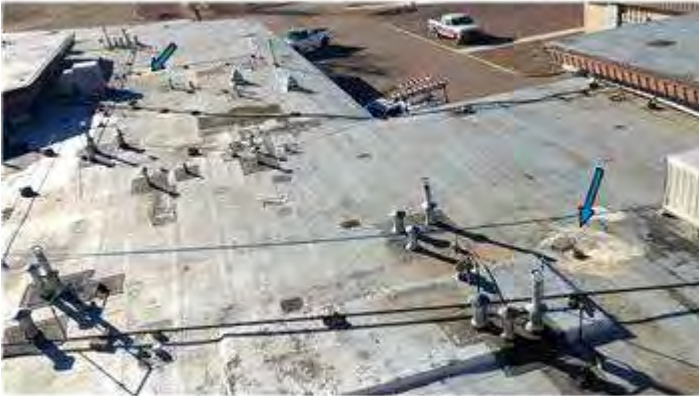
37

Looking down onto main roof with arrows showing drains on main roof They are in the wrong place and not sufficient for roof areas

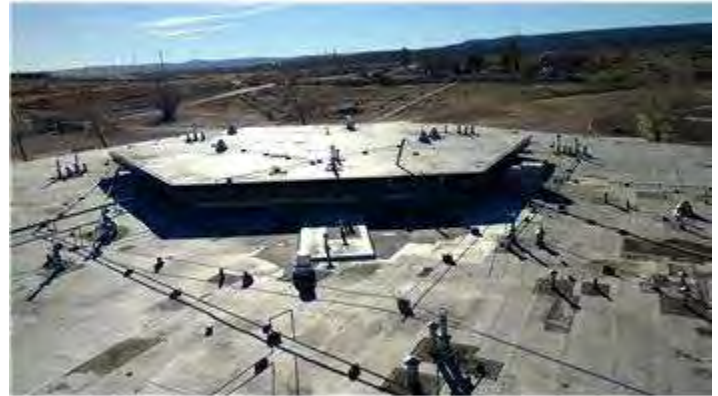
38

Main roof

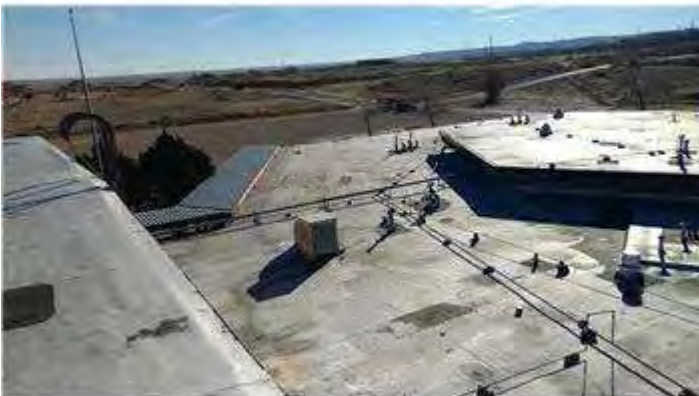
39

Main roof

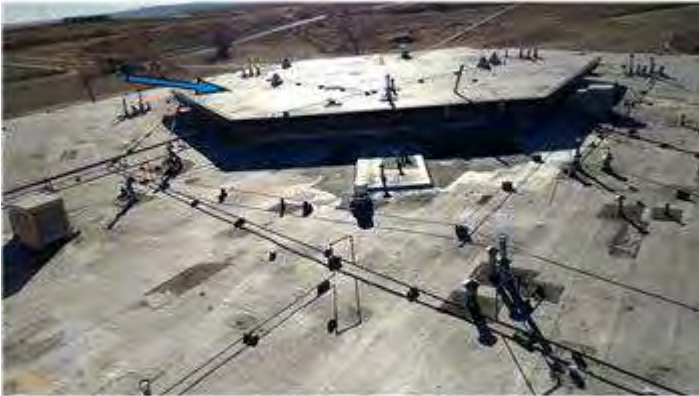
41

Main roof. High roof section is supposed to drain onto main roof

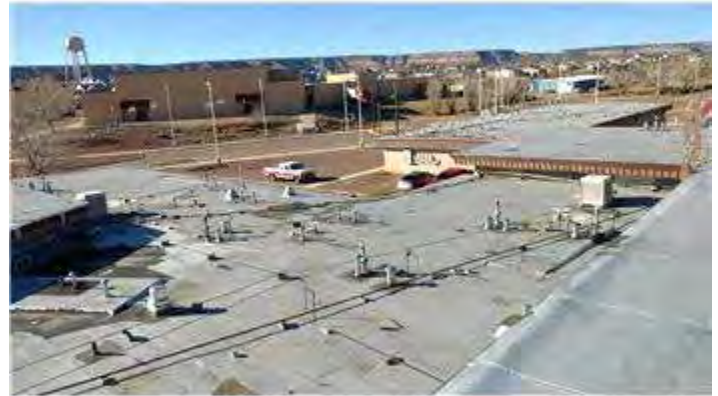
42

Main roof

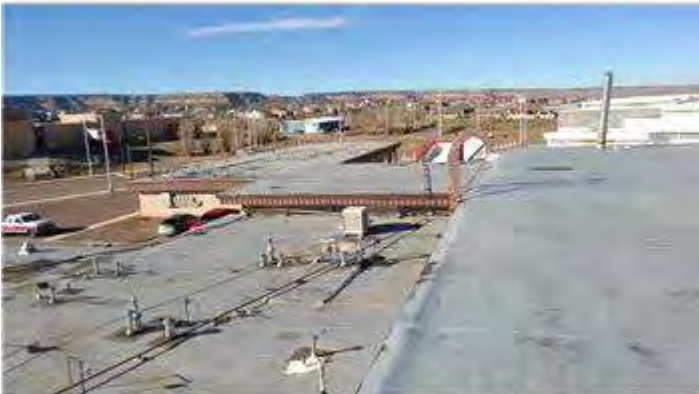
43

Gym roof has drip edge and final shot of main roof

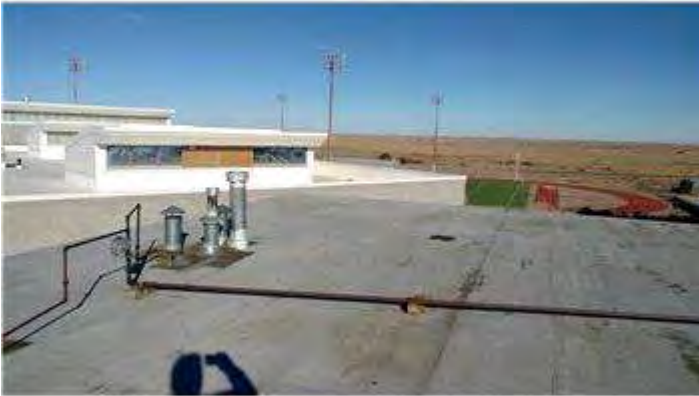
45

penetrations on mid roof area. This roof can be repaired and coated

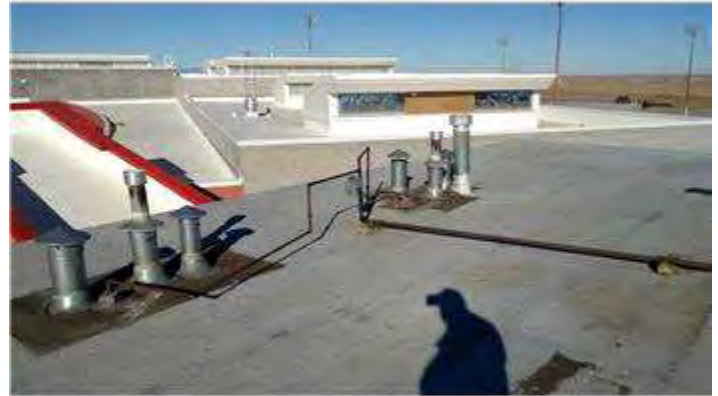
46

Penetrations need to be properly flashed and coated

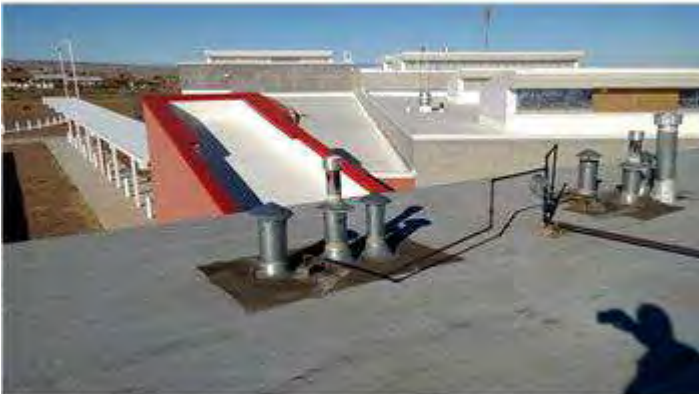
47

additional mid roof section

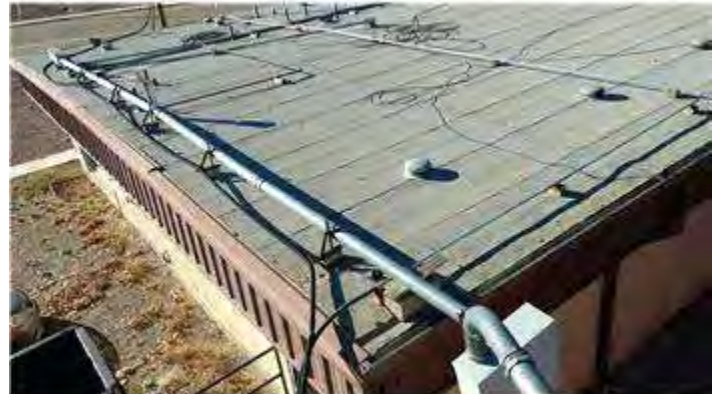
48

View of Aux building for High School. Roof is in very poor condition, We did not walk this roof

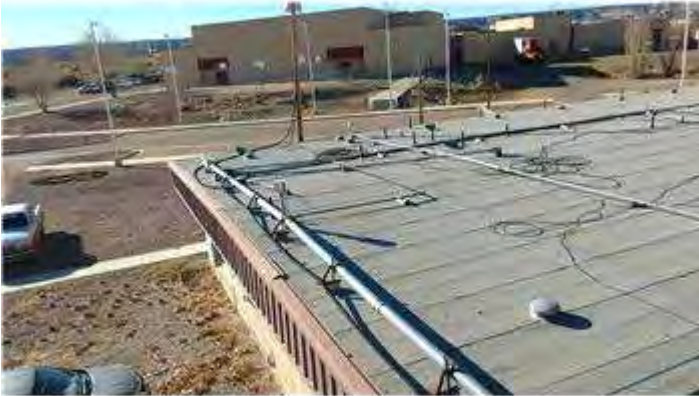
49

Aux building roof

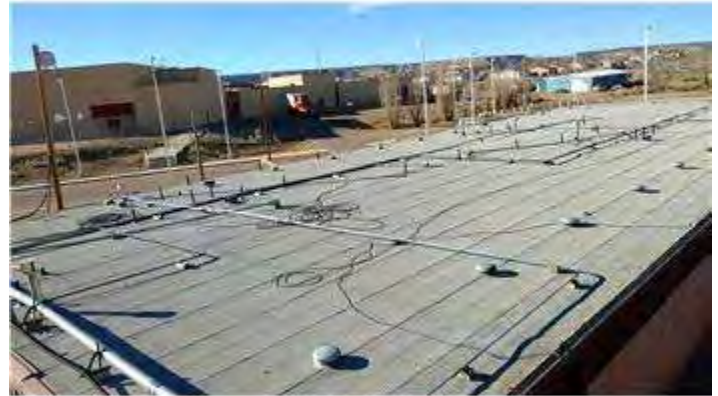
50

Aux bulding roof. Cap sheet wrinkled and ponding at laps

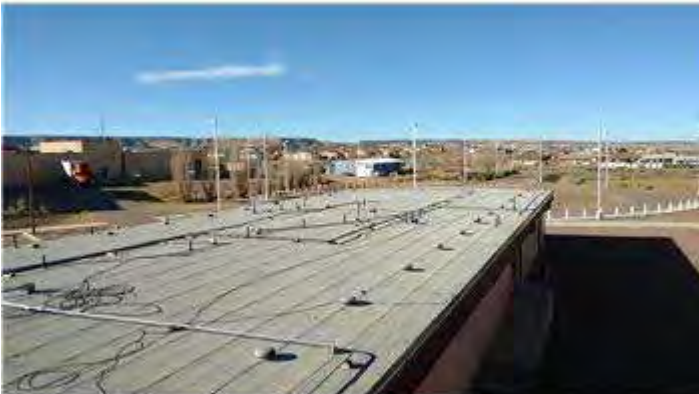
51

Aux building roof

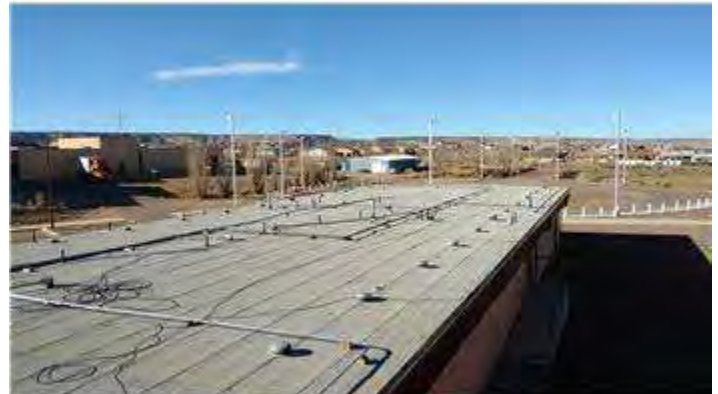
52

Final shot of Aux Building roof

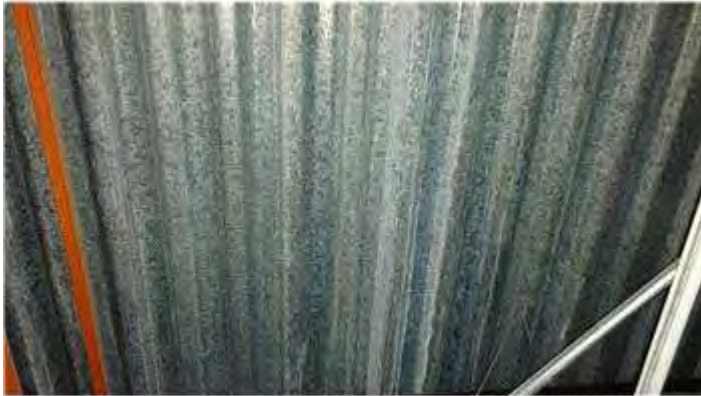
53

Deck at main roof. Deck type indicates that roof is a LWC pour over steel pan

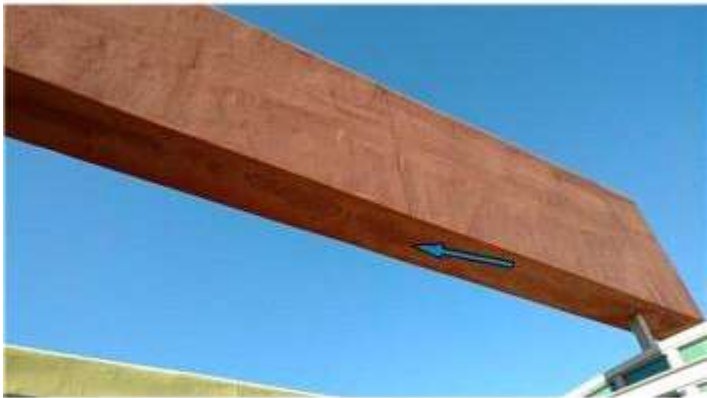
IMG_20181220_105713090
3
Staining/ efflorescence on bottom of architectural feature indicates moisture. May simply be water running off of side or that stucco on top has cracks that need to be sealed. Feature was not accessed

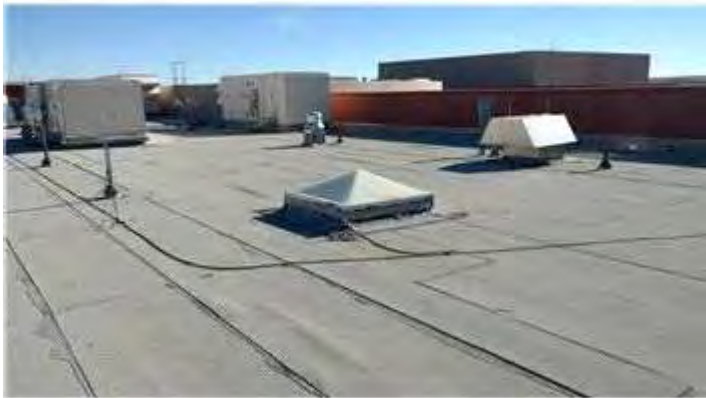
IMG_20181220_110553627
4
Access to roof area
Metal deck with cap sheet roofs. Roofs are in difficult condition

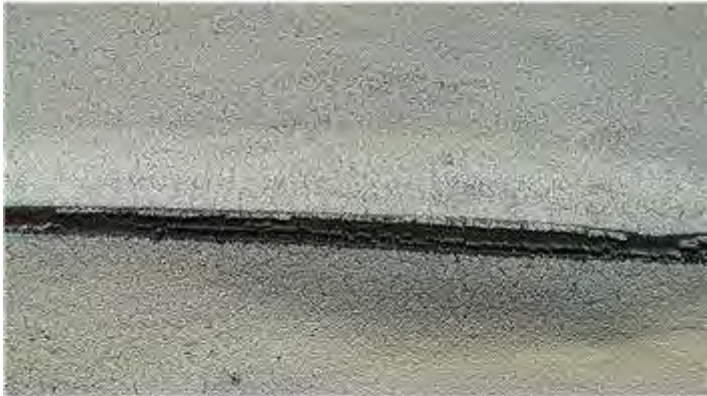
5

Blisters in cap sheet forming at laps and causing laps to open up

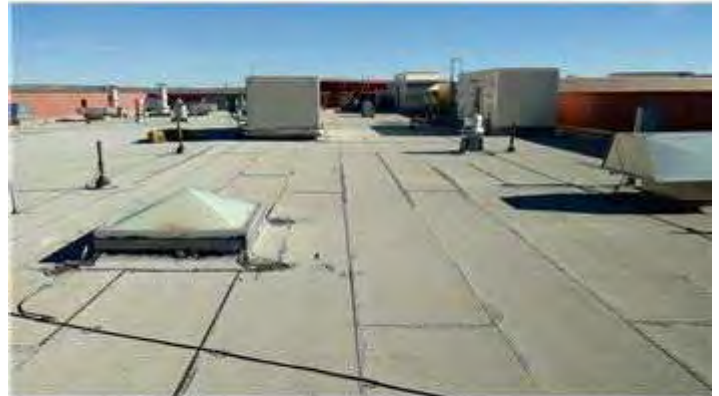
6

View of access roof
Note numerous past repairs at seams and penetrations.

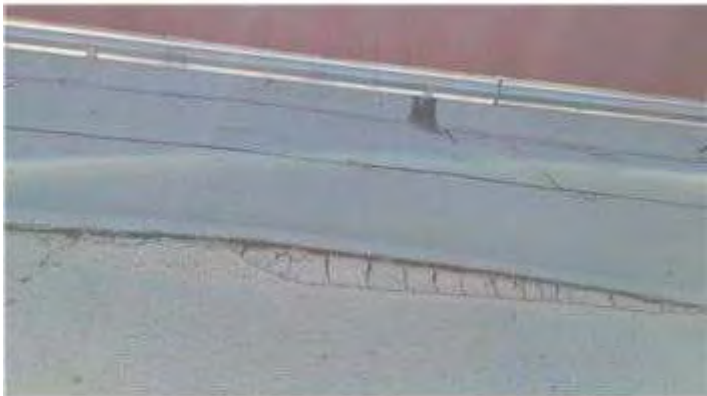
7

Blisters in field of roof

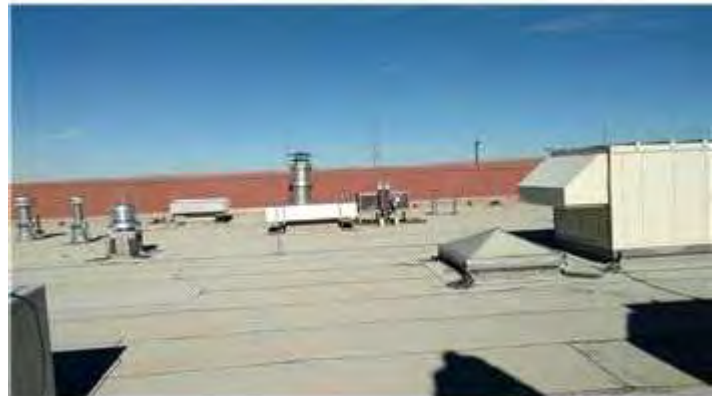
8

View of roof. Note staining of field from ridging and blisters along seams

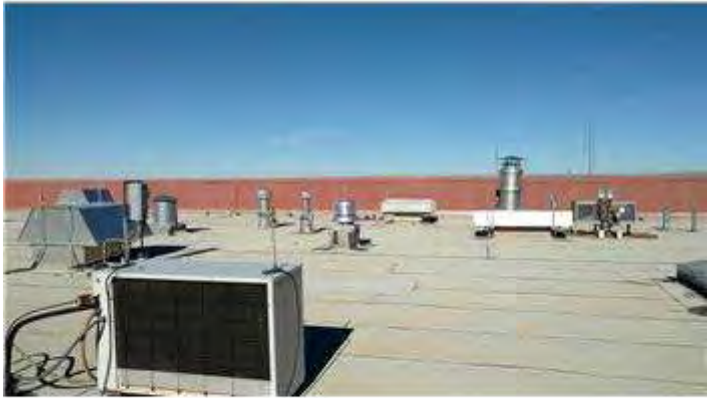
9

View of roof

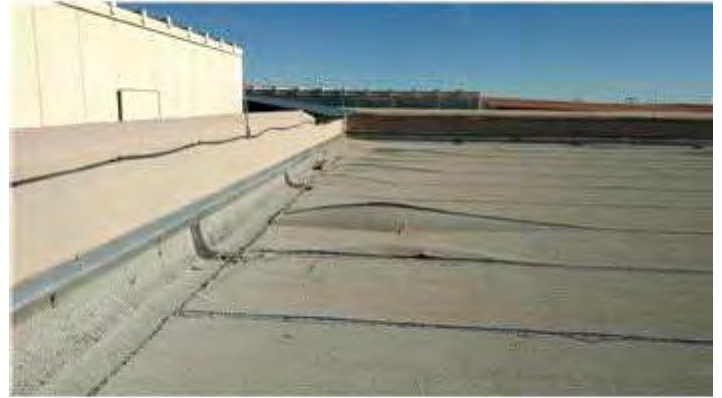
10

Mid roof with significant blistering of field and numerous open laps

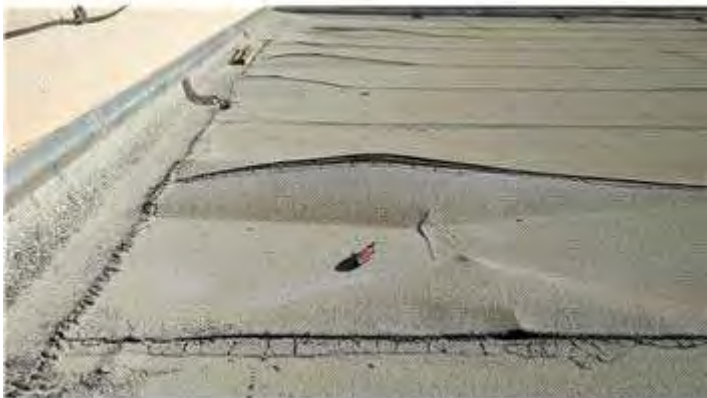
11

Scale of blisters with probe for reference.

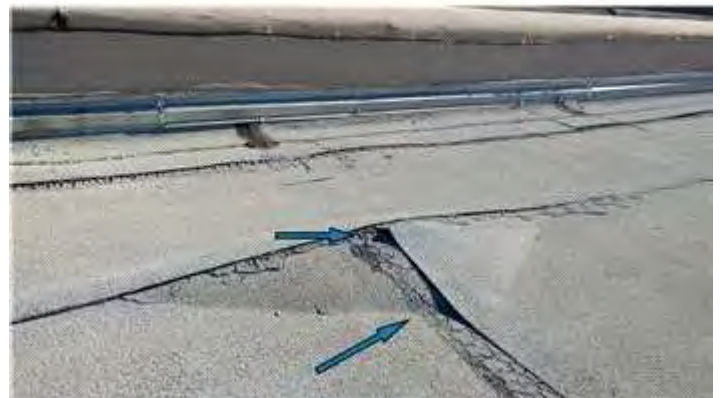
12

Blister at "T" seams causing open laps

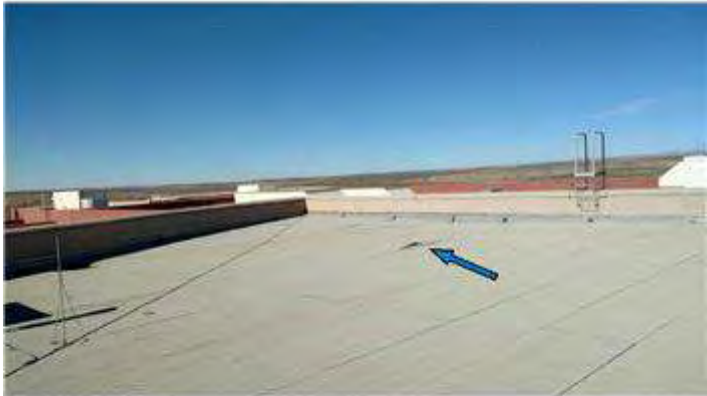
13

View of field with open laps at large blisters

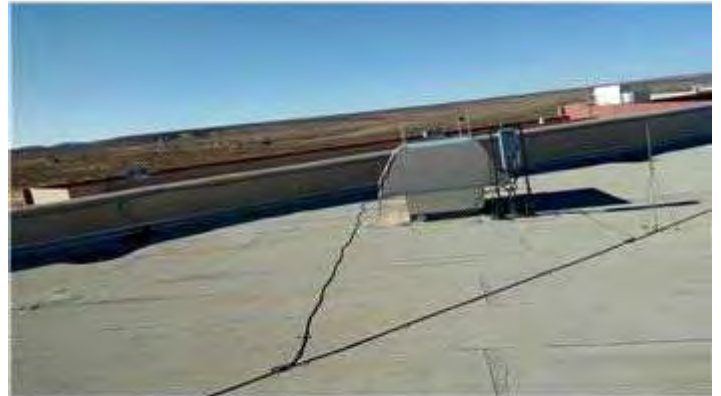
14

View of field

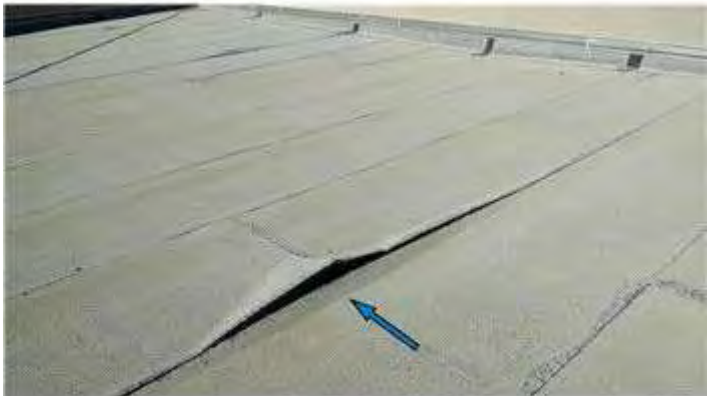
15

Blisters at seam popping open

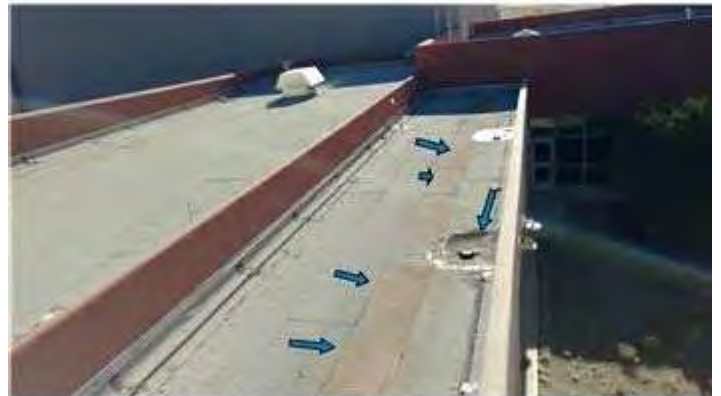
16

View of additional roof sections
Note extensive repairs in drain areas. Also not staining of cap sheet from ponding water

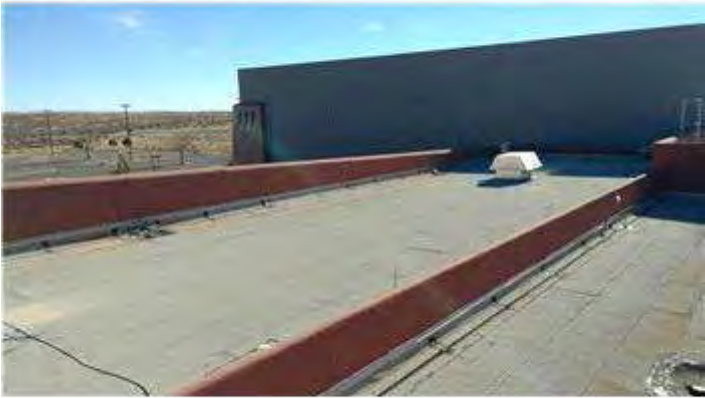
17

View of roofs

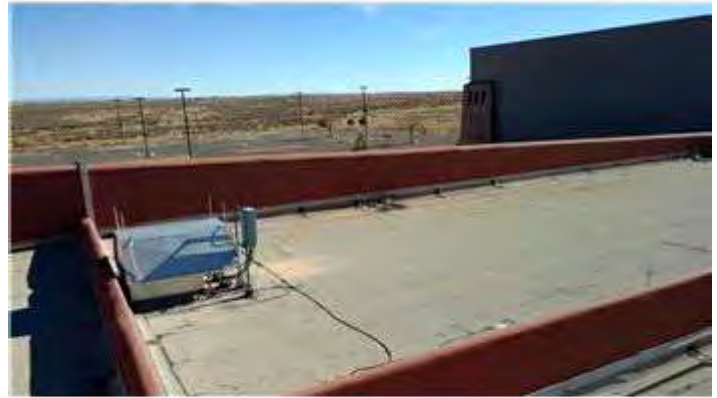
18

View of roofs

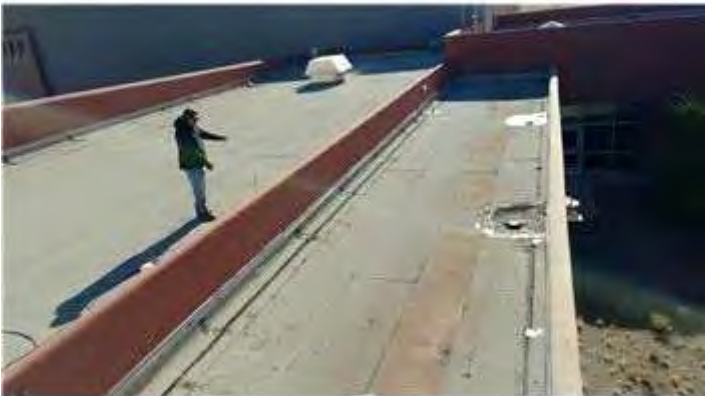
19

View of roofs. Ponding caused by lack of crickets coupled with ridging of cap sheet holding water back at seams

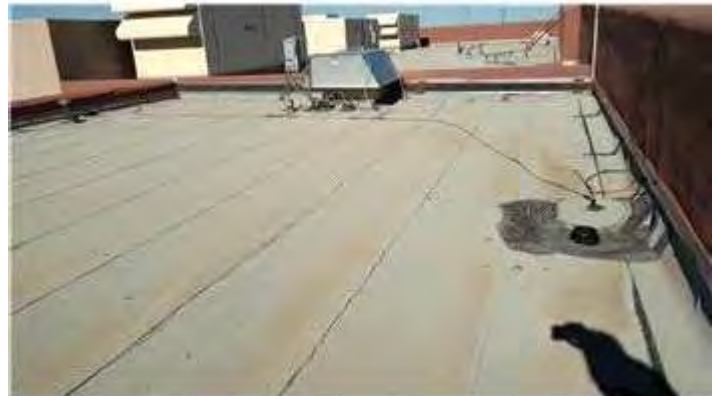
20

View of roof. Note staining on high side of each seam due to ridging and blistering

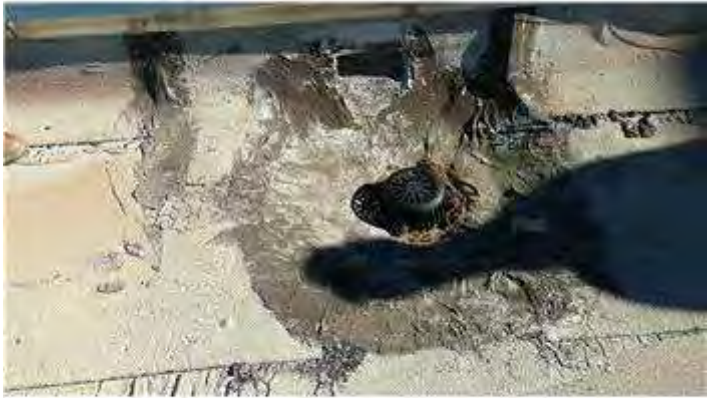
21

Past repairs at drains.

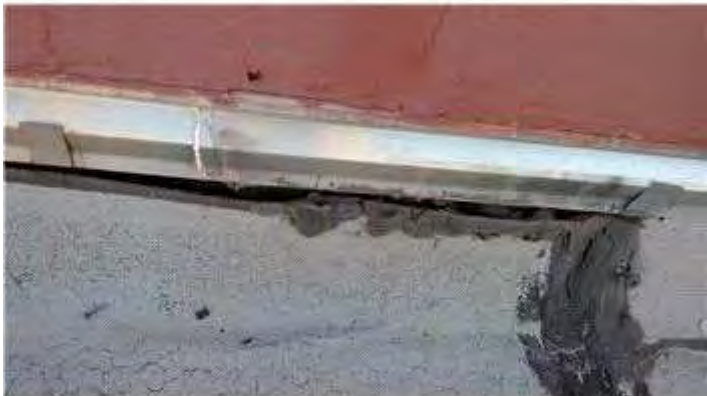
23

Wall flashings pulling loose and open from cap sheet movement

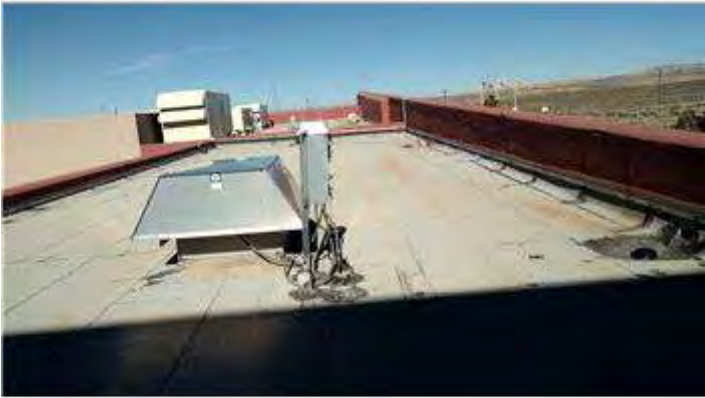
View of field of roof

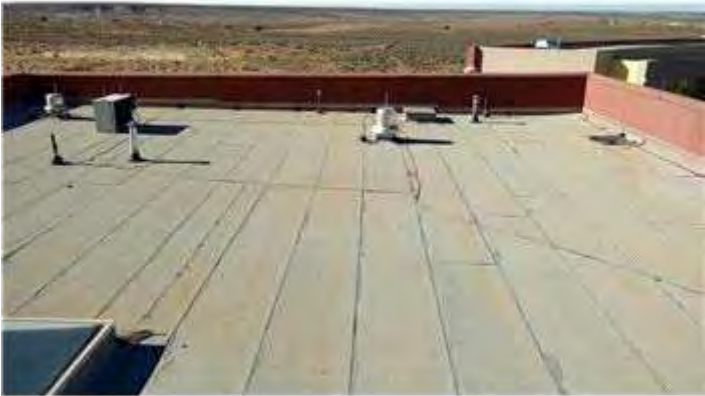
Note extent of staining across the field of the roof

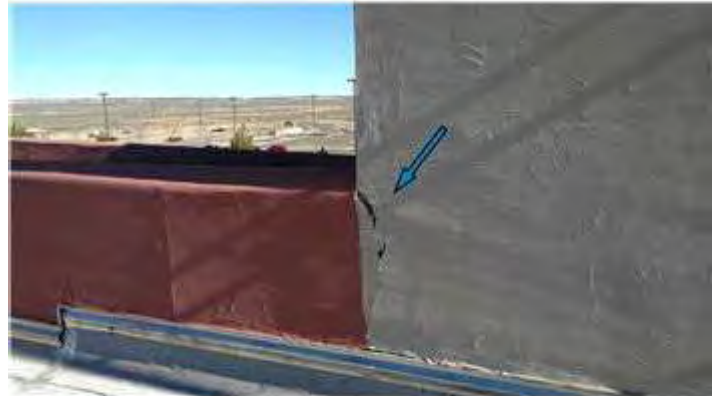
Minor stucco damage to be repaired. We noted that overall the stucco is in good to very good shape

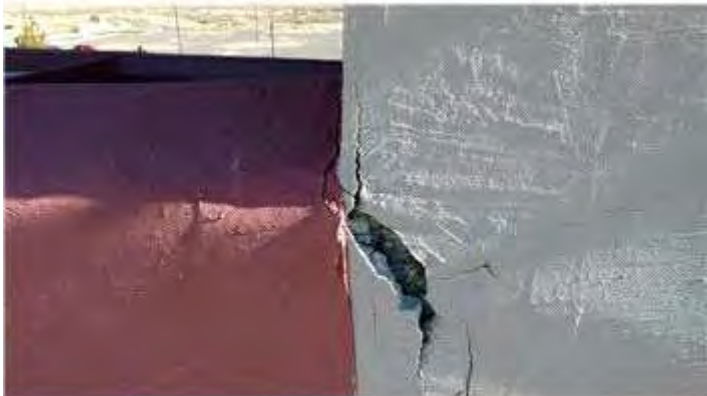
Close up of previous photo./ Corner of roof by access to gym roof

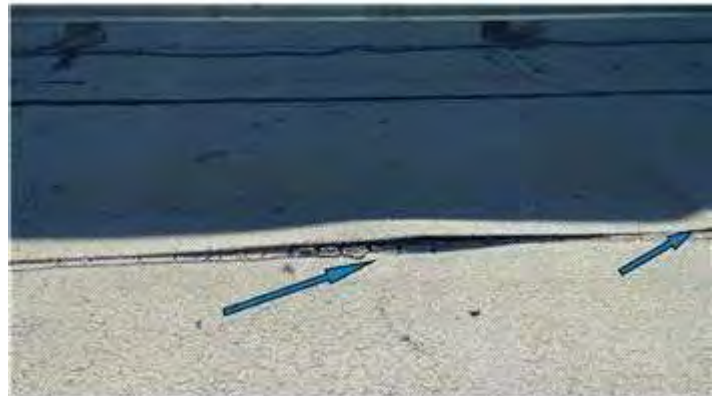
Open seams in roof

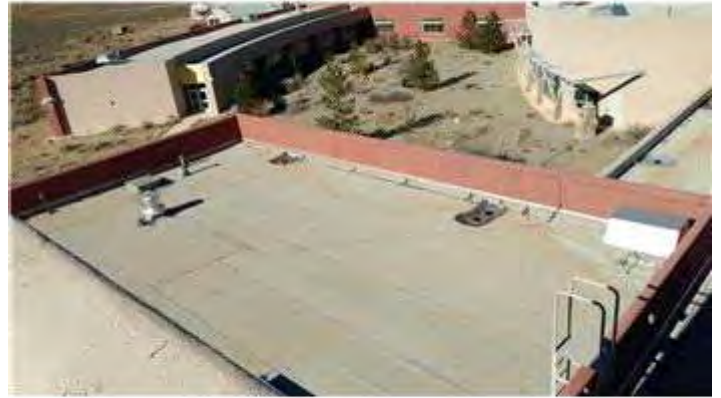
Blistering on gym roof

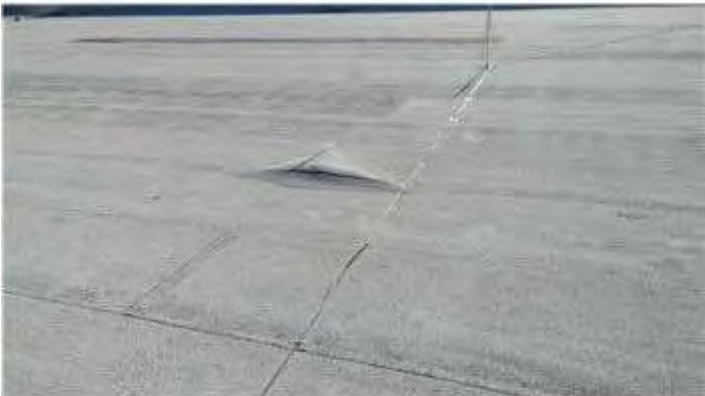
Note discoloration of gym roof from granule loss

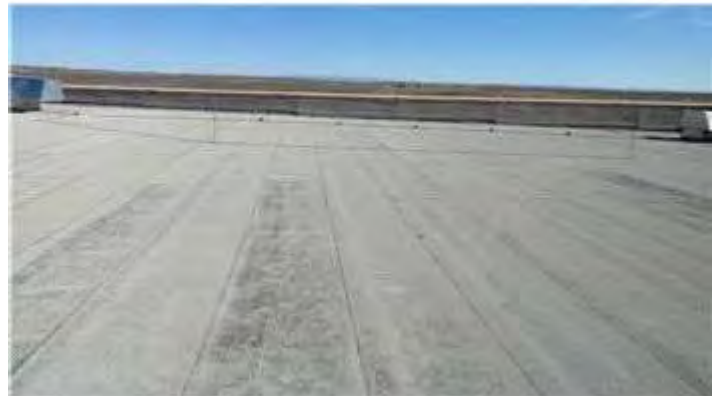
IMG_20181220_112348961
Additional photo of granule loss

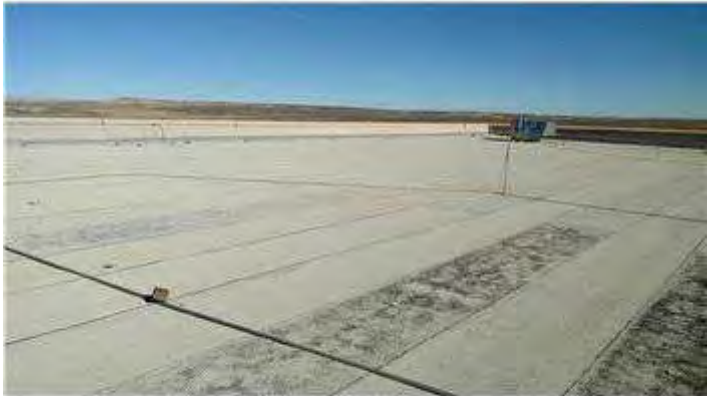
IMG_20181220_112350120
Additional photo of granule loss

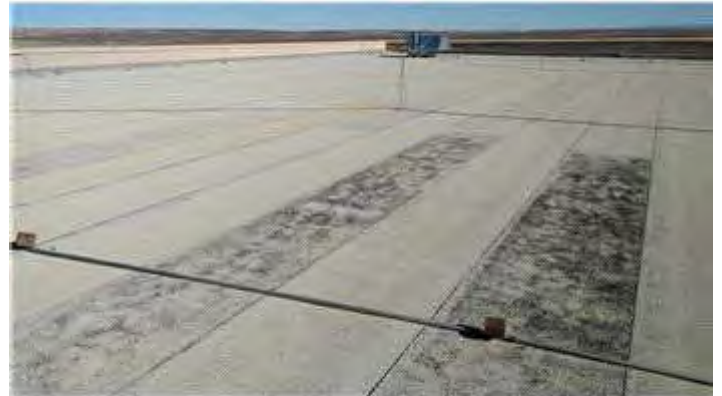
IMG_20181220_112513067
granule loss

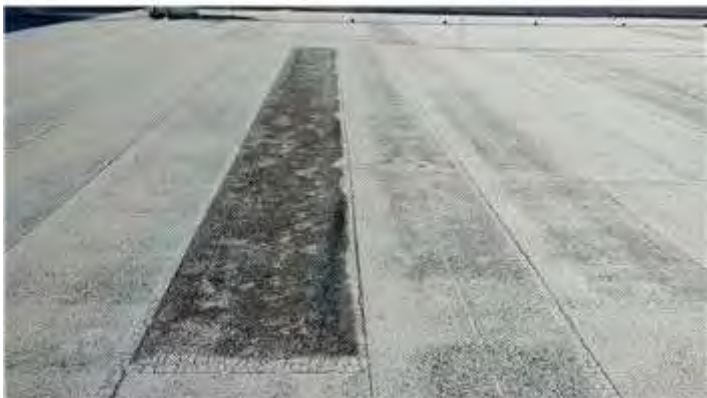
IMG_20181220_112359689
Gym roof blisters

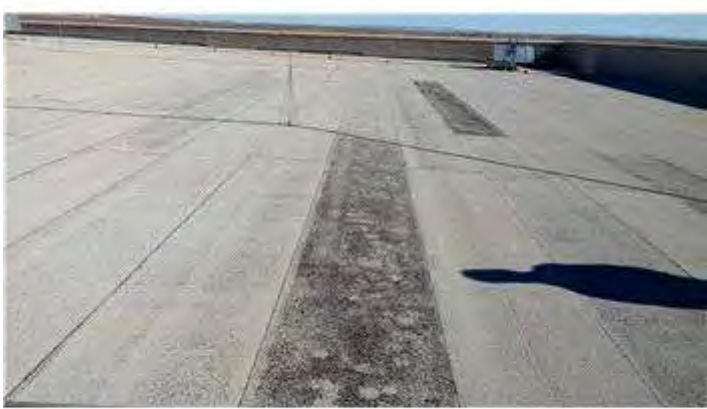
IMG_20181220_112436468
"T" seam blisters at gym roof

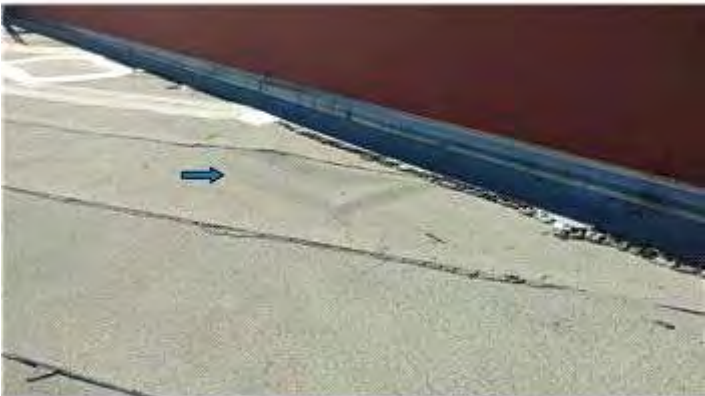
IMG_20181220_113756756
New blisters and ridging adjacent to past repairs

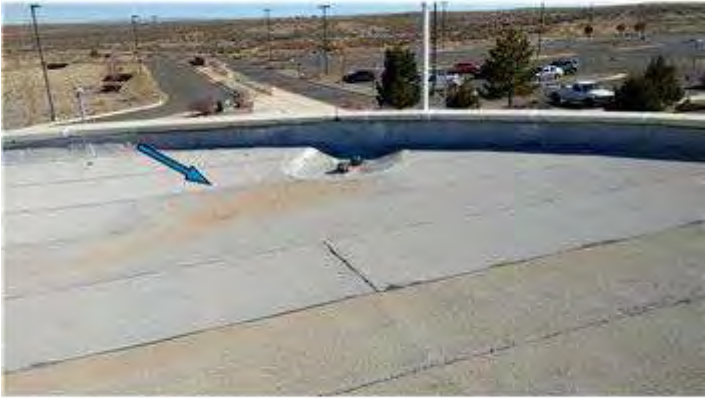
Curved roof section at main entrance to site
Some of the roof had new cap sheet installed recently. Note staining on new roof area from ponding water

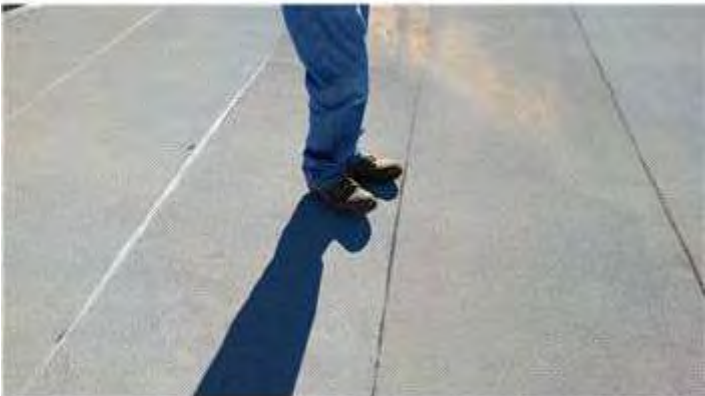
Newer cap sheet area was loose and beginning to blister

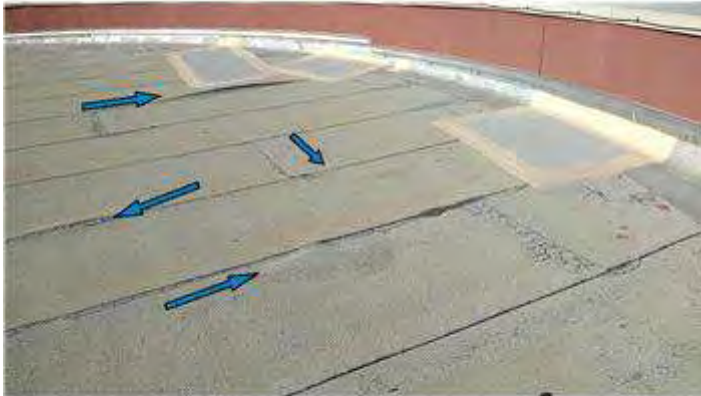
New blisters forming next to repaired areas

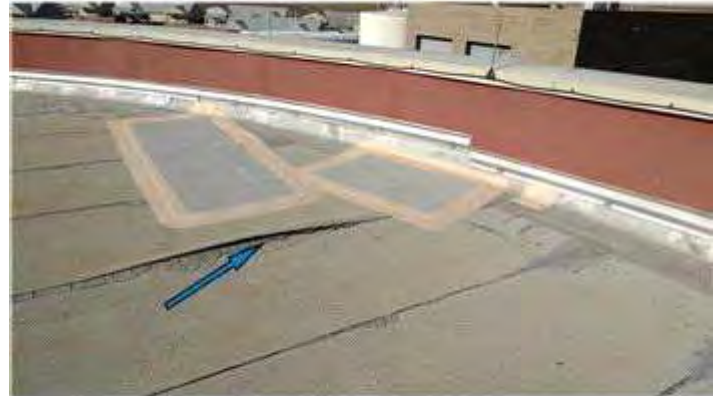
New blister has already opened up

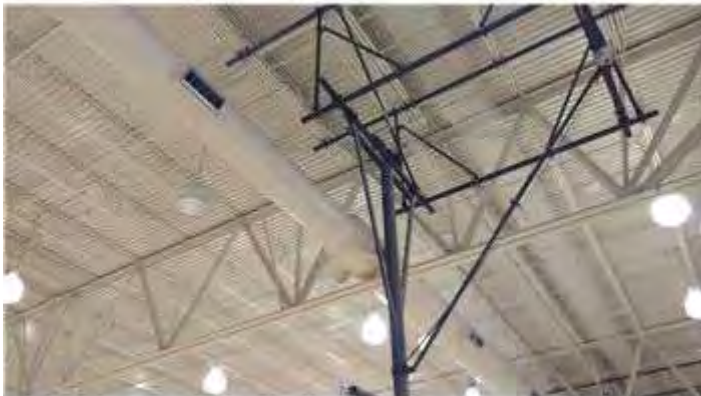
Deck for site at gym. All insulation is above deck

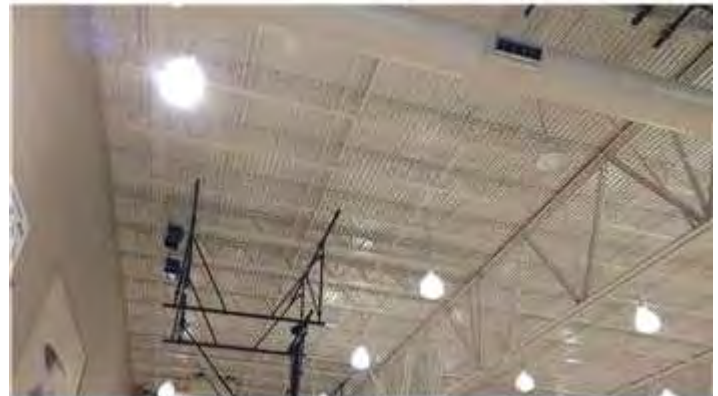
No conduit or other hazards were noted

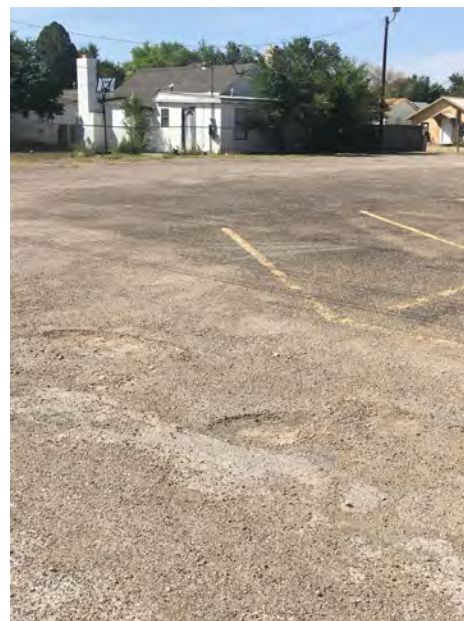
Exposed Subgrade in Existing Parking
