2019-2020 PSFA Summary of Applicant Campus

Gallup – Crownpoint Middle School (MS) **Rank: 124** **wNMCI: 35.46%** **FCI: 61.63%**

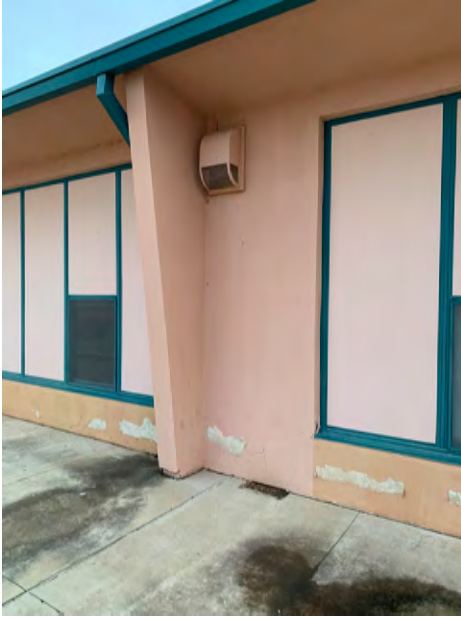
Typical Exterior Wall Construction

The original 1948 structure is in good condition for the age of the facility and can serve the community for many more years to come. The exterior walls are constructed out of load bearing concrete walls and insulated metal panel glazing system. The concrete walls are not insulated and have been plastered/painted multiple times over the years. The existing plaster/painting on the walls and overhangs is in need of patching and repair and in many areas it has begun to degrade and should be removed and replaced. The insulated metal panel glazing system is antiquated and does not provide adequate insulation and many of the seals/gaskets are leaking. The solid panels do not let in natural light or allow views to the surroundings. It is anticipated that the existing metal panel glazing system will be replaced. The gutter and metal trim around the building are in need of being repainted.

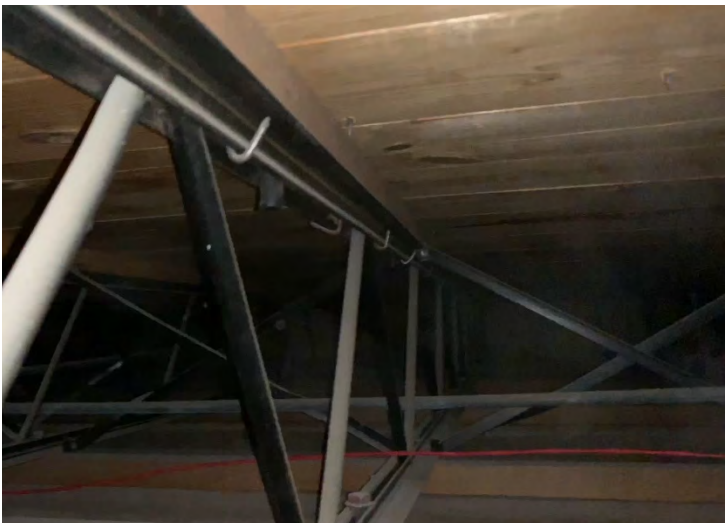
Typical Roof Construction

The roof structure is comprised of steel bar joists that rest on the exterior load bearing walls and interior load bearing brick walls that form the corridor. The roof deck is constructed of solid 1" thick wood boards. The roof structure forms a large overhang around the perimeter of the building. In 2006, the roof was replaced with a TPO membrane, polyisocyanurate insulation averaging an R30, and a 1" recovery board on top of the wood deck which is still in good condition and halfway through its expected life. Attached to the bottom chord of the existing steel bar joists is the original ceiling that should be removed if any work is performed in the ceiling cavity.

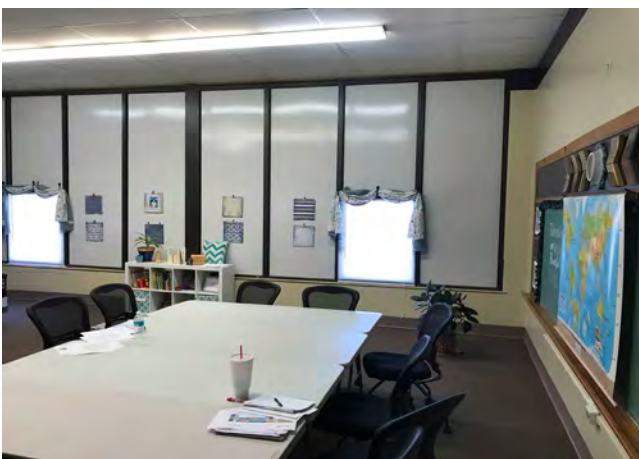
Typical Metal Panel Wall System

The wall finishes in the existing rooms is a durable plaster directly applied to masonry. For this reason all electrical components including electrical boxes, light switches and conduits are surface mounted and exposed. The current surface is not tackable and doesn't promote the easy sharing of ideas. It is anticipated that new wall furring be provided to allow for insulation along the exterior walls and new concealed electrical and data work on the interior walls.

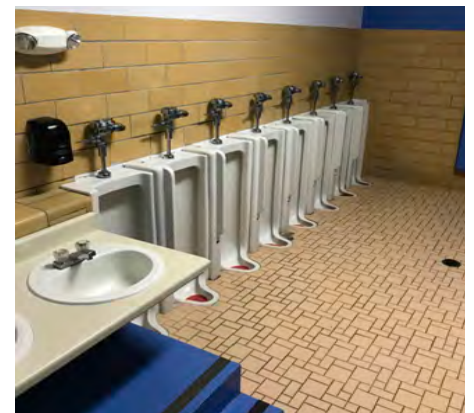
The 1948 wing of Brown Early Childhood Center currently has five common restrooms and three individual restrooms. The fixture count for the facility is well above code requirements. The restroom finishes are in relatively good condition but the existing piping is old and degraded and will need to be replaced if the facility is to be occupied for the foreseeable future. In general the restrooms should be renovated and reconfigured for higher utilization

Portales - Page 43
Typical Restroom Finishes

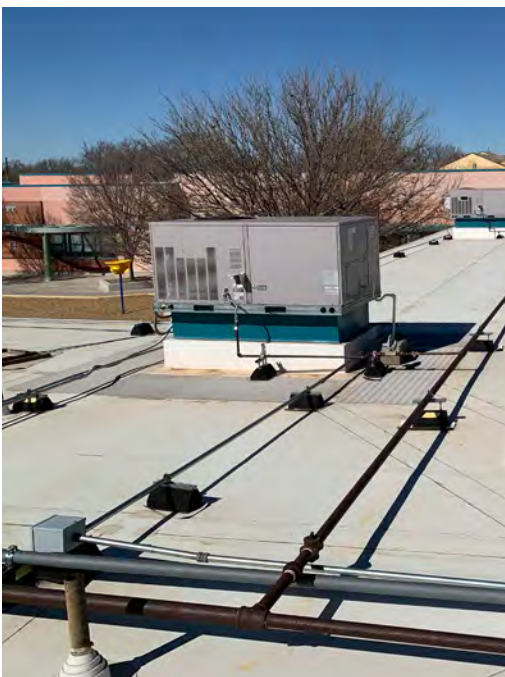
Typical Existing Roof Top Unit

The original 1948 Brown ECC is currently served by nine (9) packaged rooftop unit with DX cooling and gas heating. Each unit was installed in 2001 and are over 18 years old, exceeding their expected life-cycle of 15 years. However, the units are operational and in good working condition. Two of the existing RTU's are located within ten feet of the roof's edge and are in code violation of OSHA regulation without a railing.

The mechanical HVAC system for Brown ECC should be replaced. The existing units are over 18 years old and reaching the end of their expected life cycle. To achieve better heating, cooling and ventilation, its recommended new high SEER / high efficiency packaged rooftop air handling units (RTU) with variable speed compressors and electronically commutated motor (ECM) fan motors, a full outside air dry bulb

economizer "free cooling", a direct expansion (DX) cooling coil, and a natural gas fired furnace heating section be provided. Each RTU will provide heating, cooling, and provide minimum outside air ventilation during occupied times as required by ASHRAE 62.1 2007 for the number of occupants in each space. When outdoor ambient conditions are favorable, the use of outside air for cooling via the economizer will be utilized for energy reduction.

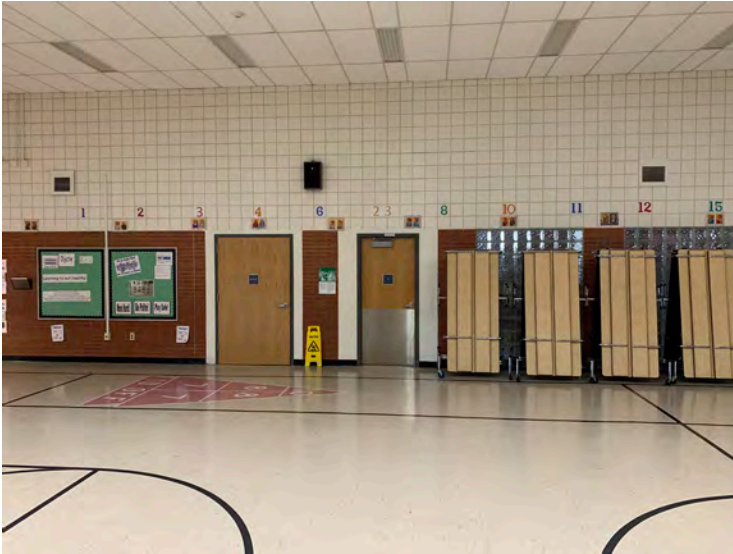
Existing Gymnasium

The gymnasium addition is served by two (2) packaged rooftop units with DX cooling and gas heating. All HVAC systems are operational and in good working condition. The supply and return air distribution system is ductwork located above the corridor ceiling to each zone sidewall air distribution. No new work is anticipated in the gymnasium.

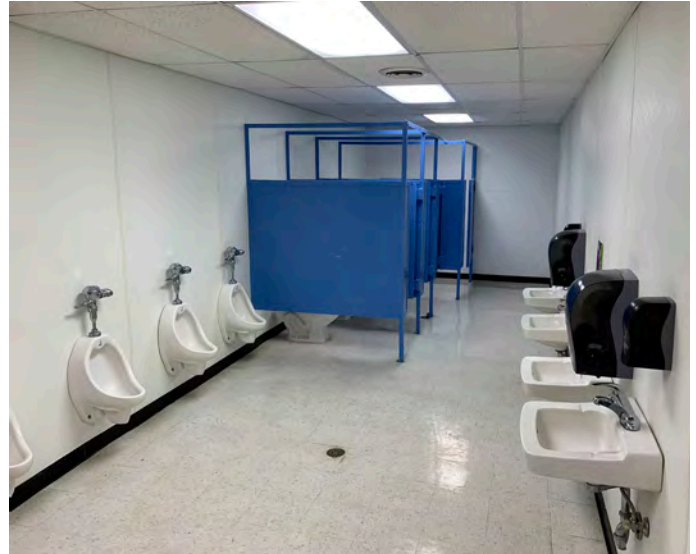
Toilet exhaust fans are present, but ventilation is generally inadequate.

Existing Restroom Ventilation

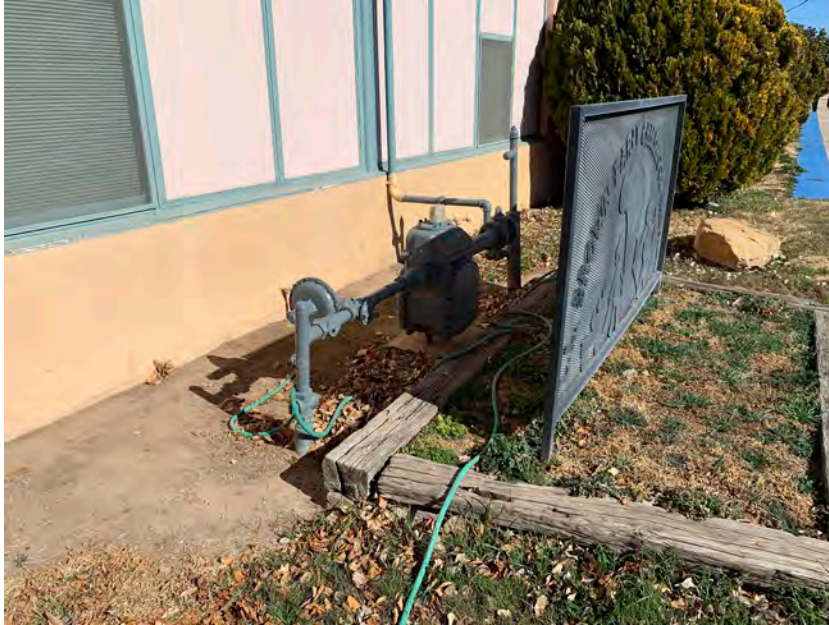
Existing Natural Gas Meter

Natural gas originates at a main located in West 5th Street. A large commercial gas meter is located on the south side of the facility. The meter may need to be replaced with a more appropriately sized unit and the regulator may need to be adjusted or replaced to accommodate the

revised loads for the anticipated future renovation. The existing rooftop distribution piping is in good condition and will remain unchanged. If new RTU's are added to the facility a new dedicated low pressure main will connect the new rooftop equipment to the meter assembly.

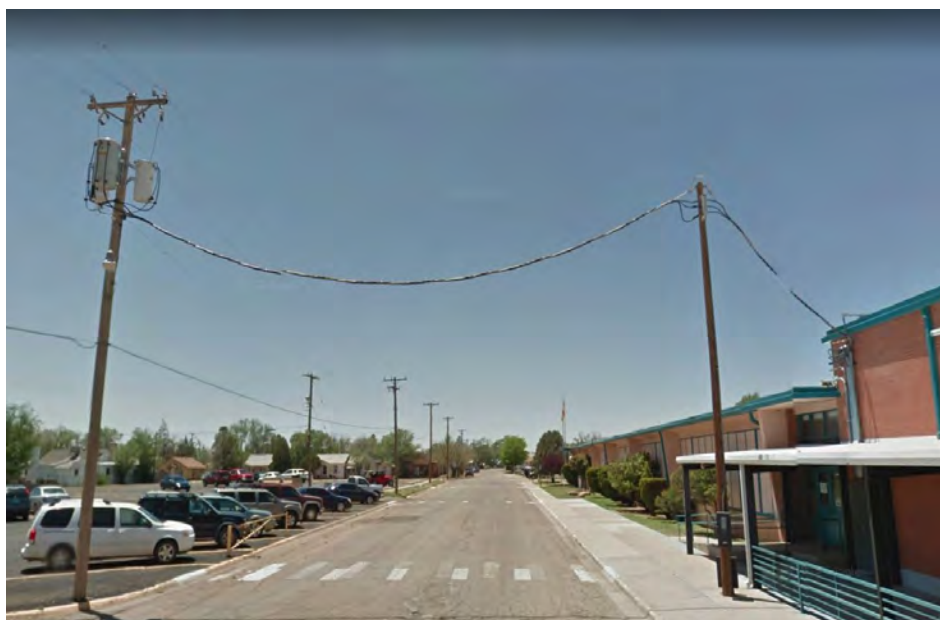
Currently an existing 800A main switchboard is fed from the primary power pole and sits outside of the building and is not in a NEMA 3R enclosure. However, it does sit under an existing canopy. Secondary feeders are routed overhead from the power pole with the transformers across to an existing weather head attached to the building. Then down to Main Switchboard (MSB) for this building. Existing electrical

Brown ECC Existing Primary Power Pole, Secondary Power Pole

The anticipated new service would be designed for 208Y/120V, 3Ph, 4W throughout the entire building and upgrading old existing 120/240V, 1Ph, 3W electrical equipment. The new main service equipment will be upsized to accommodate all items in listed above and bring up all existing deficiencies to code, PSFA adequacy, and District standards.

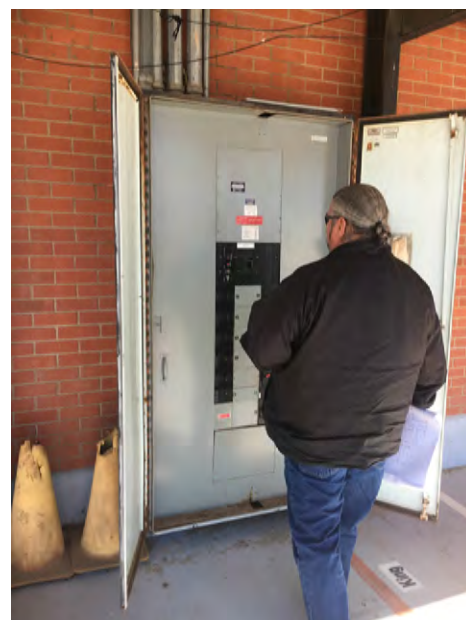
secondary distribution equipment in this facility is served with 208Y/120V, 3Ph, 4W. Existing Main Switchboard is rated for 800A.

Due to the age of the existing facility, additional issues were discovered during exploration. The existing service and distribution equipment, 400A, 120/240V, 1Ph, 3W, is very old and replacement parts are not easy to find. Existing panels throughout the building do not have capacity for additional circuits. Additional smaller load centers have been added over the years and have been tapped from the existing panels. Existing circuits and equipment sit on top of other equipment and code violation for clearances are apparent. Original main electrical equipment sits in a closet with other electrical equipment and relocating this equipment in its own room would greatly improve safety.

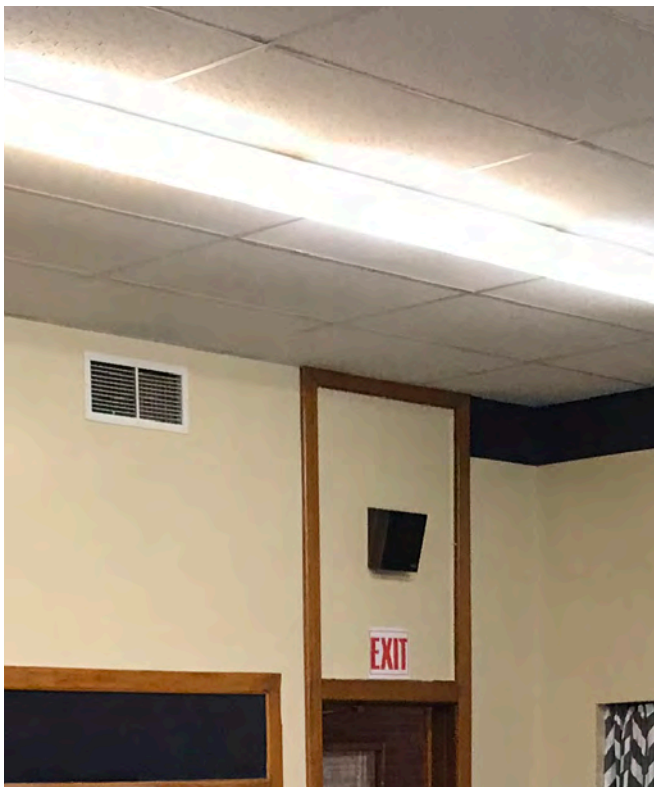
Existing Intercom

The existing Rauland intercom system at Brown Early Childhood Center has a faulty SW-25 switch bank with several defective ports. Each port is required to connect each classroom individually. Due to the unit having several defective ports, several classrooms have been connected together to enable announcements to be heard. However, this fix prevents the classrooms that were on the bad ports and now connected to another classroom, from being able to use the call button in that classroom to call the office. The faulty Rauland SW-25 switch bank is end of life and no longer manufactured. The District anticipates replacing this system with any future renovations.
